*Middle Waikato Bed Degradation  
Investigation Stages III & IV.*

*Contract number: AM2004/5-30*

**Proposed Middle Waikato River  
Bed Degradation Management  
Strategy - Appendices**

Mid-Waikato Bed Degradation Investigation Stages III and IV  
River Bank and Infrastructure Condition Photographs - May 2005

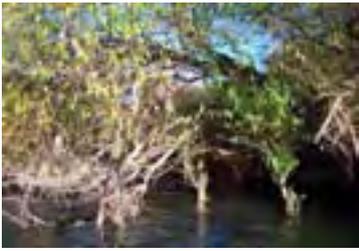
km 106.8L

106.60	WP126		L		Hummocky, vegetated, moderately steep slope.
106.60	WP126		R		Shallow fall/ slabbing failures (1-3m high cut).
106.80	WP127	km106.8L.jpg	L	Spillway from WWTP.	Protected by willow trees.

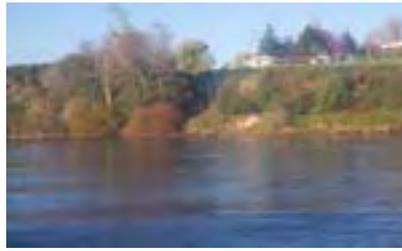
km 107.25L

106.80	WP127		R	Houses.	Riprap bank protection. Evidence of ongoing active erosion. Houses set back from river.
107.25	WP128	km 107.25L.jpg	L	Wide road reserve.	Soil failure; shallow beach with high terrace behind. Benched slope.

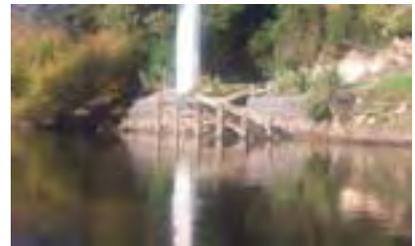
km 108.7L

108.50	WP138		R	Private property	Houses at top of steep arcuate scarp. Slope tree covered; trees will need to be maintained to maintain stability.
108.70	CS54	km 108.7L.jpg	L	Pukete Sewer Bridge	Pumiceous silt/ sand bluff. Gabions fronting abutment appear already above surface of beach. Gabion baskets also around pier of bridge. Jetty access, abutment and in-river piers will be vulnerable as a result of bed degradation.

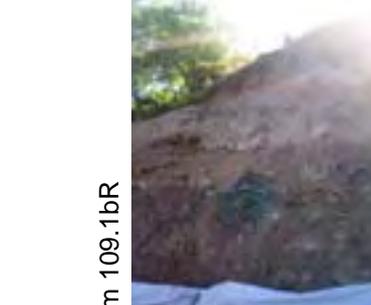
km 109.1bR

109.10	WP145	km 109.1bR.jpg, km 109.1cR.jpg, km 109.1dR.jpg	R		Fallen trees. Recent cut prepared for walkway; bench too narrow to maintain stability if lower slope lengthened due to degradation.

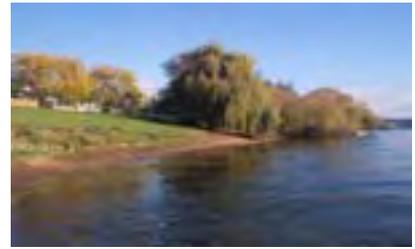
km 109.2dL

109.2	3.1	CS55	Yes	L	Ad-hoc 25-m long retaining structure, with localised gabions at toe.	Property	Moderate	Gabions already failing due to shallow foundation depth. Uneconomic to provide engineered solution.

109.20	CS55	km 109.2dL.jpg	L		Broken retaining wall with gabion baskets, bent trees, active movement. To South, short bank gently sloping with terrace behind; soil creep in terrace slope.

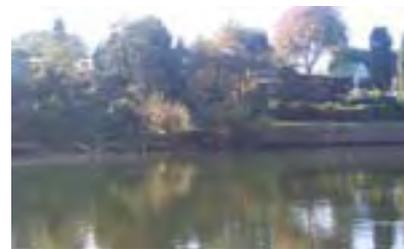
km 110.2aR

110.20	WP160	km 110.2aR.jpg, km 110.2bR.jpg	R	Private property, jetty.	Retaining wall may be undermined by bed degradation.
110.30	WP161	km 110.3R.jpg	R		Timber retaining wall, 2 tiers - lower tier likely to be undermined as a result of bed degradation.

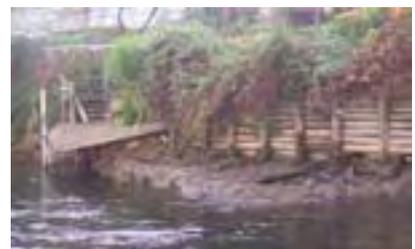
km 110.4aR

110.4	3.1	WP162	Yes	R	Timber retaining wall and landing	Property	Moderate	Landing has failed. Timber retaining wall scheduled to be replaced by sheet pile wall in near future.

Distance from river mouth, km	Beca waypoint/ cross-section No.	Photo Filename	Bank	Feature	Bank Condition Comments
110.40	WP162	km 110.4aR.jpg, km 110.4bR.jpg	R	Retaining wall and jetty.	Adhoc retaining structures undermined by about 0.5 m at present. To be sheetpiled? Soils appear fairly competent in bank toe. Gabions in lower slope. Just upstream banks steep, vegetated, fallen rocks at toe.

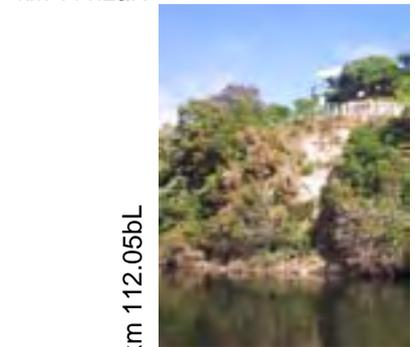
km 112.05bL

111.90	WP174	km 111.9aL.jpg	R-L		
112.05	CS59	km 112.05aL.jpg, km 112.05bL.jpg	L		Hummocky slope failing next to sheet-piled outfall (3 sheetpiles at 2 m spacing and timber). Loss of material below; walkway above; houses beyond. Bare of vegetation.

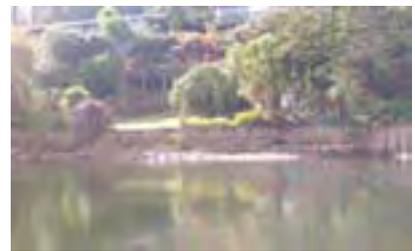
km 112.8aR

112.80	WP185	km 112.8aR.jpg, km 112.8bR.jpg	R		Retaining structures.
112.90	WP186	km 112.9cL.jpg - km 112.9gL.jpg	L	Private property	Substantial timber retaining wall (depth of piles unknown, degradation may affect it). Much loose rubble debris at bank face, houses behind. Becomes willow protected.

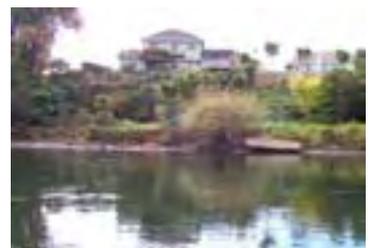
km 113.2R

113.2	2.9	WP187	Yes	R	Failed timber jetty	Property	Moderate	Needs reconstruction

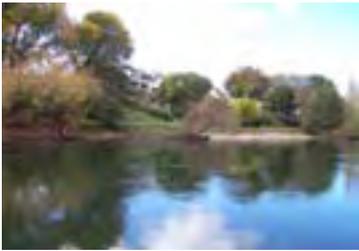
km 113.3R

113.3	2.9	WP188	Yes	R	75-m long timber retaining wall, set back from water's edge	Property	Slight	Probably no action required
113.5	2.9	CS61	Yes		Fairfield Bridge	Infrastructure	Severe	Two piers in river. Review record drawings for impact of bed degradation

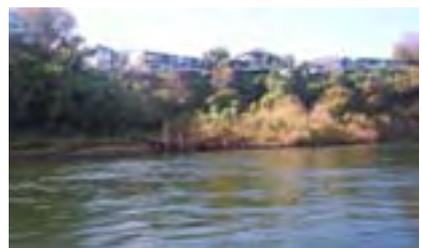
km 114.5R

114.5	2.9	WP209	Yes	R	Timber landing	Property	Moderate	In dilapidated state
114.7	2.9	WP210	No	L	Timber steps	Property	Slight	Will need extending
115.4	2.9	CS64	Yes		ECMT Railway Bridge 6 and Claudelands Bridge	Infrastructure	Severe	Left bank slip immediately downstream of rail bridge has been retained; bridge abutment assumed to be safe on bored piles. Two piers in river, rail bridge pile caps about 0.5 m above water level. Review record drawings for impact of bed degradation

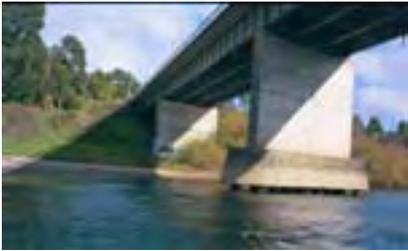
km 118.5L

118.5	2.6	CS68	Yes		Cobham Bridge	Infrastructure	Severe	Two piers in river, with pile caps just above water level. Review record drawings for impact of bed degradation

118.00	WP251		R		Shallow beach; slope behind moderate.
118.50	CS68	km 118.5L.jpg	L	Cobham Bridge	Beach elevated. Protection may be required downstream of pile slab if bed degradation occurs.

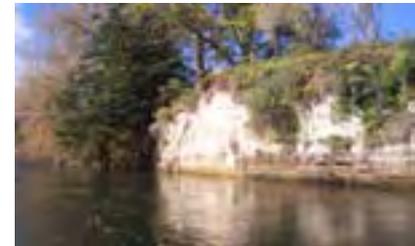
km 119.5L

119.40	WP264	km 119.4R.jpg	R	Hamilton Gardens	Sheetpile wall. Rockfall along discontinuities.
119.50	WP265	km 119.5L.jpg	L		Spalling and slabbing of subvertical cliff.

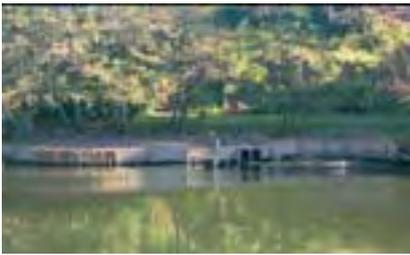
km 126.7L

126.70	WP291	km 126.7L.jpg	L		Active sliding/ creep on old landslide surface.
126.70	CS75		L		Timber retaining wall facing with riprap in behind; private effort, no value on bed degradation.

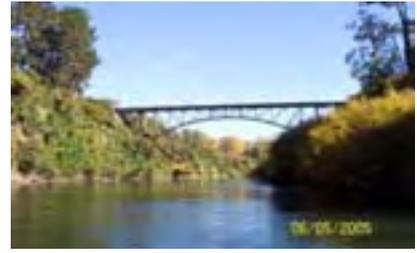
km 142.0

142.0	<i>0.6</i>	CS18	Yes		Victoria Bridge, Cambridge	Infrastructure	Slight	Arch bridge, abutments clear of river
142.8	<i>0.5</i>	CS16	Yes		Fergusson Bridge, Cambridge	Infrastructure	Moderate	Piers founded in river banks of alluvial sandy Hinewera Formation. Rock fall in zone fronting piers triggered by deepening of bed may expose piers and require remediation
