# Estuarine Vegetation Survey : Inner Firth of Thames

Prepared by:  
Meg Graeme M.Sc,  
Natural Solutions  
Marine & Terrestrial Ecologists Ltd

For:  
Environment Waikato  
PO Box 4010  
HAMILTON EAST

June 2006

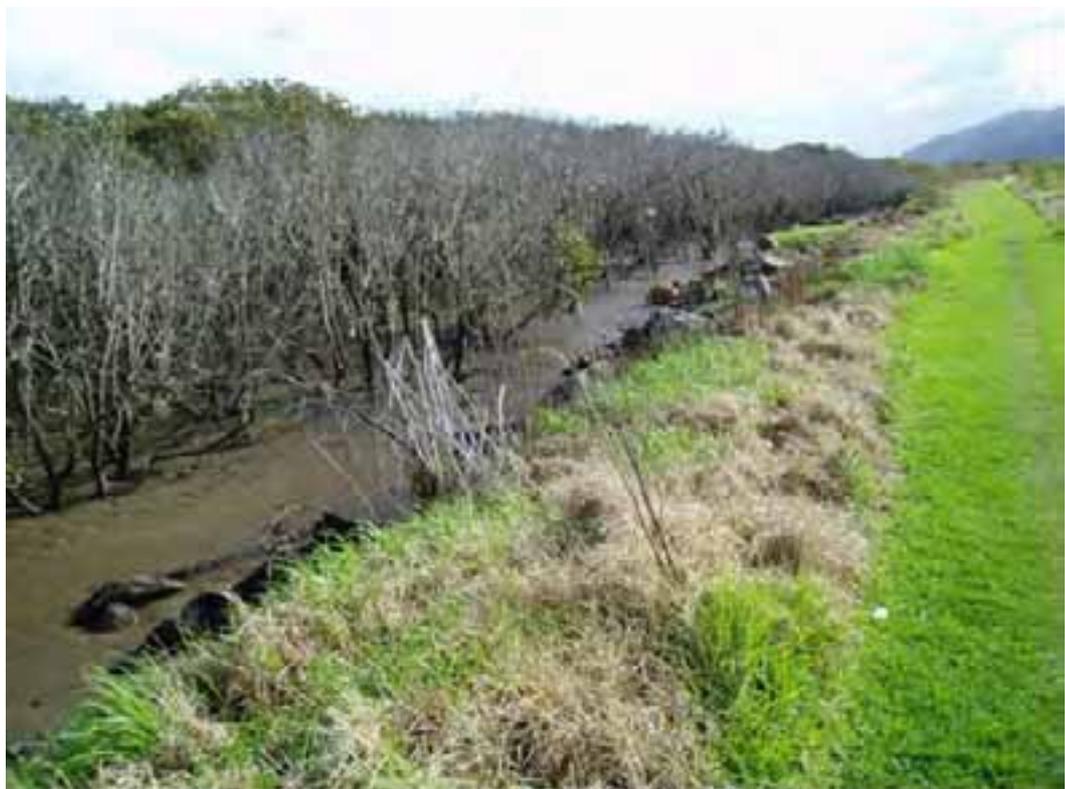
**Figure 3:** Dead mangroves and 'hard fill' edge backing mangrove band along Thames township foreshore – new subdivision at mouth of Kauaeranga River.

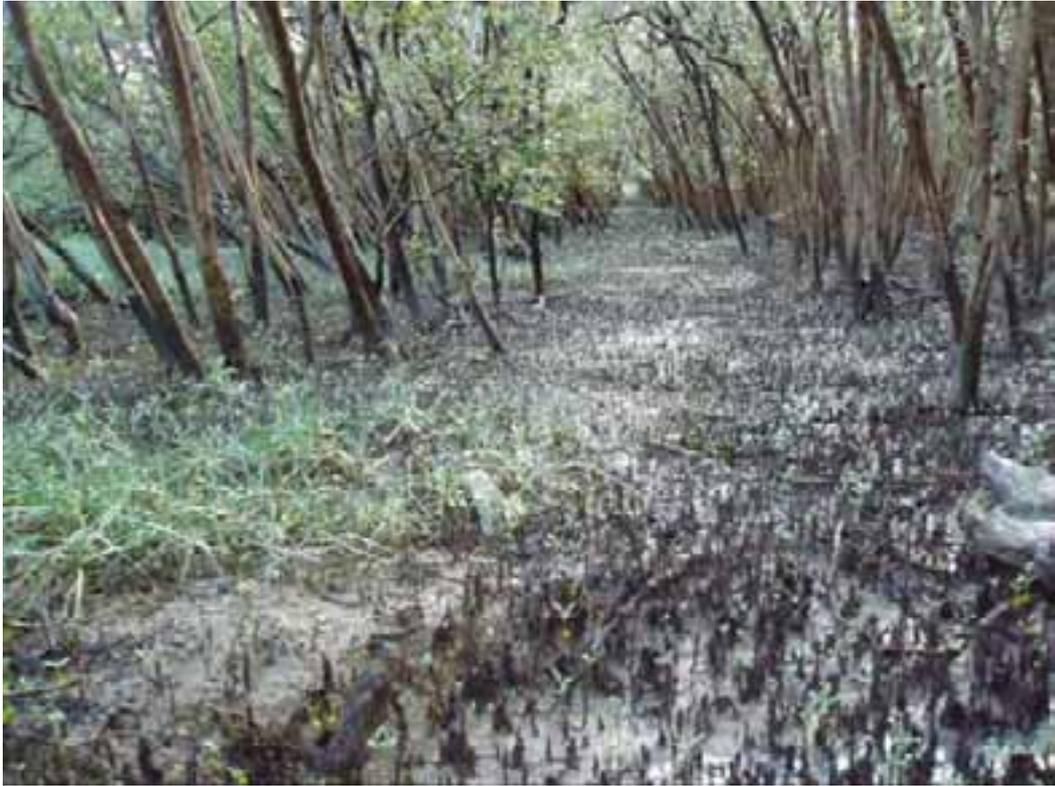
**Figure 6:** An old track cut through the mangroves and patches of spartina in the mangal beside the Thames Toyota factory on the true right bank of the lower Kauaeranga River.

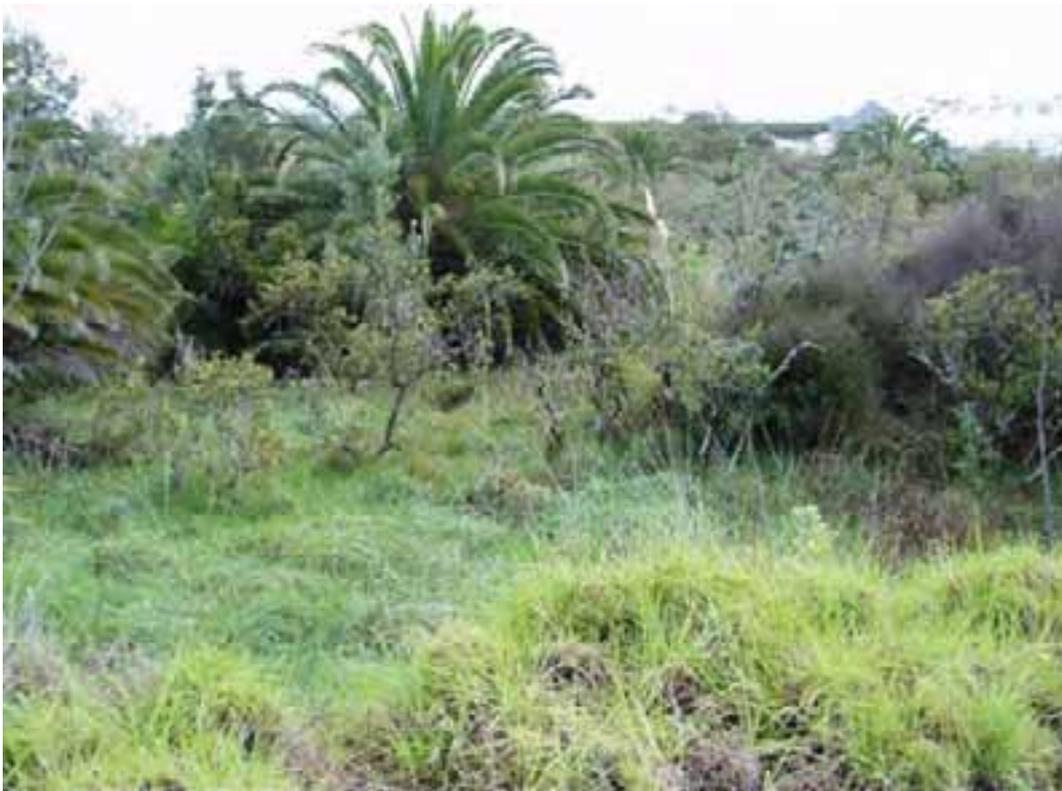
**Figure 8: Saltmarsh ribbonwood, mangroves and karo competing with introduced weeds (phoenix palms, tall fescue, honeysuckle, wattle and smilax between the SH 25 bridge and the Toyota factory).**

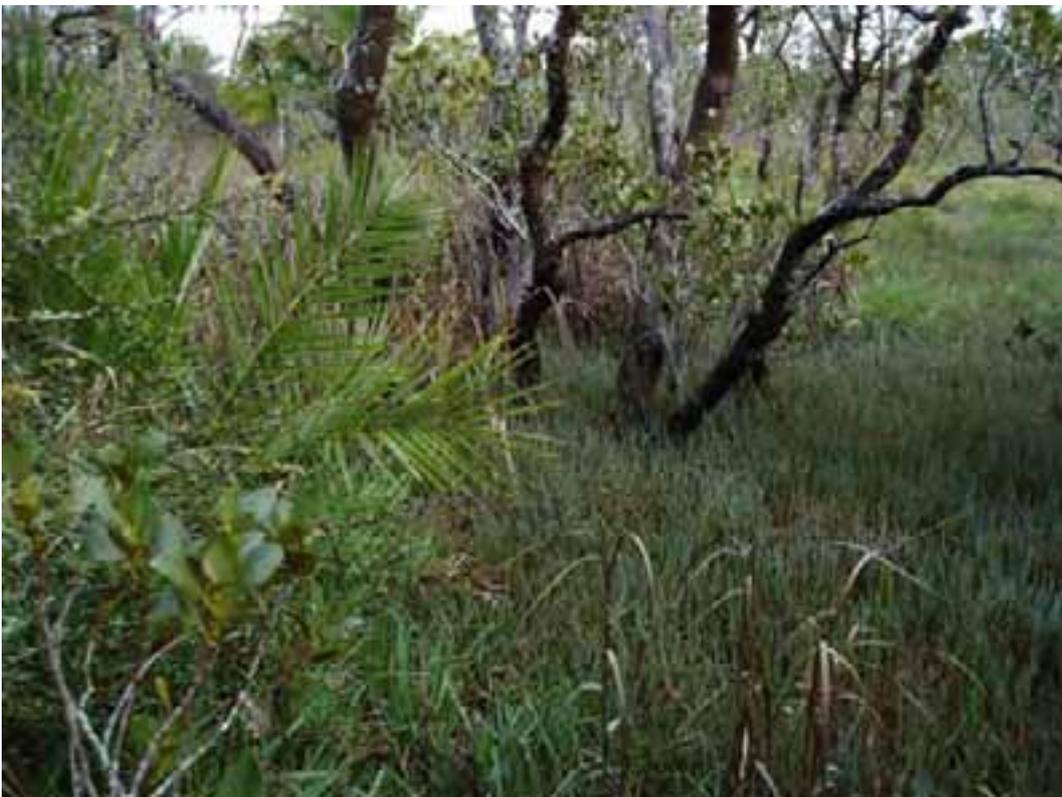
**Figure 9: A phoenix palm seedling and buffalo grass growing amidst glasswort, mangroves and marsh clubbrush (between SH 25 bridge and the Thames Toyota factory).**

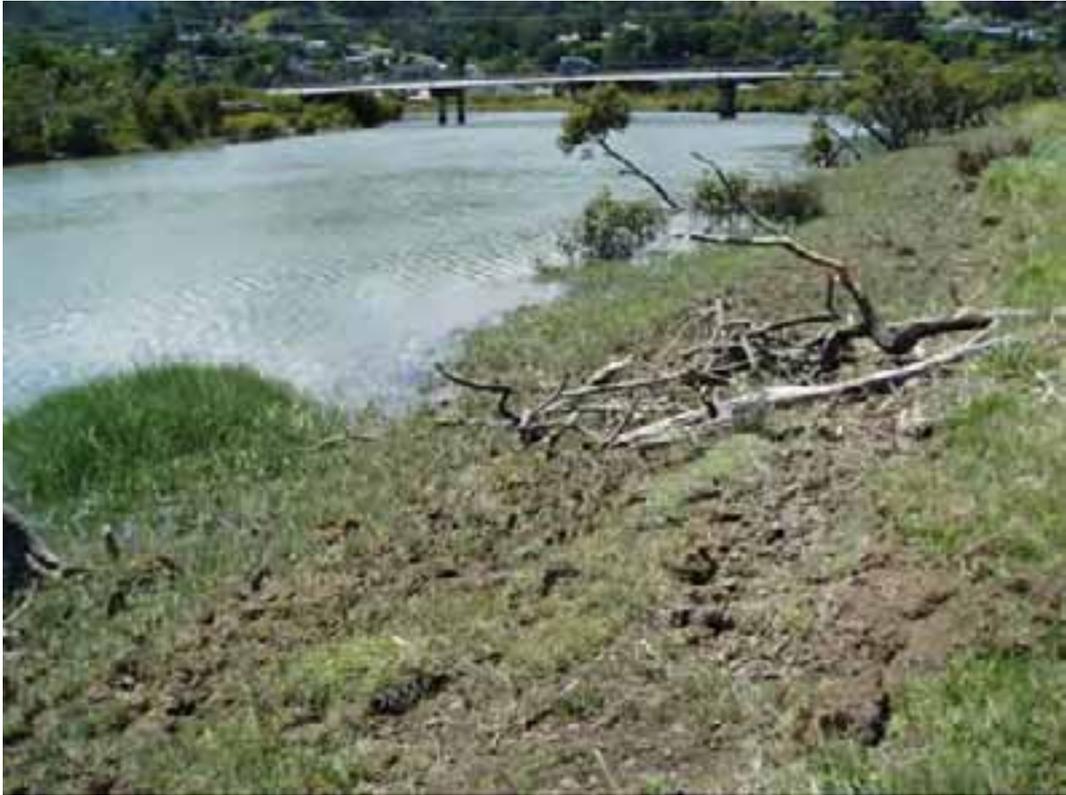
**Figure 10: Pugged spartina on the lower true left bank of the Kauaeranga River.**

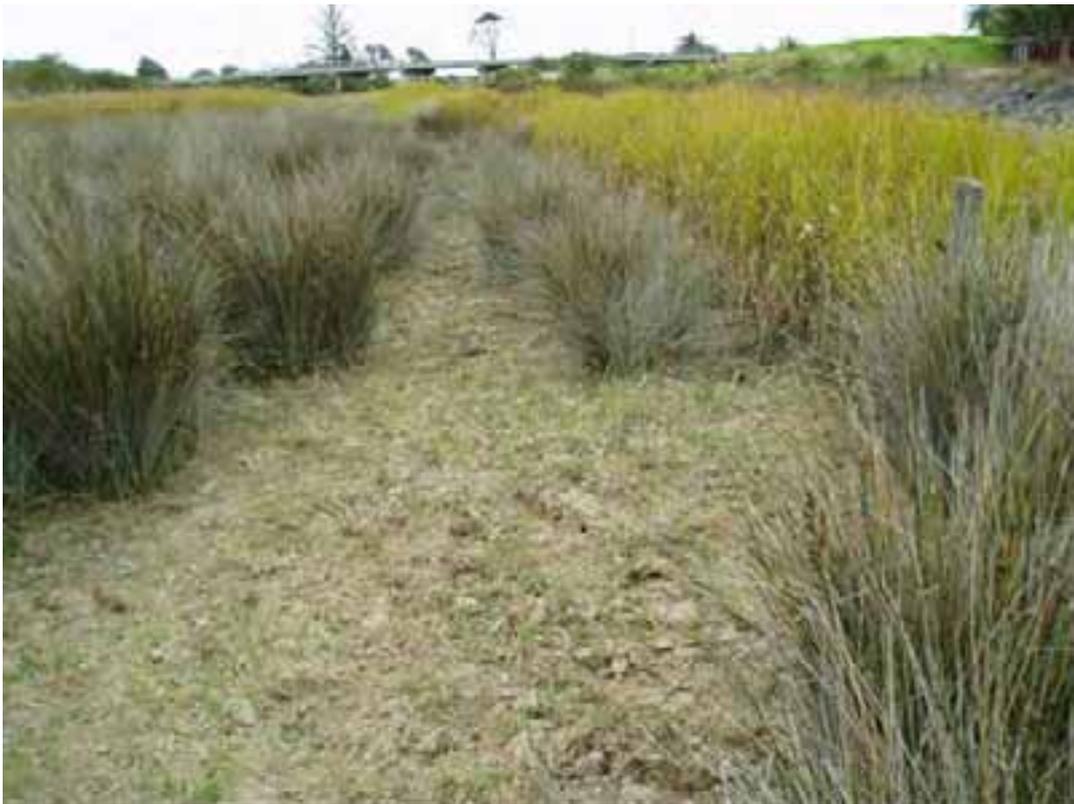
**Figure 11: A grazed area of the lower Kauaeranga floodplain upstream of the SH 25 bridge. The swamp clubrush has been preferentially grazed out leaving patches of sea rush and heavily grazed spartina.**

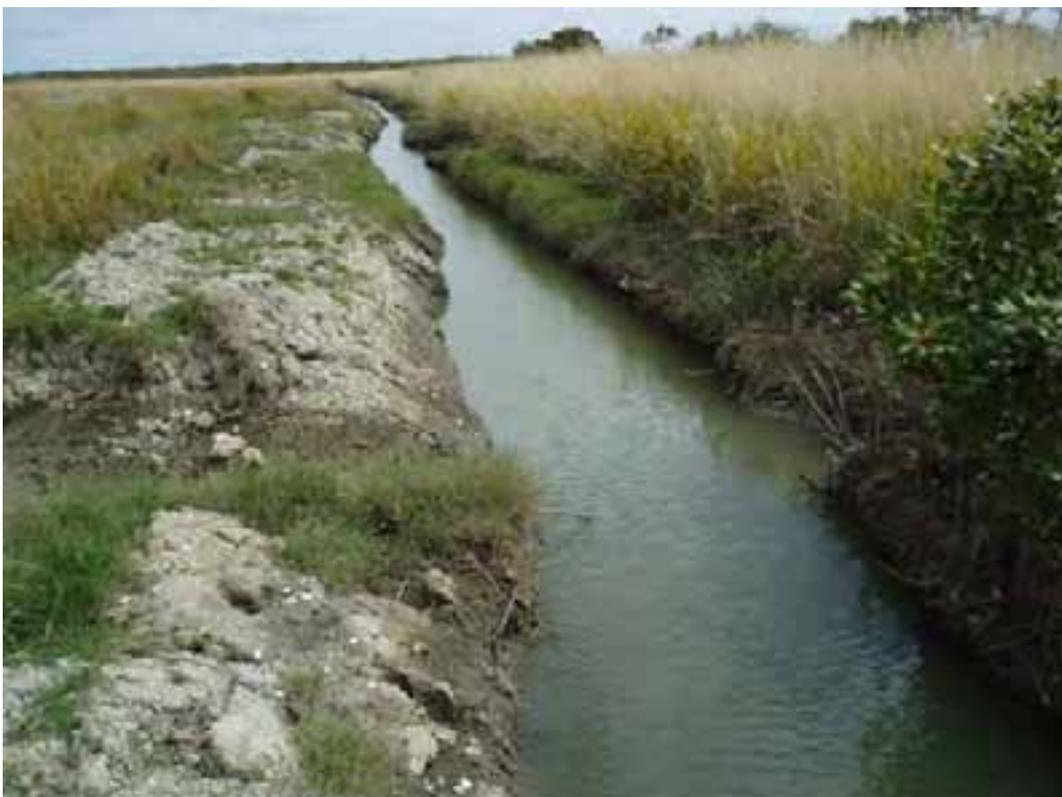
**Figure 13:** Saltwater paspalum (grey green in foreground and middle ground) lined a newly dug drain near the motor cross field, Kauaeranga River.

It is also strongly recommended that the few pioneer populations of saltwater paspalum be controlled at the same time, before this weed has an opportunity to spread further afield. Saltwater paspalum has shown itself to be an aggressive spreader throughout the mid and upper tide zones (Graeme & Kendal, 2001). It particularly threatens low-stature sea meadow communities. The few pioneer populations of saltwater paspalum should be eradicated as soon as possible. This can be undertaken using Gallant herbicide and so it would be a wise use of resources to co-ordinate the spraying of saltwater paspalum with the spartina control programme. The effects of Gallant in estuaries have been extensively researched and it has been successfully used to control saltwater paspalum in the Matua Estuary in Tauranga. It should only require a slight variation to the current spartina consent to include the control of the small saltwater paspalum populations in the Firth.

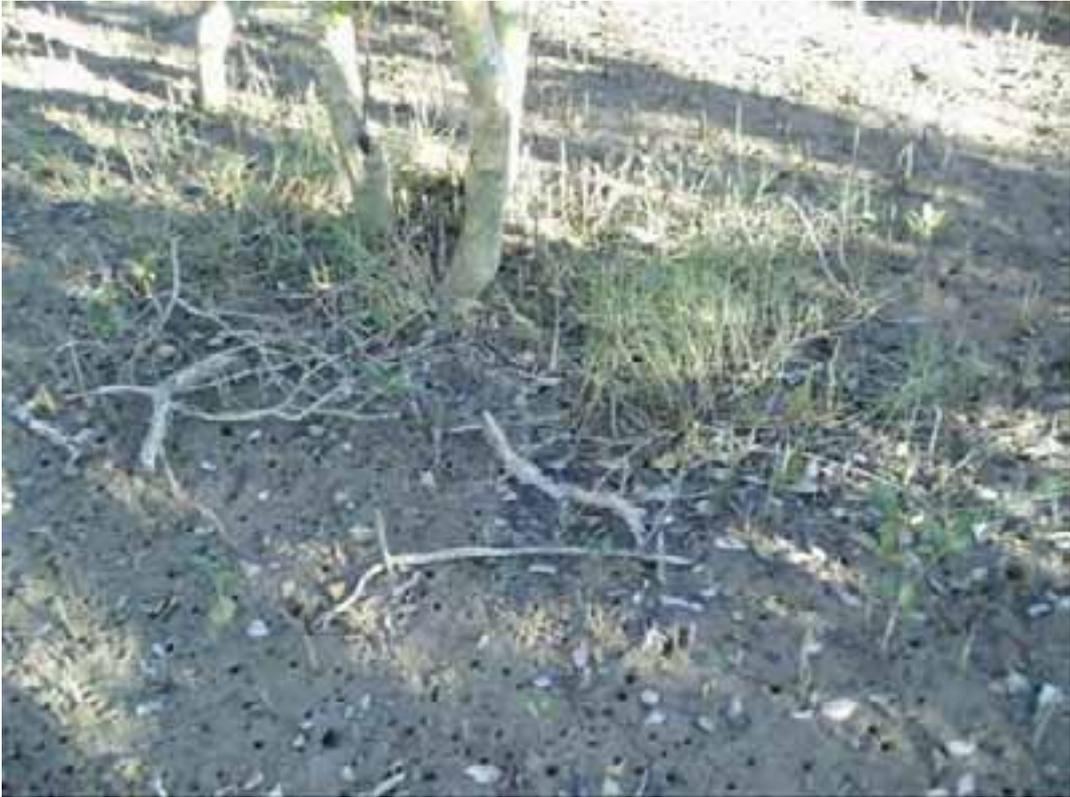
**Figure 18:** A small patch of saltwater paspalum found under open mangal canopy (opposite treatment ponds).

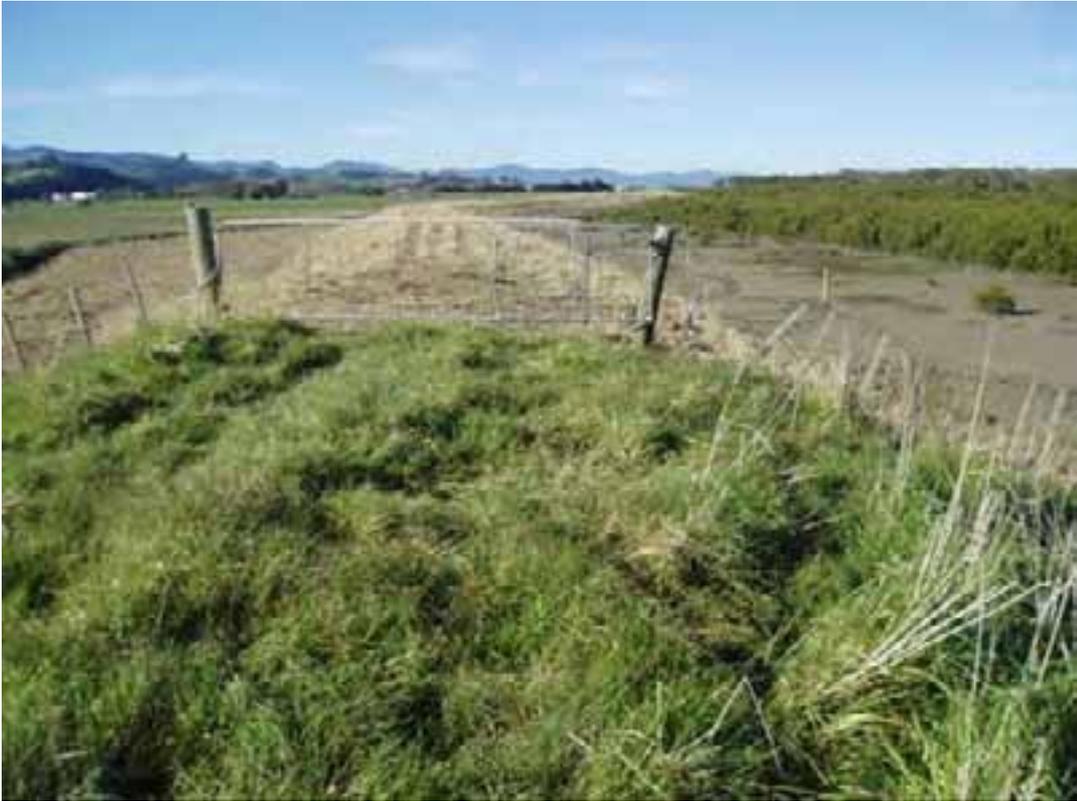
**Figure 20:** Heavy stock grazing of the stopbank and stock pugging and grazing of the open flats, sea meadow and mangrove edge (south of the treatment ponds). A thick bank of young mangroves is visible in front of the mature mangrove boundary.

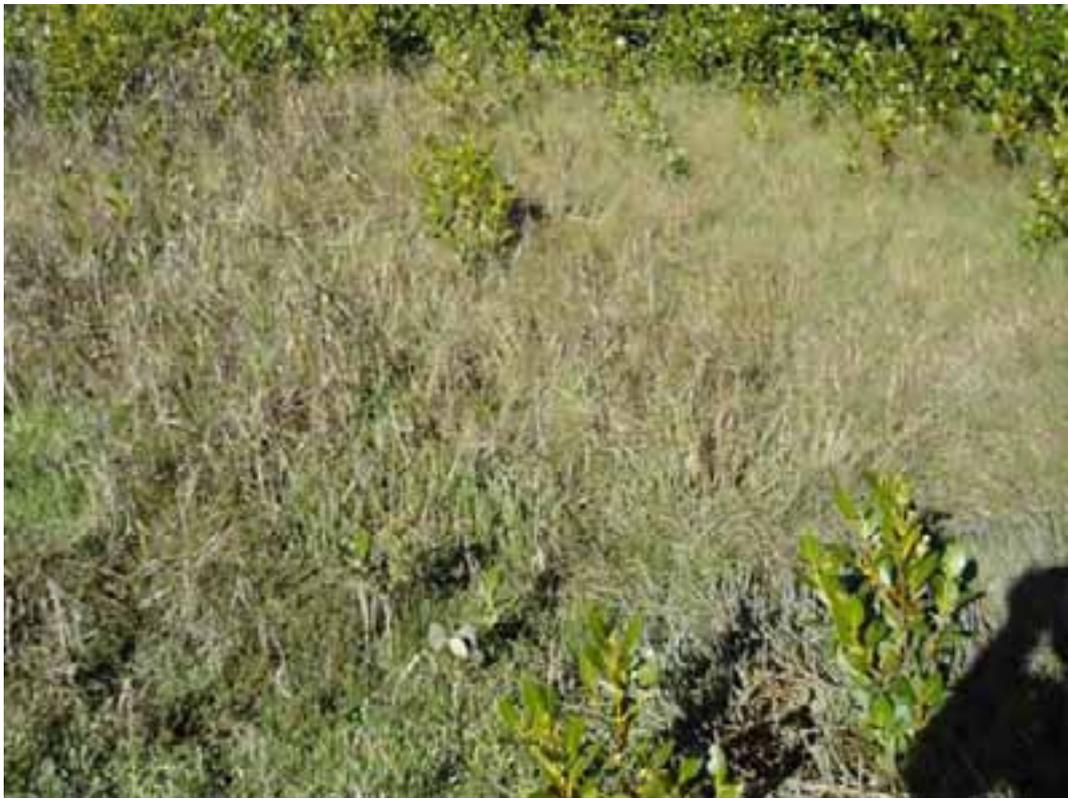
**Figure 21:** A patch of saltwater paspalum upstream of the Waipapa River mouth. Mangroves and sea primrose were present around the edges.

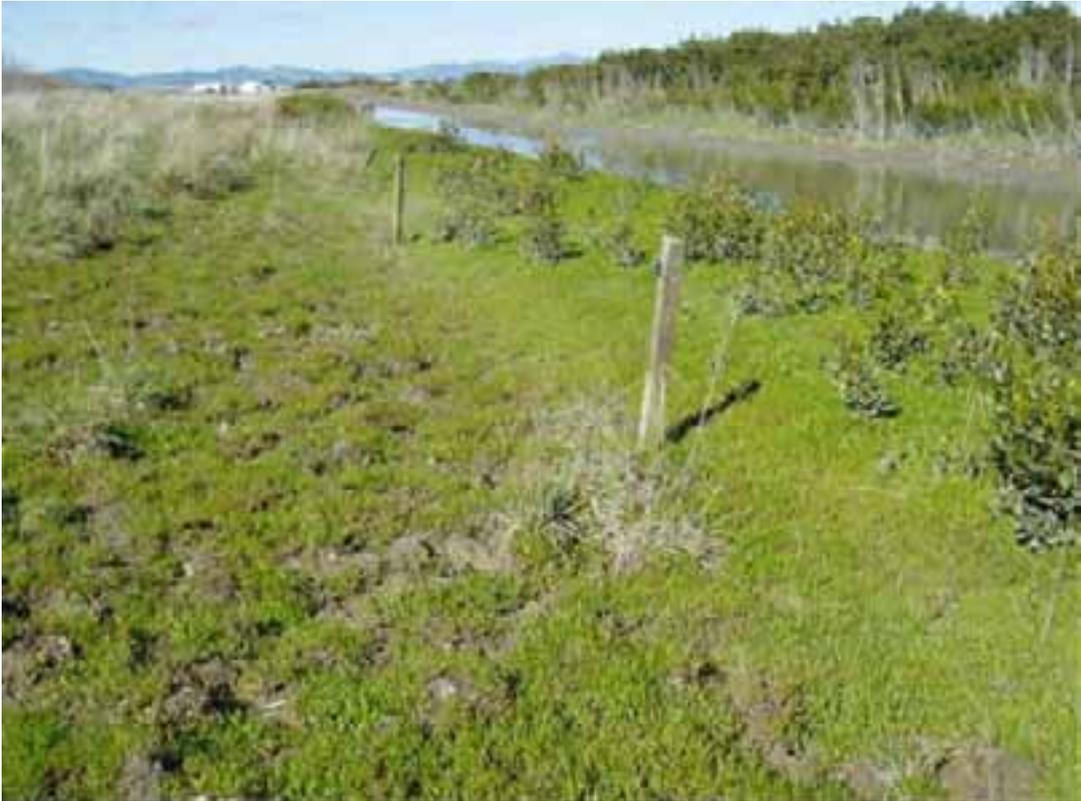
**Figure 22: Pugged and un-pugged Bachelor's button along a drain looking south toward Kopu boat ramp. A small plant of Maori musk was also found here.**

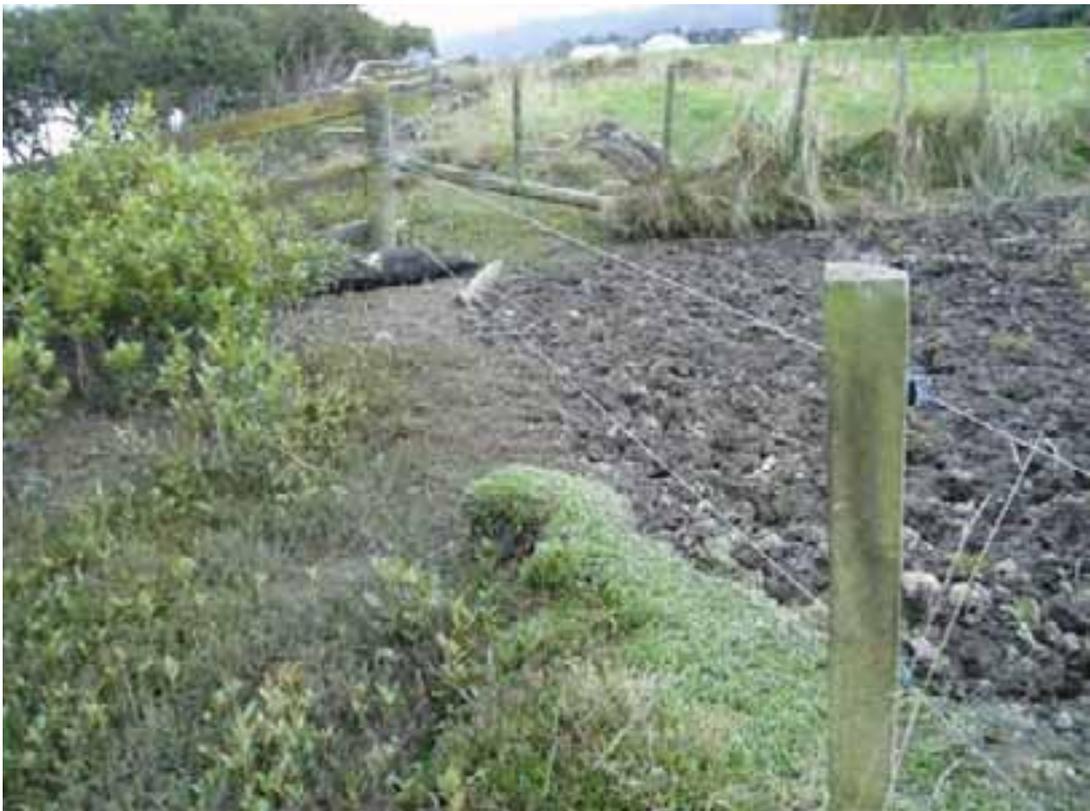
**Figure 23: Severe pugging of the Waihou River bank. Saltwater paspalum and sea meadow were present on the un-pugged banks.**

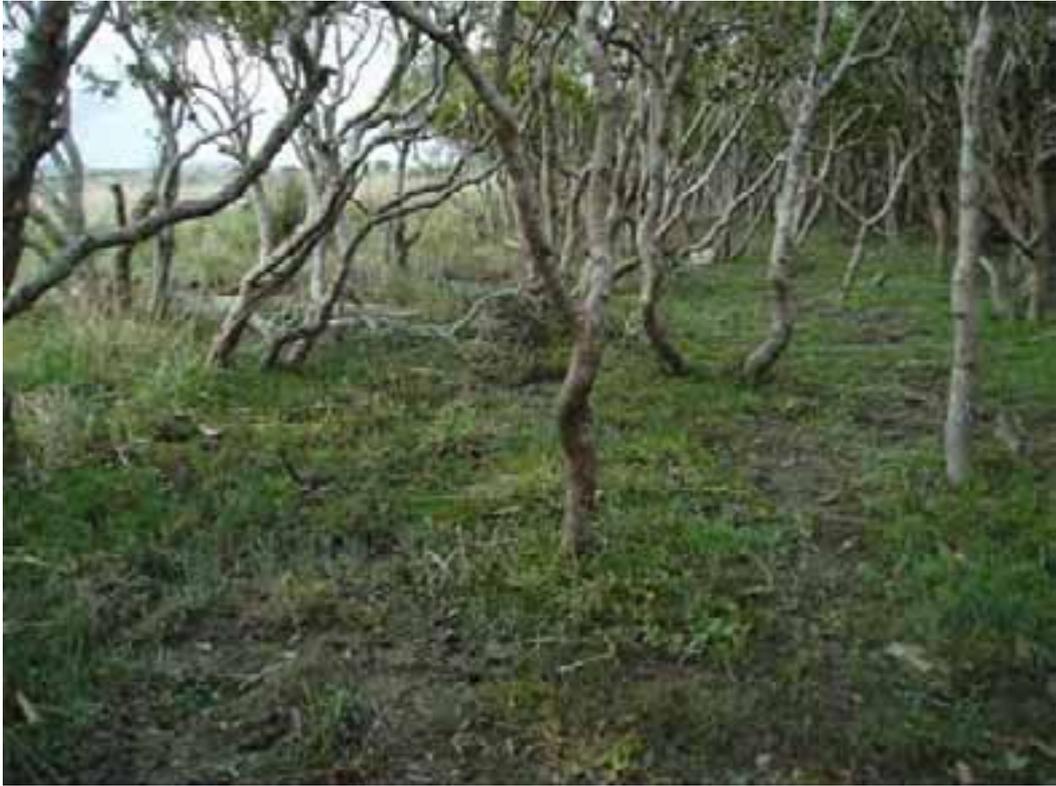
**Figure 24:** South of the Kopu bridge this mangal edge with a subcanopy of sea meadow was unfenced and hence pugged and grazed. True right bank Waihou River.

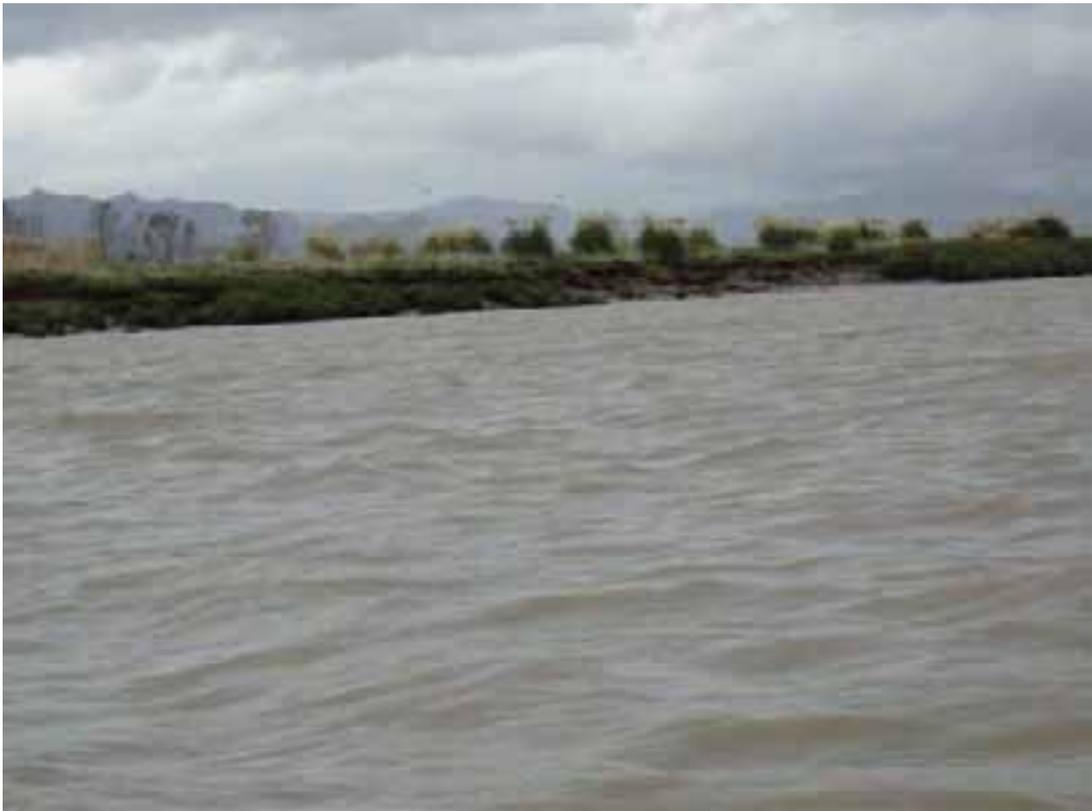
**Figure 29:** Thick banks of spartina are eroding into the Waihou River downstream of the Matatoki Canal.

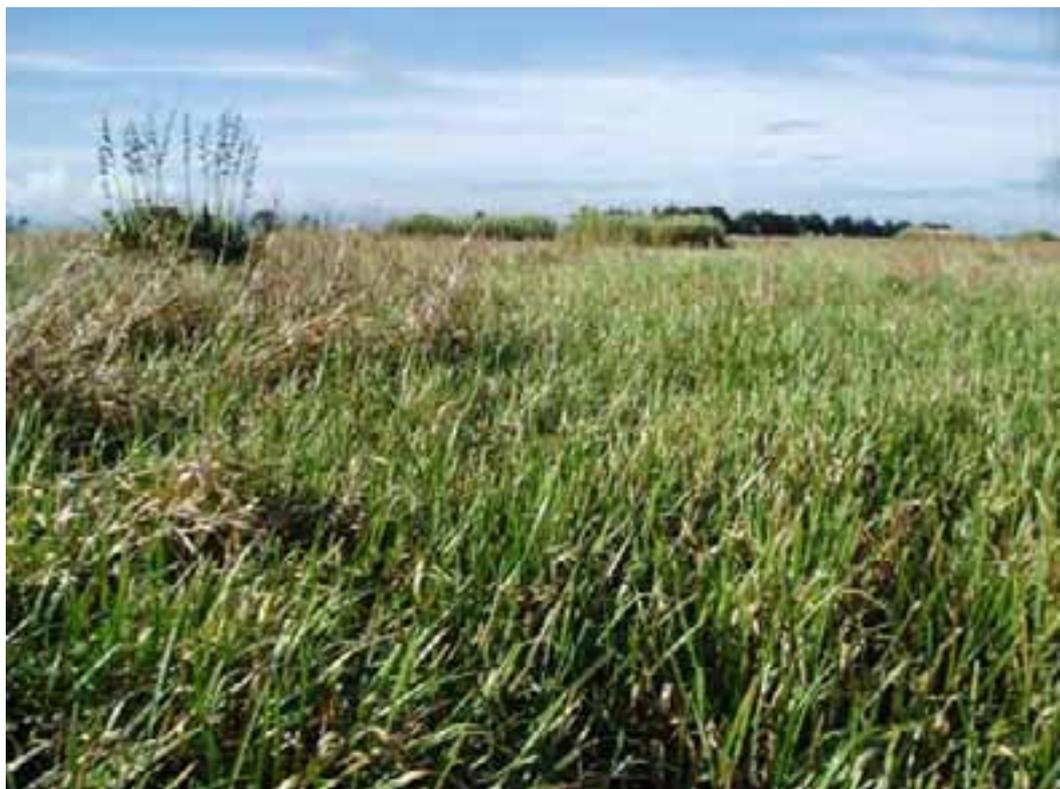
**Figure 31: Sweet reedgrass dominating swamp clubrush, flax and raupo behind mangroves on the Waihou River bank near the Matatoki Canal.**

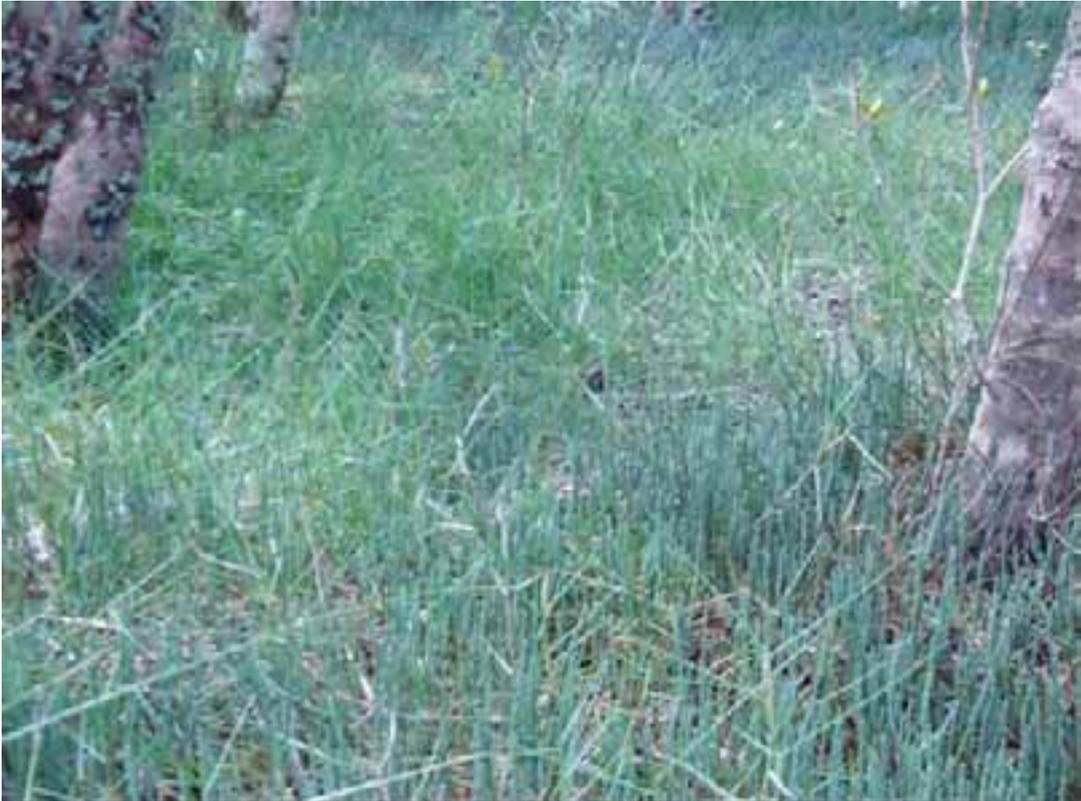
**Figure 38: Saltwater paspalum (light green in centre) invading a glasswort bed under the mangal canopy downstream of the Kopu Bridge (true left bank).**
