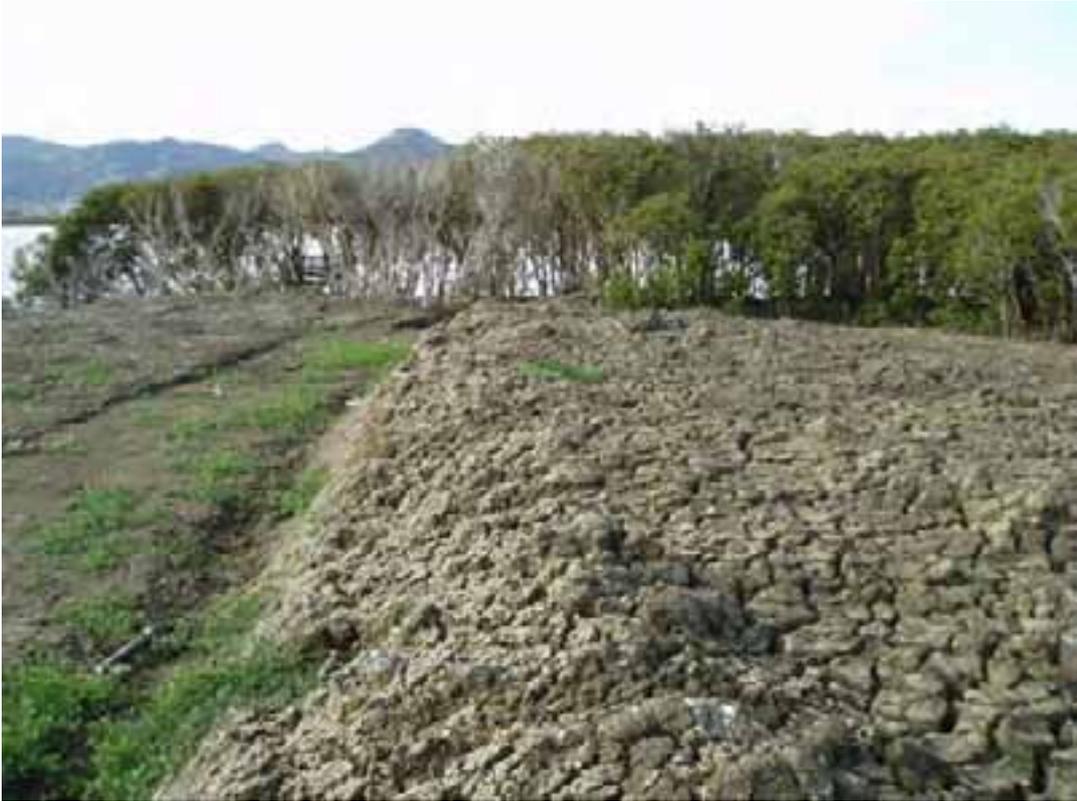
**Figure 40:** Crushed and bulldozed mangal edge from drain clearance activities. Drain to left.

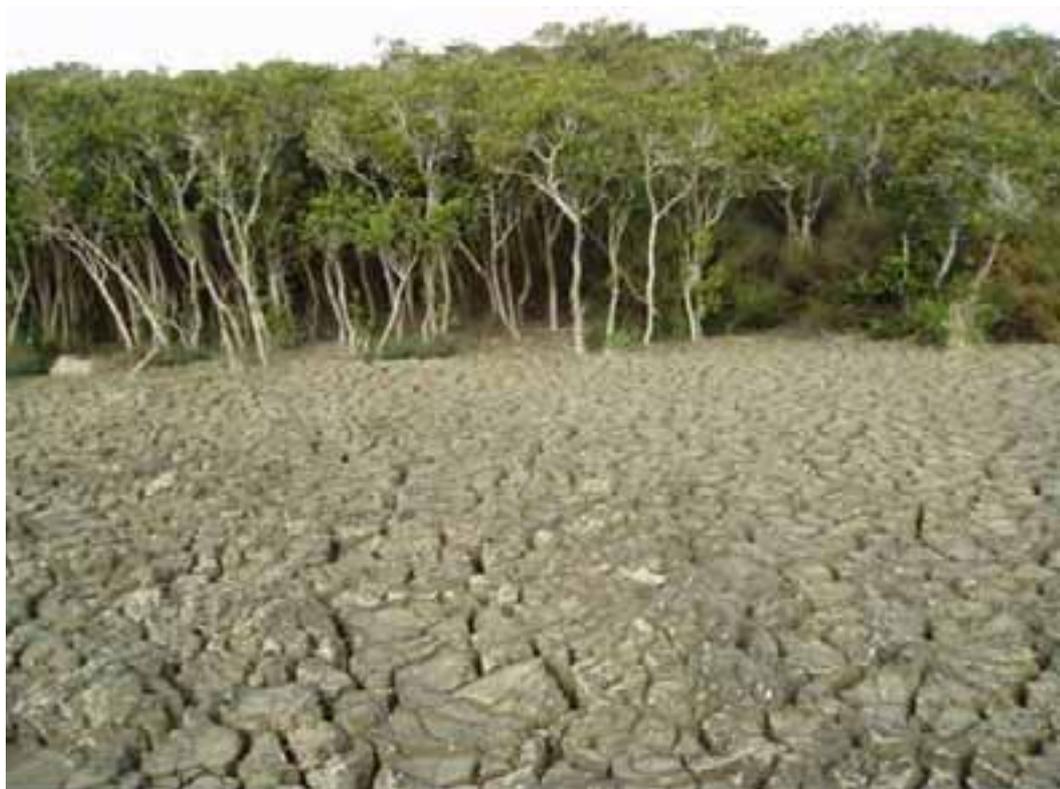
**Figure 41:** Edge of bulldozed mangal and cracked drain dredgings.

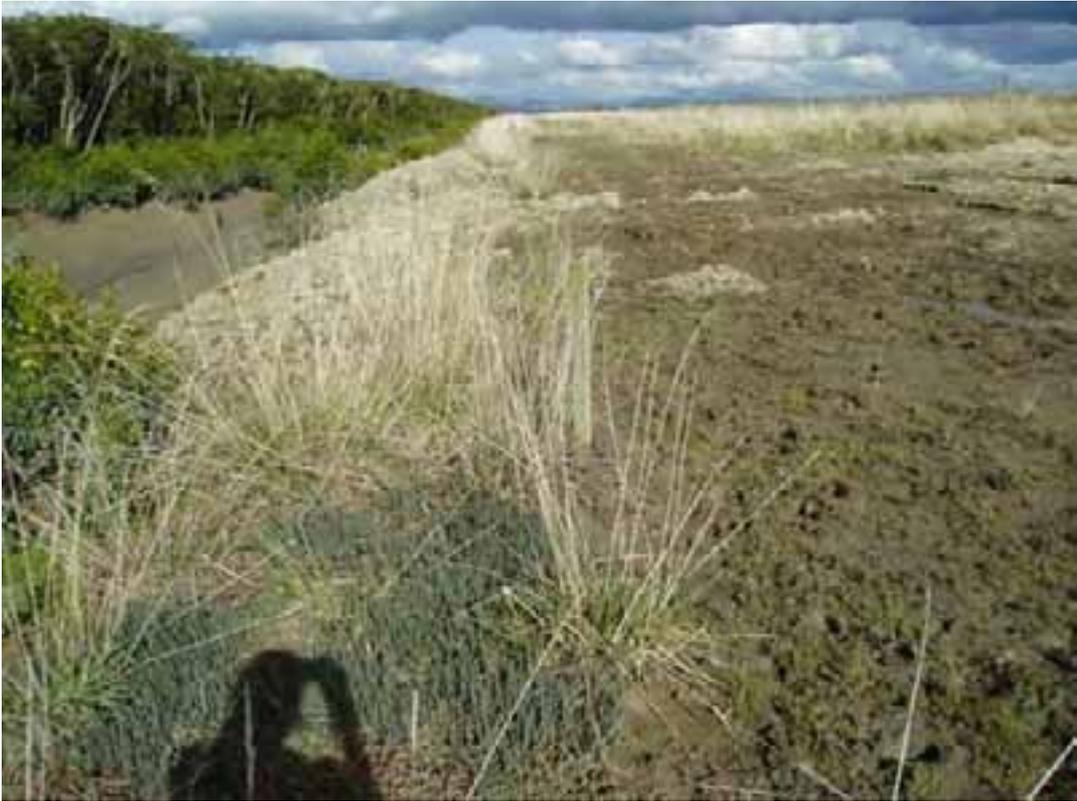
**Figure 42: Grazed and pugged sea meadow on the flat between the drain and stopbank. This area was commonly grazed and pugged around the Firth.**

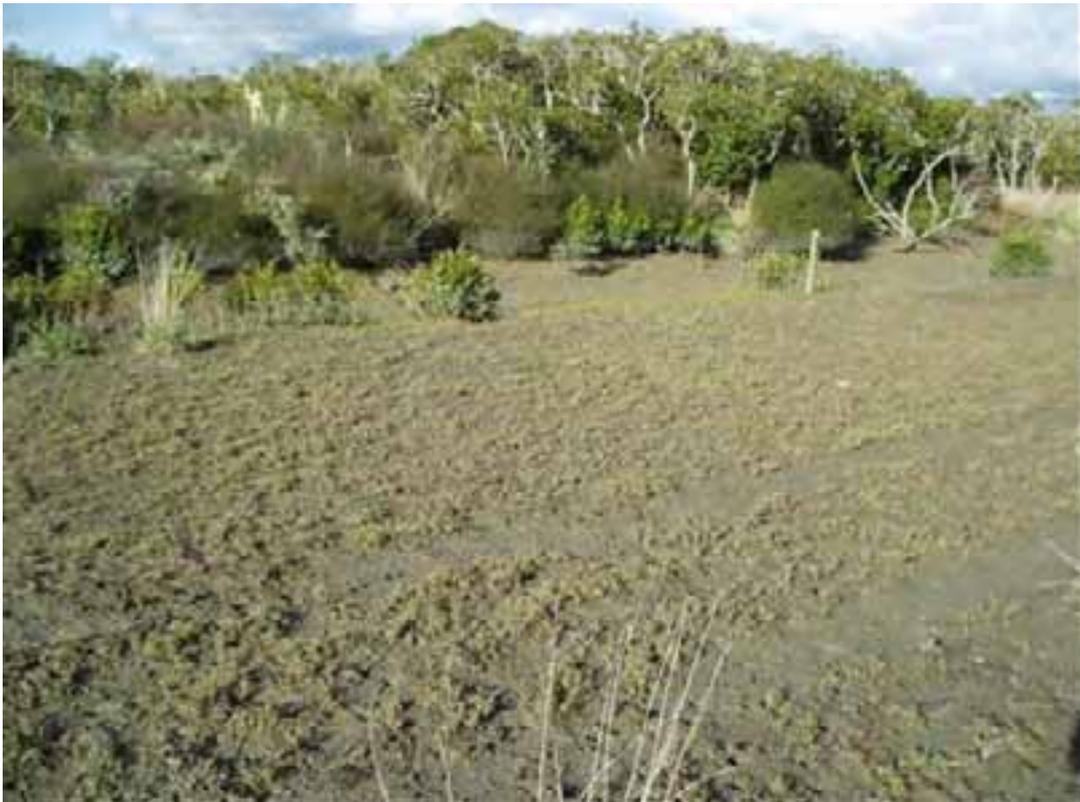
**Figure 43: More grazed and pugged sea meadow on the flat between the drain and stopbank.**

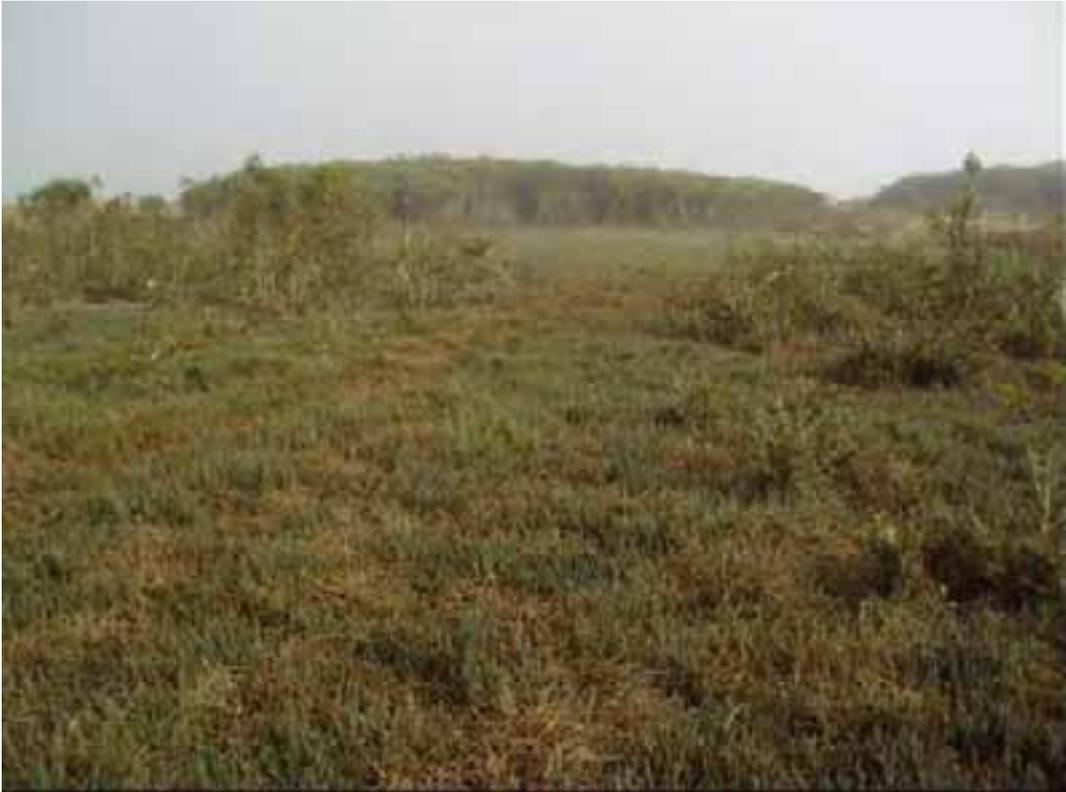
**Figure 44:** Stock tracks through the sea meadow (glasswort) and stock grazing of the mangroves. The stock bank is on the left behind the mangroves. Waihou River mouth (true left bank).

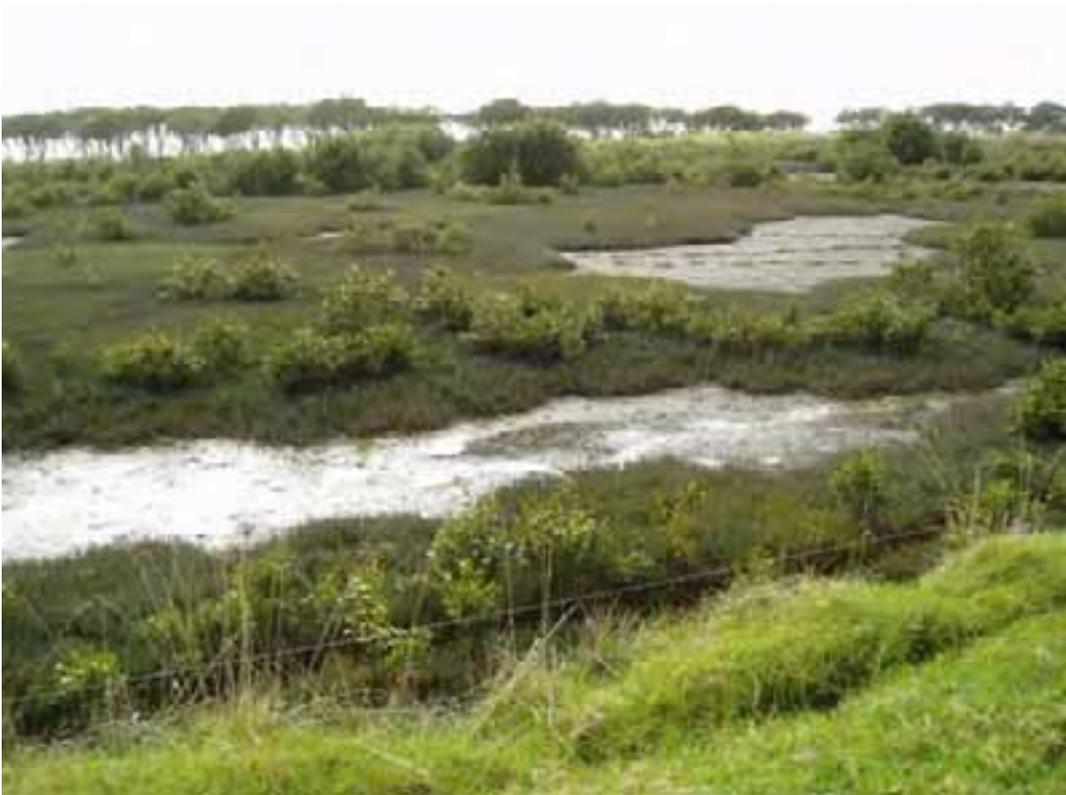
**Figure 45:** Although the fence here is appropriately sited at the toe of the stopbank, it is not of a good enough standard to keep stock out of the coastal marine area. Note tracks over mud.

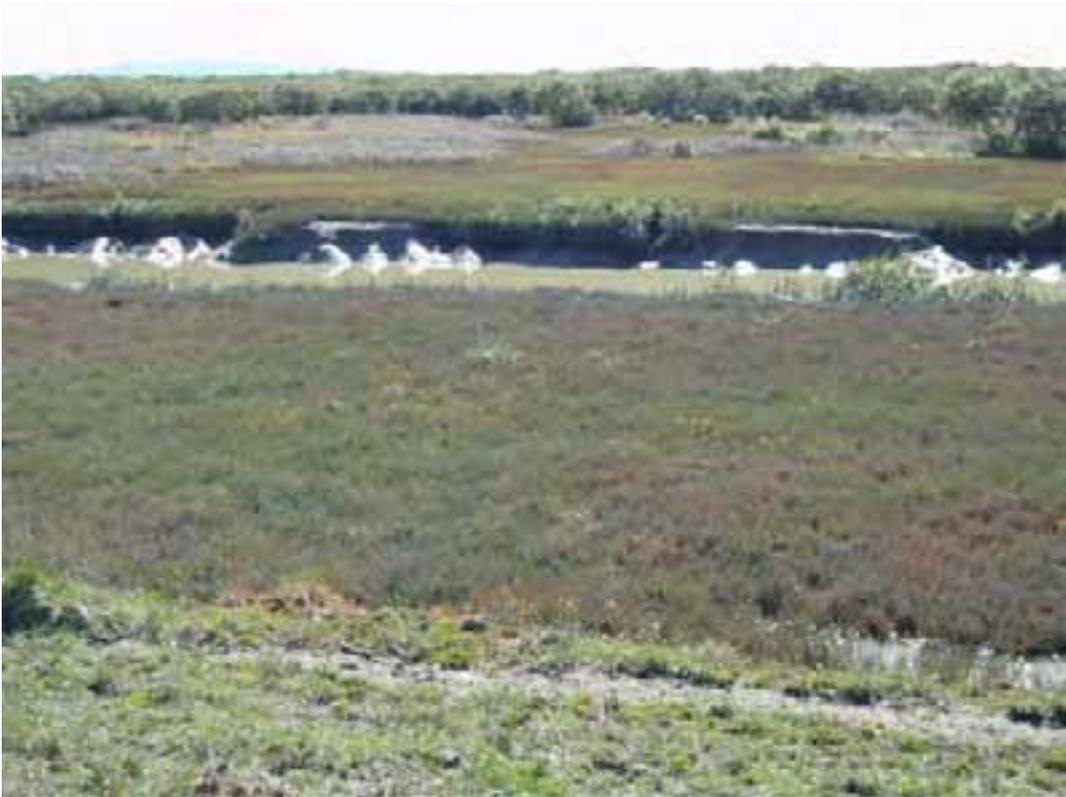
**Figure 49:** Dense glasswort fields amongst swamp clubrush, scattered saltmarsh ribbonwood and mangroves on the true right bank of the Piako River mouth. The glasswort in the foreground is unfenced. It is still fairly healthy though pugged.

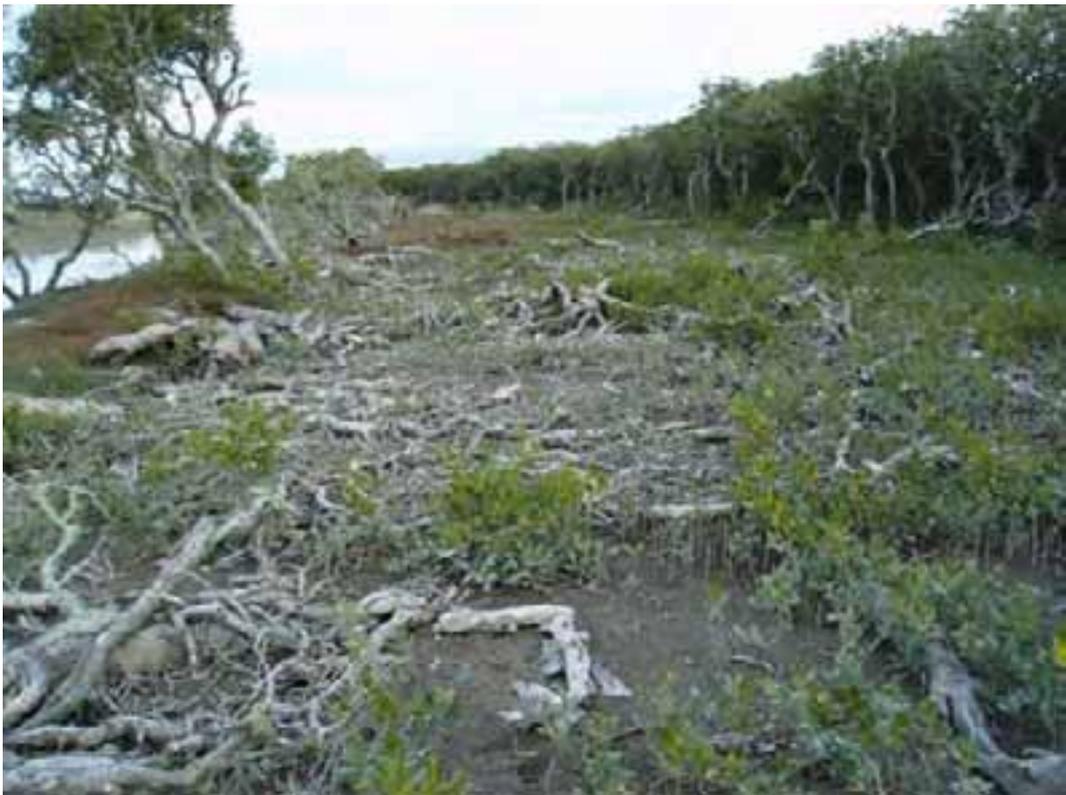
**Figure 53: An old bulldozed path through a mangal as part of drain maintenance. The sea meadow (reddish patches) would have extended in under a dense mangrove canopy.**

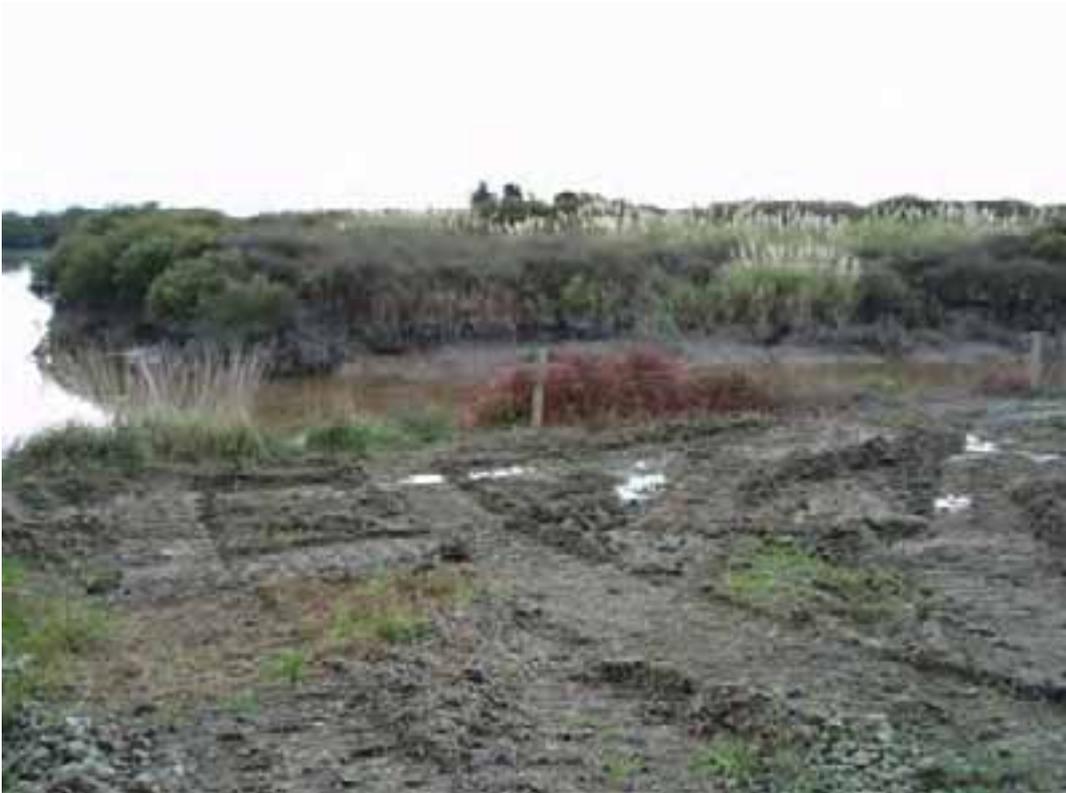
**Figure 55:** An example of the estuarine vegetation that is lost to drainage activities. The undisturbed bank has a fringe of mangroves backed by saltmarsh ribbonwood. Pampas was invading the higher ground.

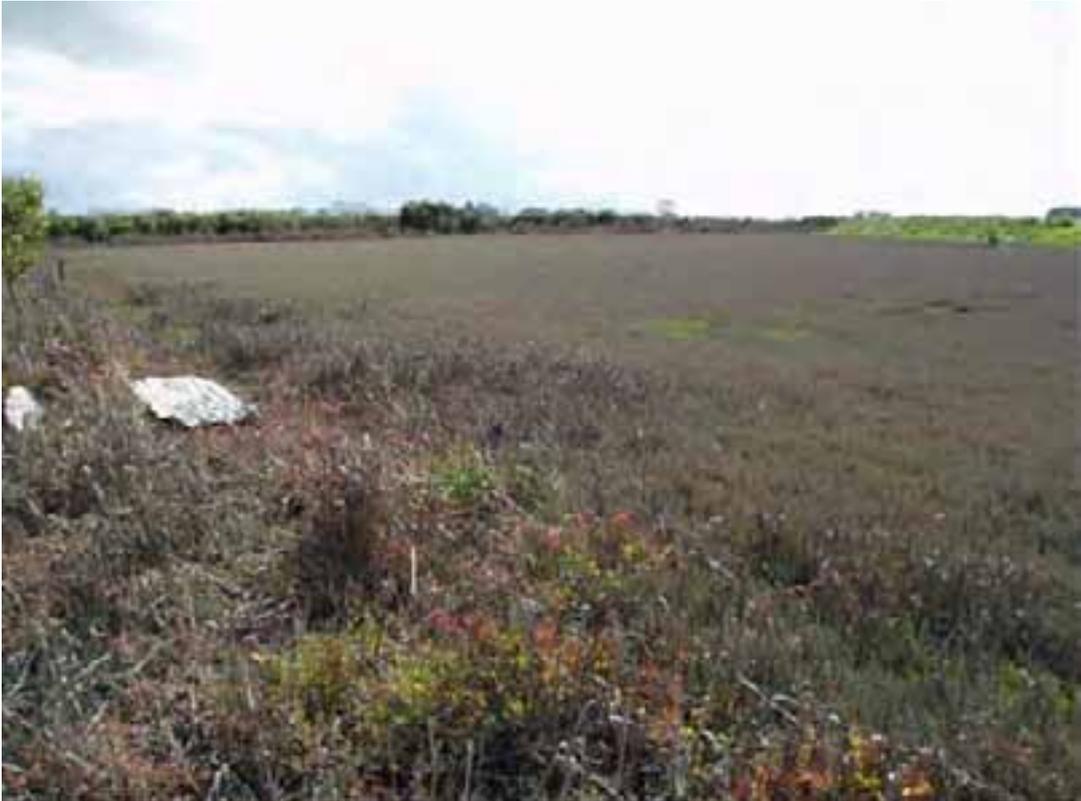
**Figure 56: Large unfenced glasswort sea meadow bound by the stopbank upstream of the Piako River bridge (true right bank).**

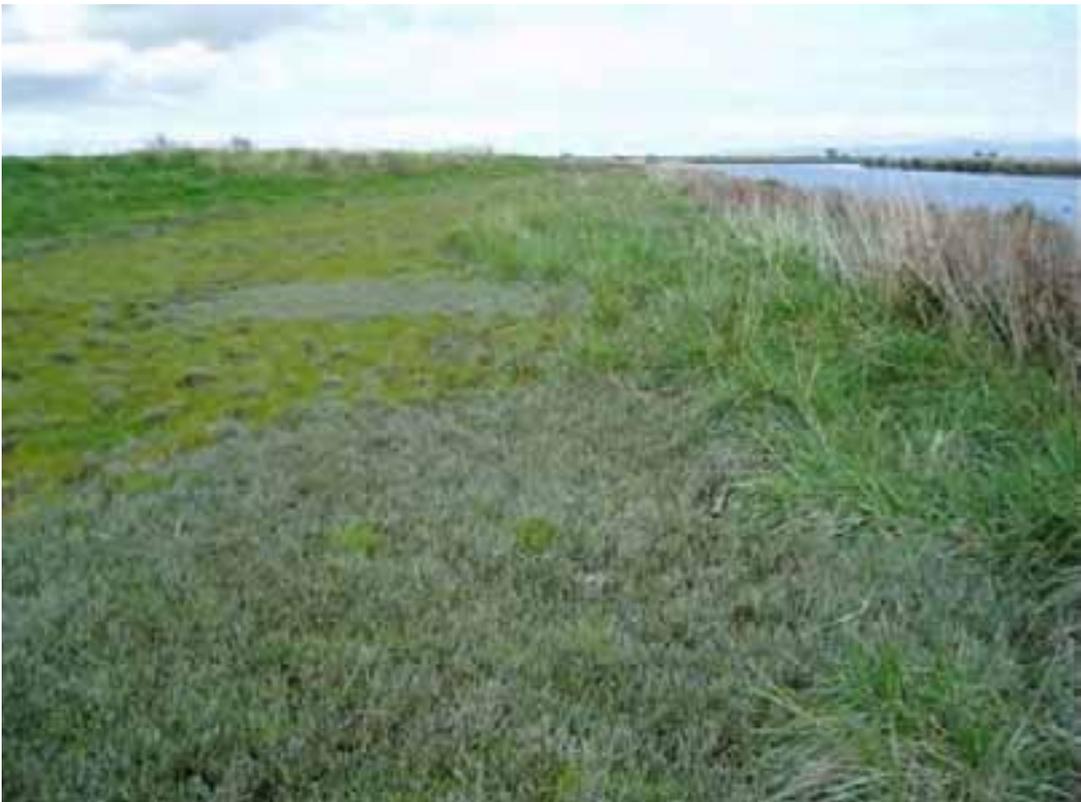
**Figure 57: Grazed spartina and sea meadow along the true right bank of the Piako River.**

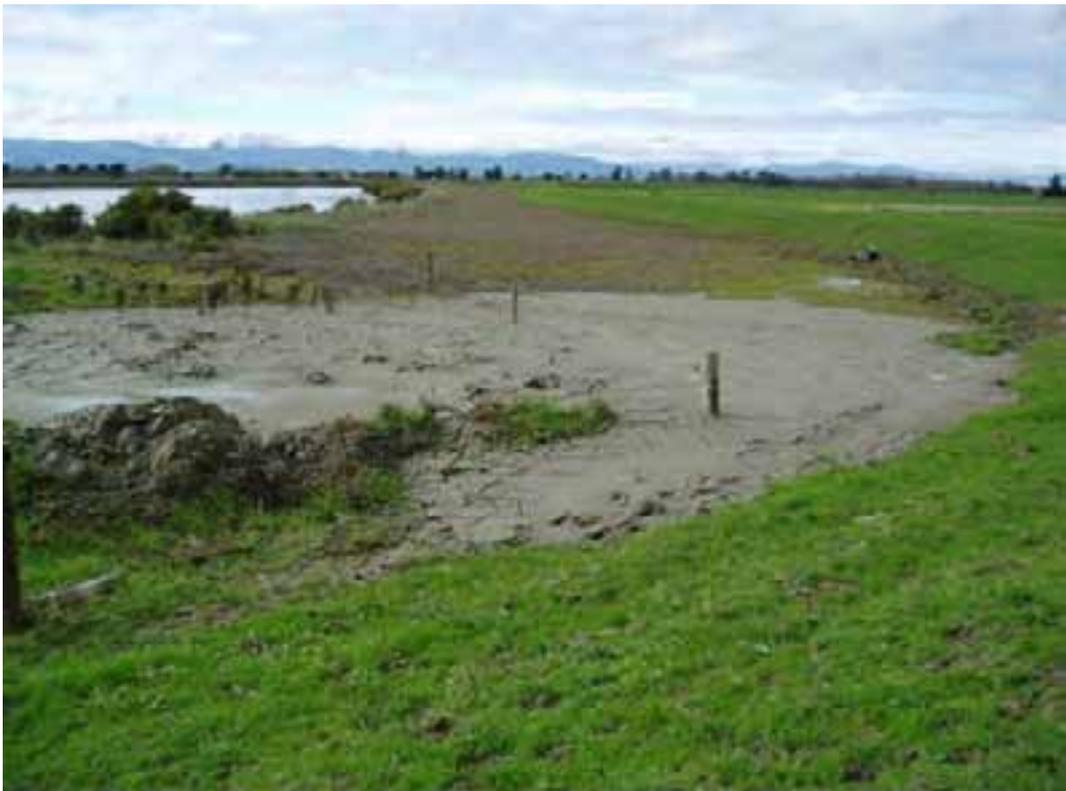
**Figure 61:** This is an example of poor riverside management just upstream from the good example above. Here the entire river flat between the river bank and stopbank was being grazed. This has resulted in an unnatural sea meadow community that is pugged.

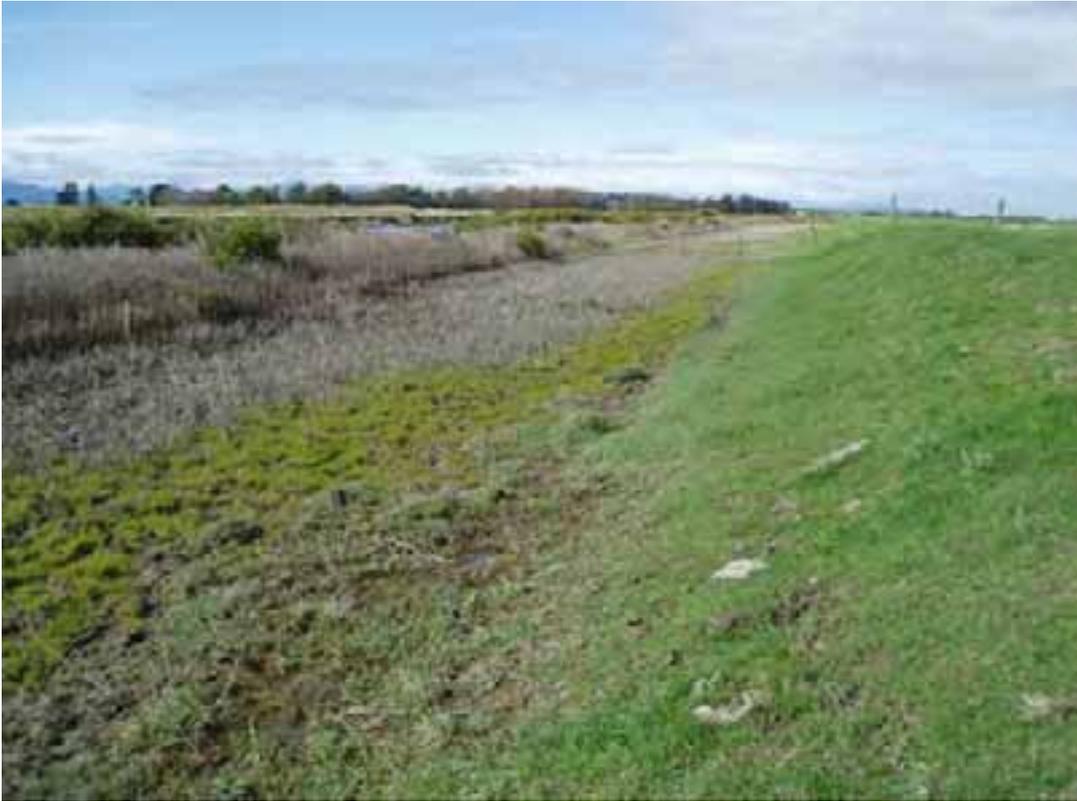
**Figure 62:** Photo showing the grazing effect on mangroves, saltmarsh ribbonwood and marsh clubrush presence. A dead cow was found in an open drain near the river bank.

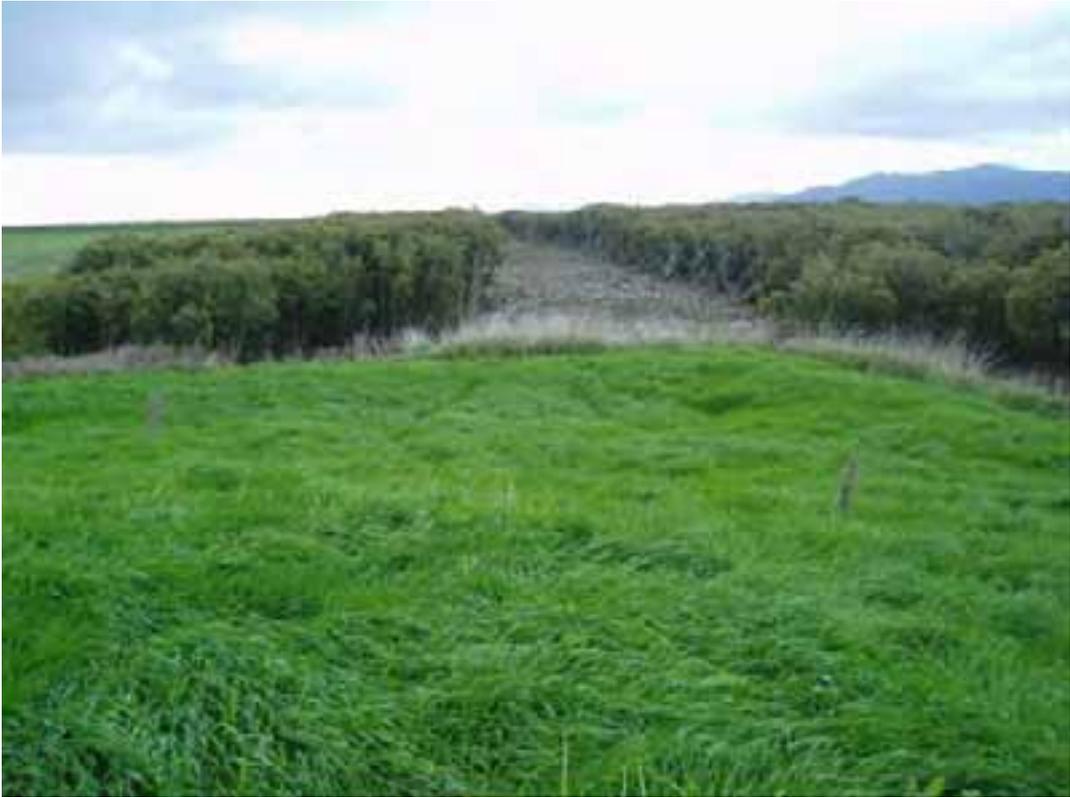
**Figure 64:** The 5 m tall mangal at the Piako River mouth has suffered because of a digger bulldozing its way to a drainage outlet to undertake maintenance.

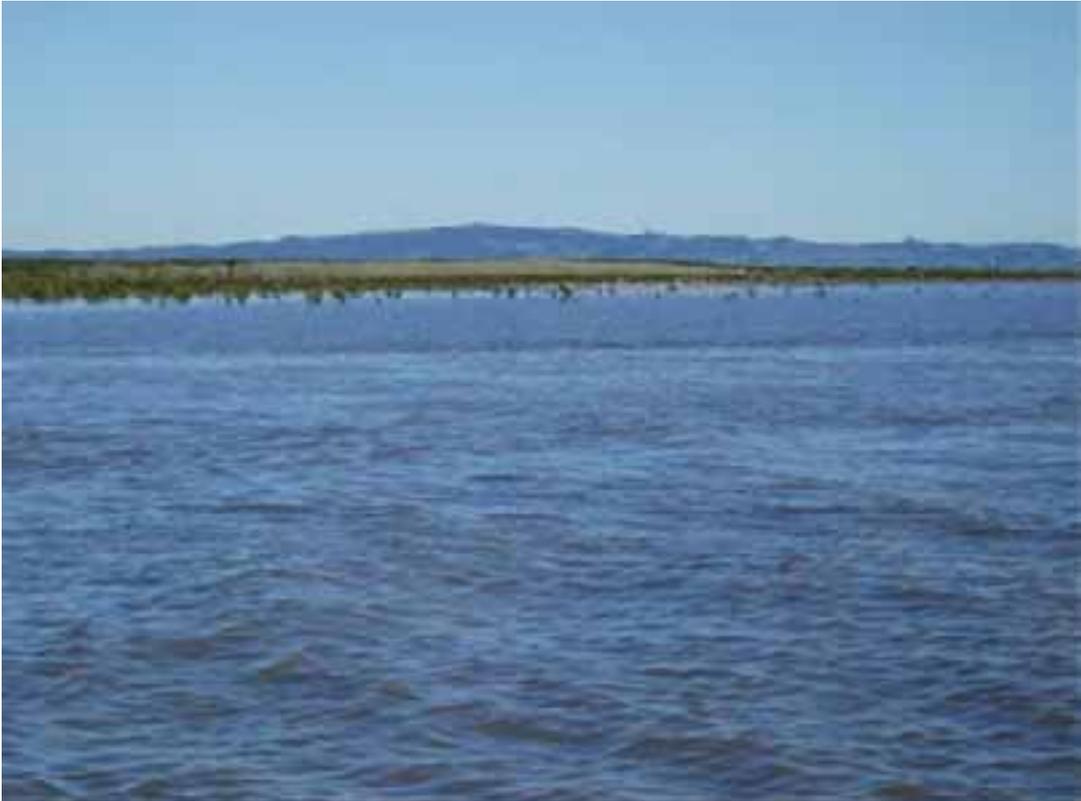
**Figure 68:** An expanding band of young mangroves backs onto a dead band of mangroves at the mouth of the Piako River. There was an abrupt change in tree height at the boundary between the older mangroves and young trees establishing in the front.

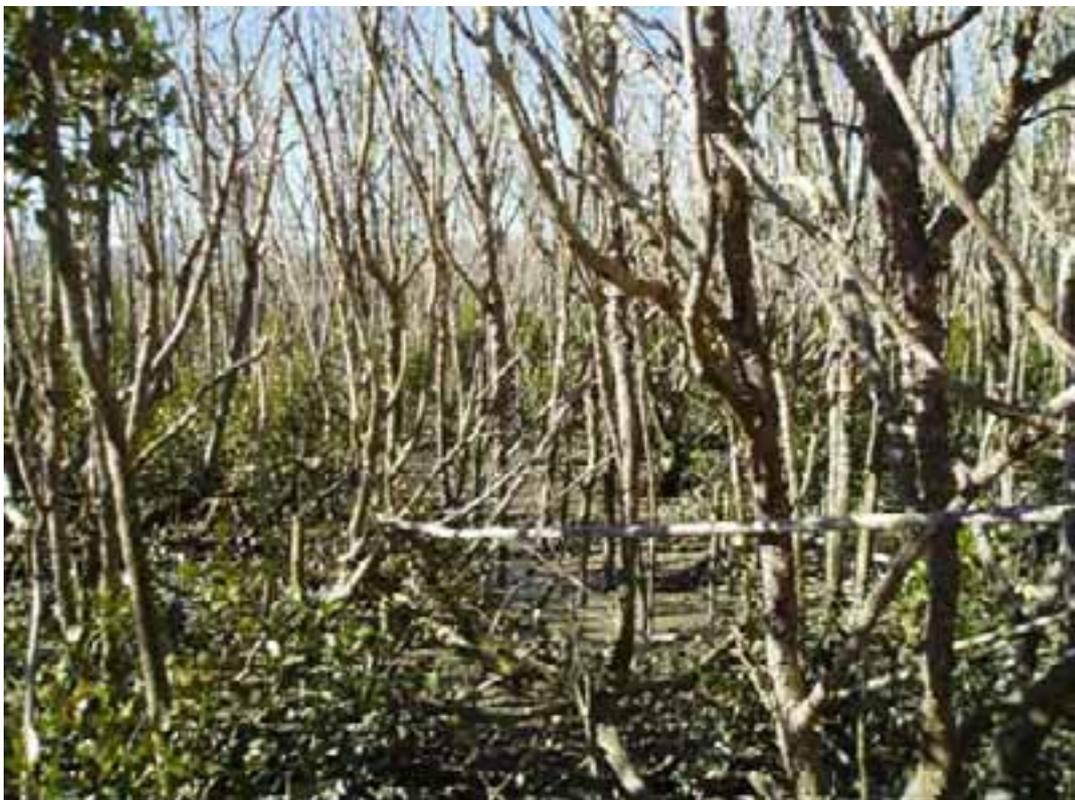
**Figure 69:** A view inside the dead mangrove zone. The dead mangroves were between 3 and 4 m high with new 0.5-1 m high mangroves growing within the dead zone. Some scattered older trees were surviving within the dead zone.

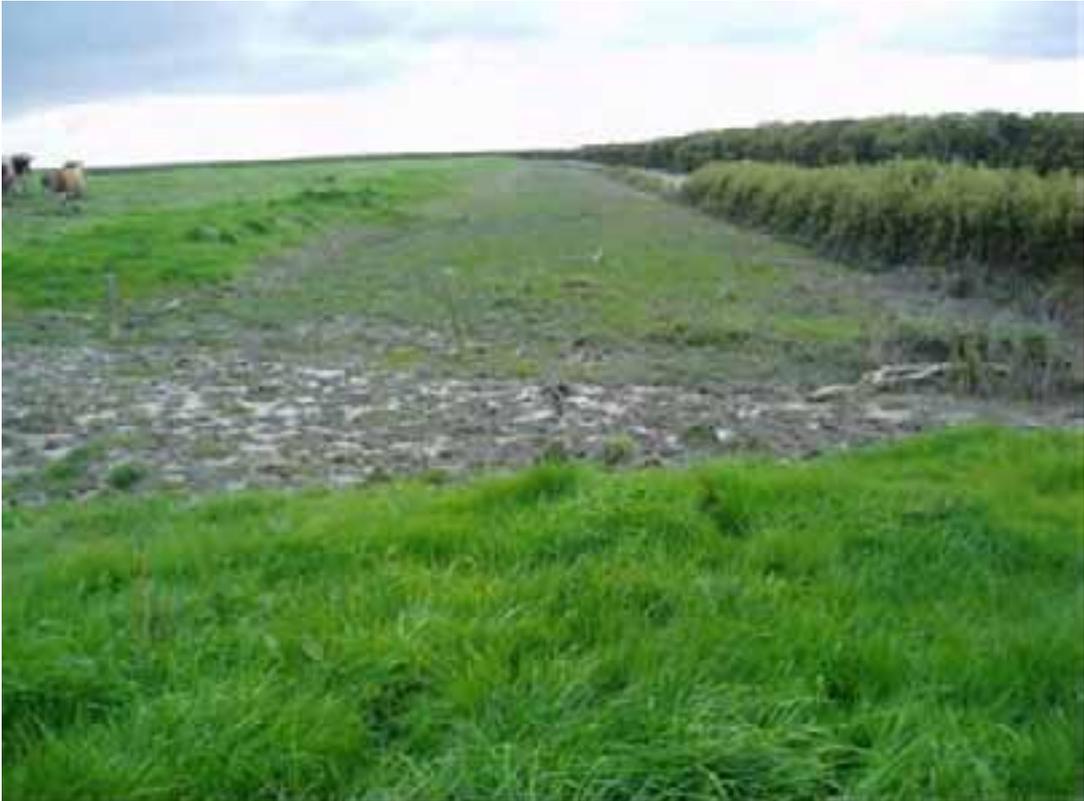
**Figure 74: Stock access on the coastal marine area side of the stopbank at the Piako end. This results in destabilised and defecated drain banks, pugged sea meadow and grazed mangroves.**

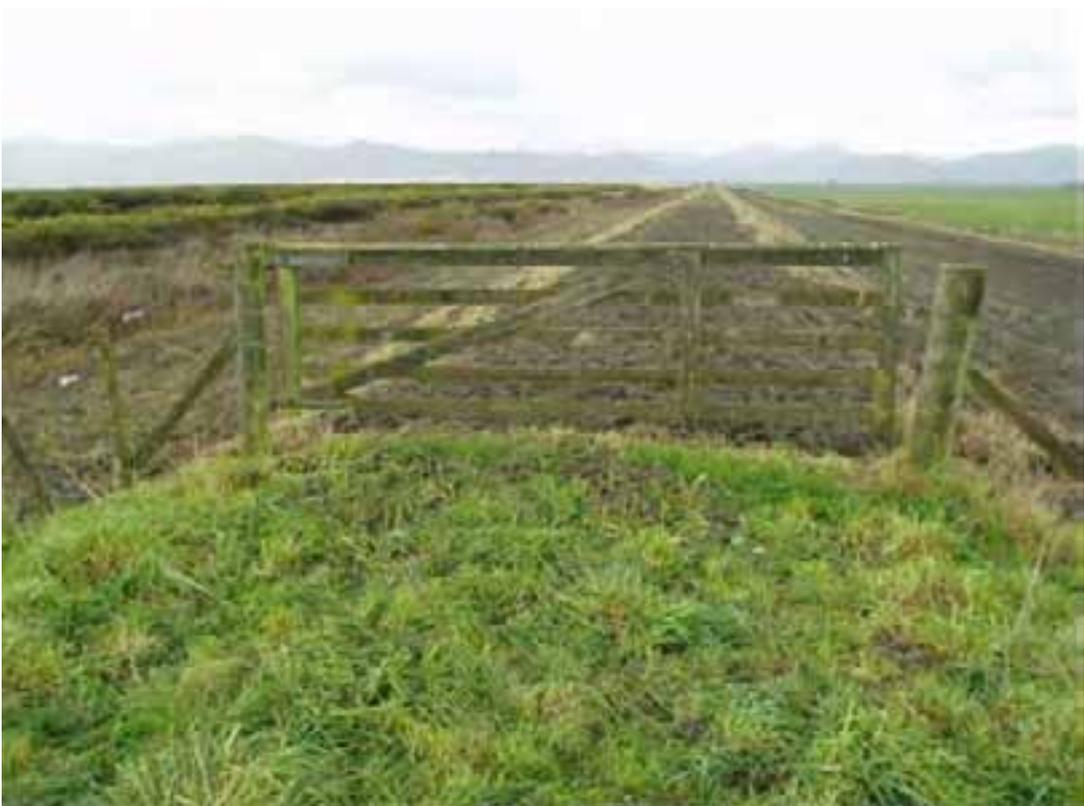
**Figure 75: Poor land management leading to elevated sediment levels in drains either side.**

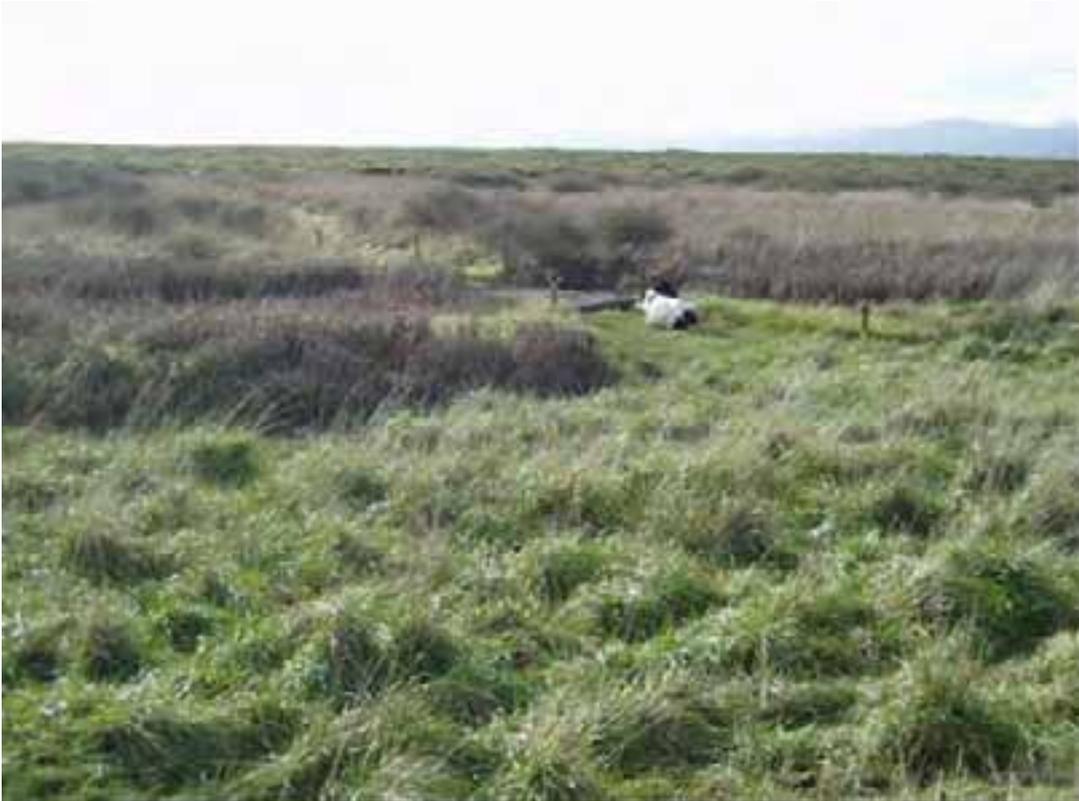
**Figure 76:** An access point across the stopbank drain. These access points were not appropriated fenced and gated to stop stock accessing the main Firth wetland.

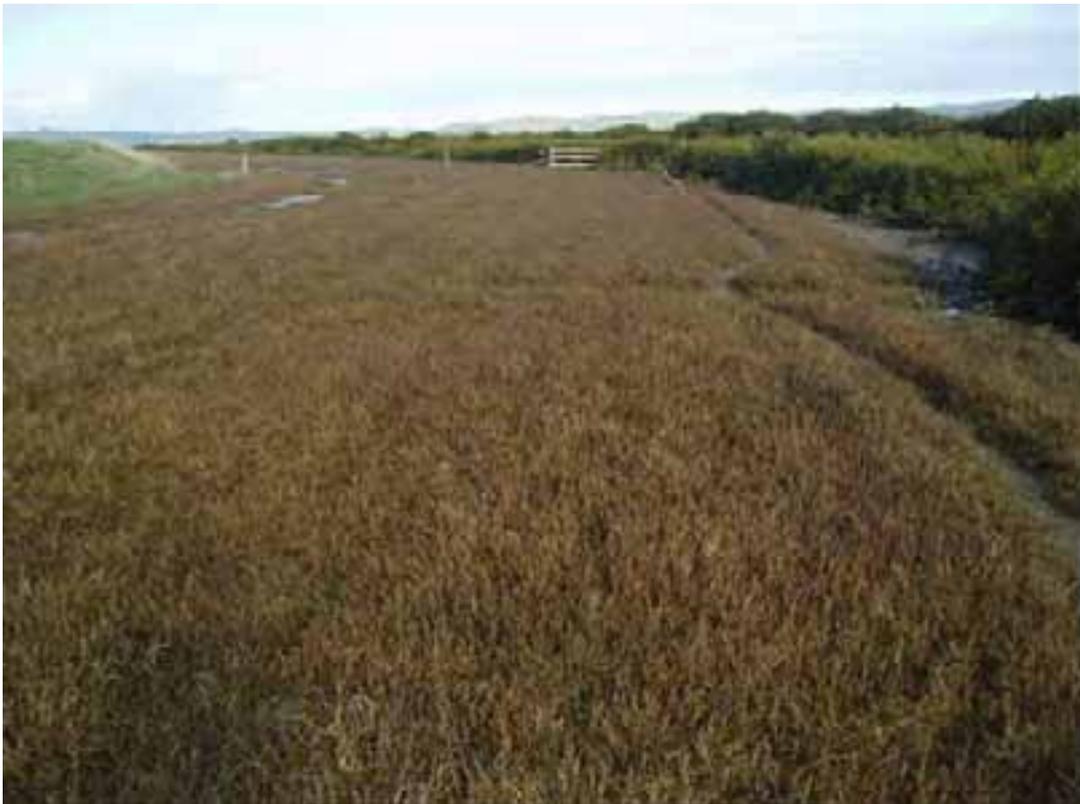
**Figure 78:** Grazing of the coastal marine area. Fence in background shown in Figure above.

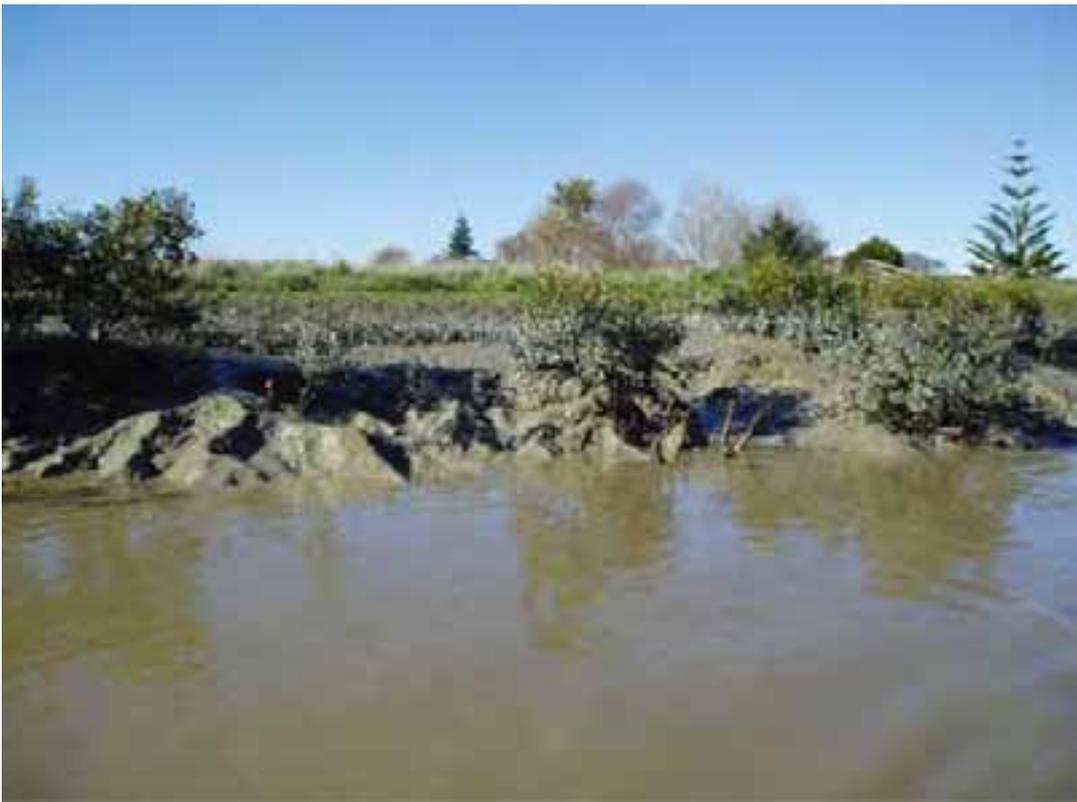
**Figure 81: Grazed and pugged sea meadow and mangroves on the true right bank of the Waitakaruru River downstream of the SH bridge (Maukoro Canal).**

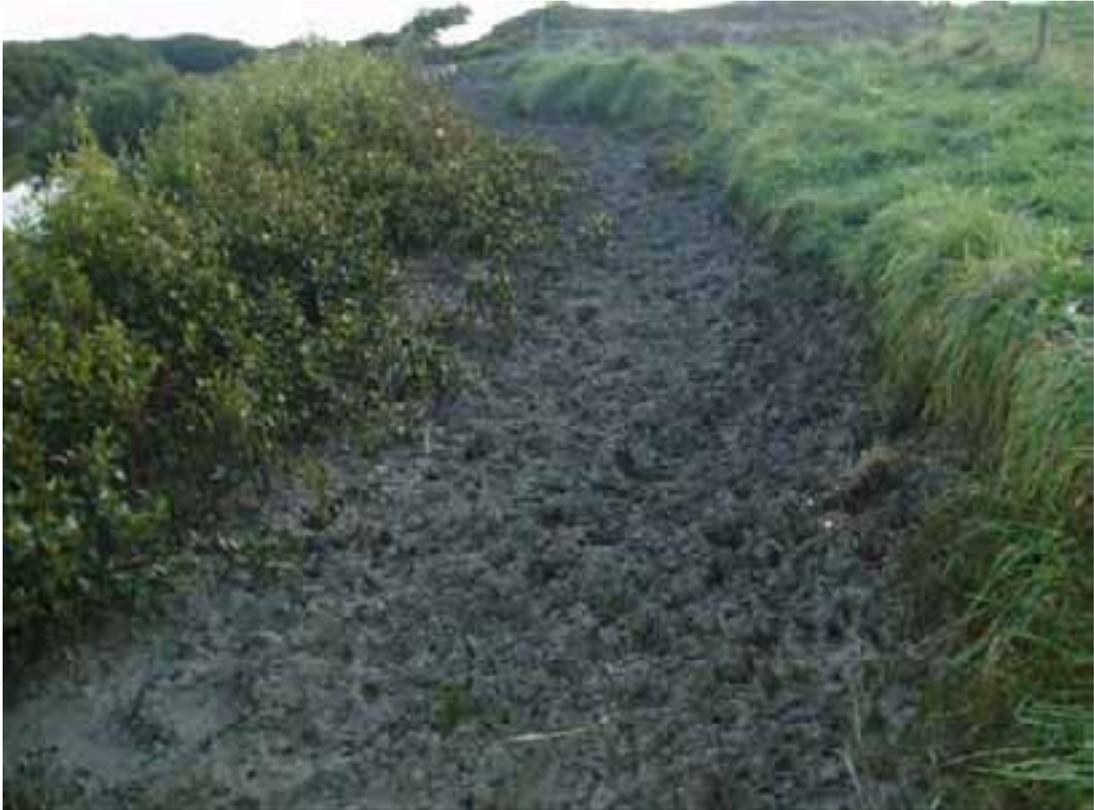
**Figure 82:** More pugging and grazing within the coastal marine area on the true right bank of the Waitakaruru River downstream of the SH bridge (Maukoro Canal).

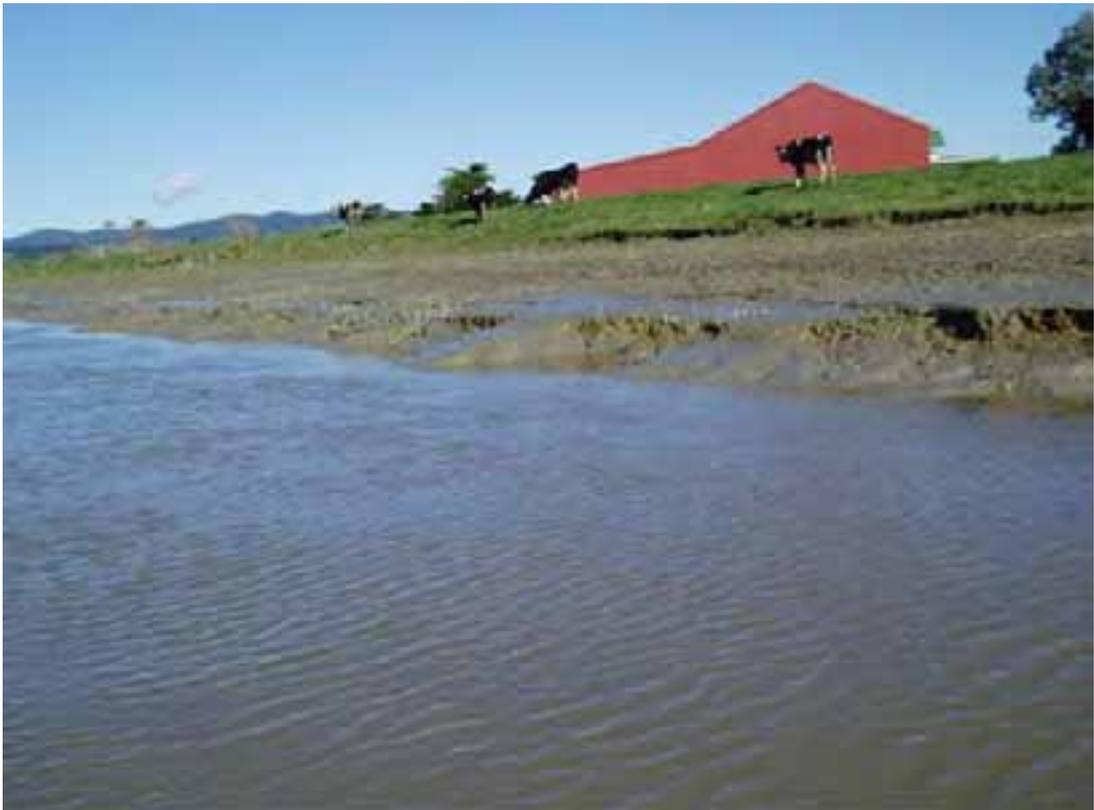
**Figure 83:** Heavily grazed spartina and sea meadow banks along the Waitakaruru Canal upstream of the SH bridge.

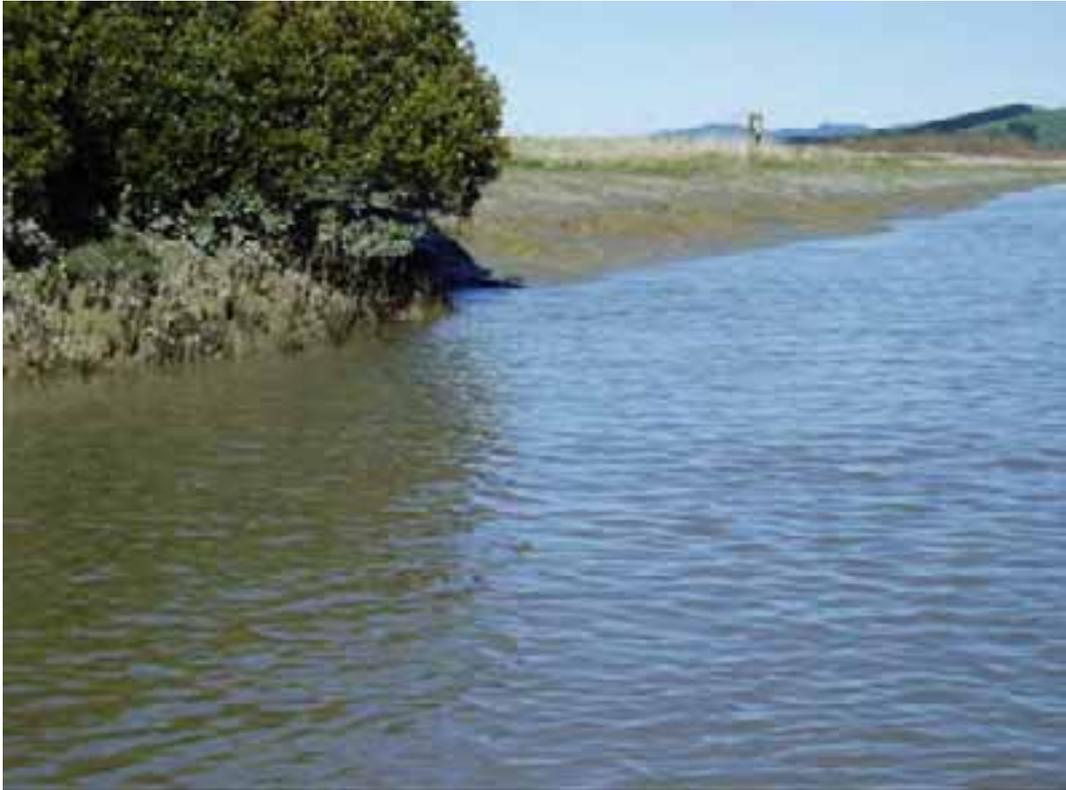
**Figure 84:** Mangroves along the Waitakauru Canal upstream of the SH 25 bridge displaying their bank stabilisation characteristics. No bank protection is provided where channel dredging has removed all natural vegetation. Further downstream where mangroves have been removed, spartina has taken over the bank protection role.

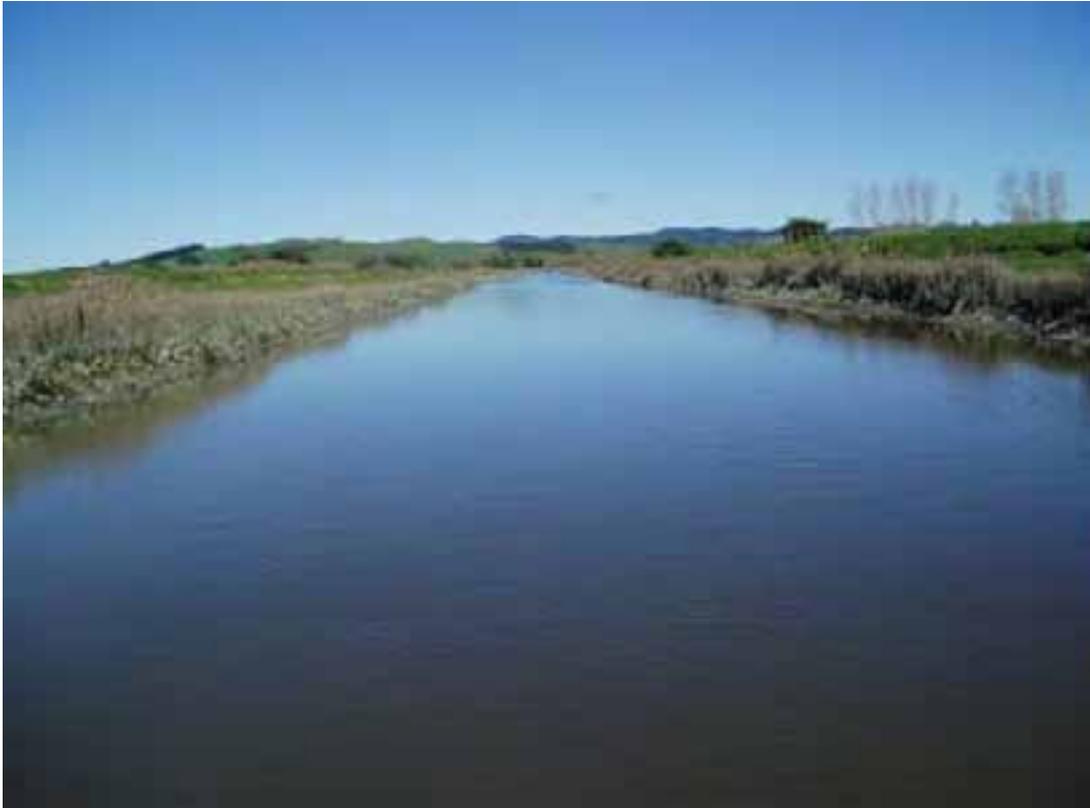
**Figure 85:** The unfenced banks of the upper Waitakaruru Canal edged by grazed marsh clubrush and mangrove seedlings.
