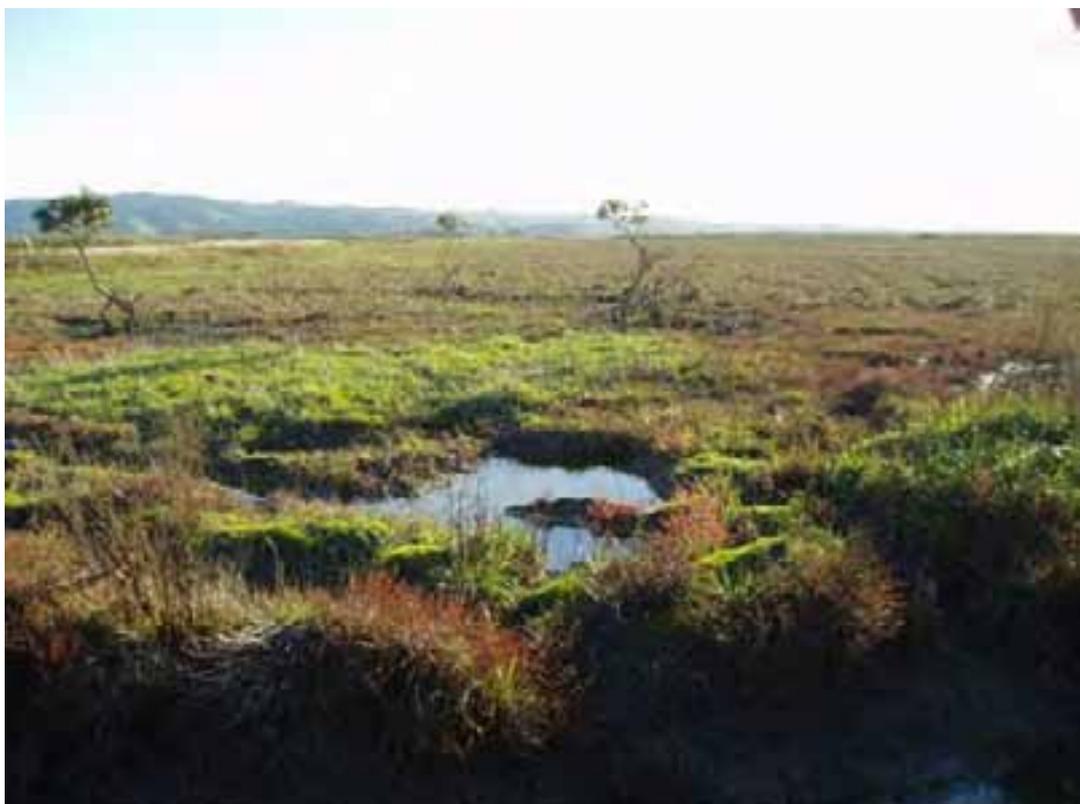
**Figure 89:** A particularly bad example of grazing in the coastal marine area. This extensively grazed spartina patch was seaward of the new storage sheds on the Miranda road (E2721398 N6439648) and was seaward of the stopbank drain.

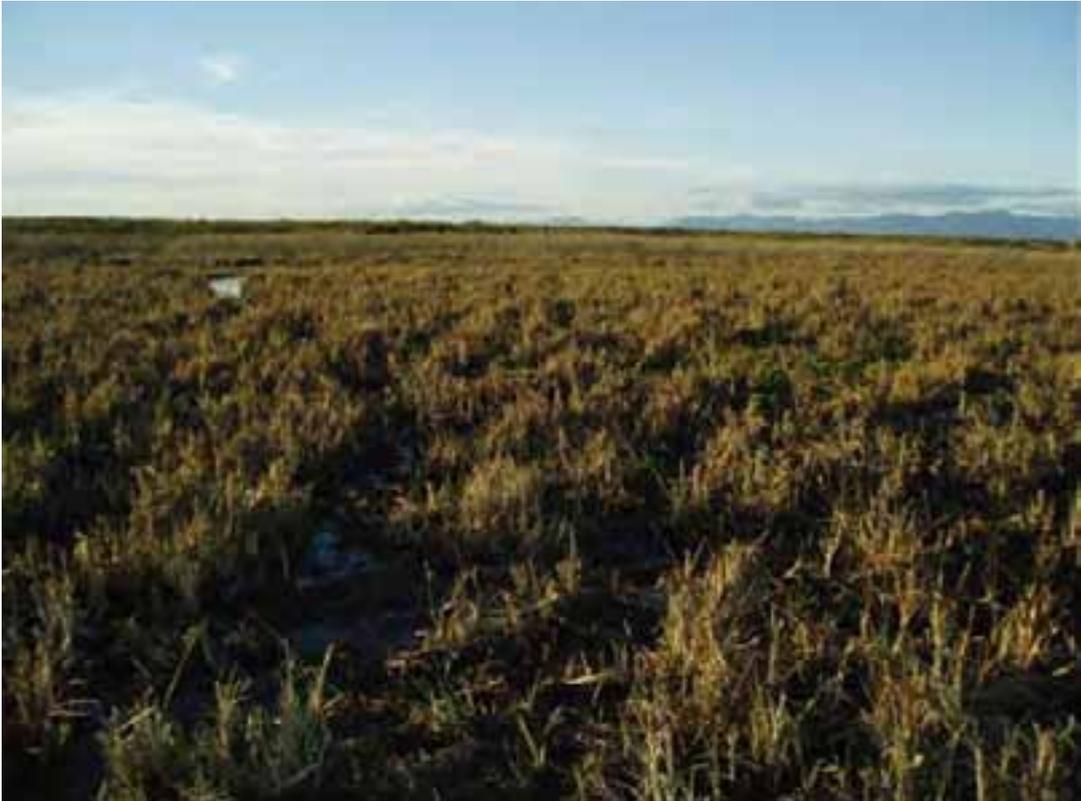
**Figure 90:** Another view of the grazed and pugged spartina described above. Also present was bachelor's button and a band of dead mangroves lining the mangal in the background.

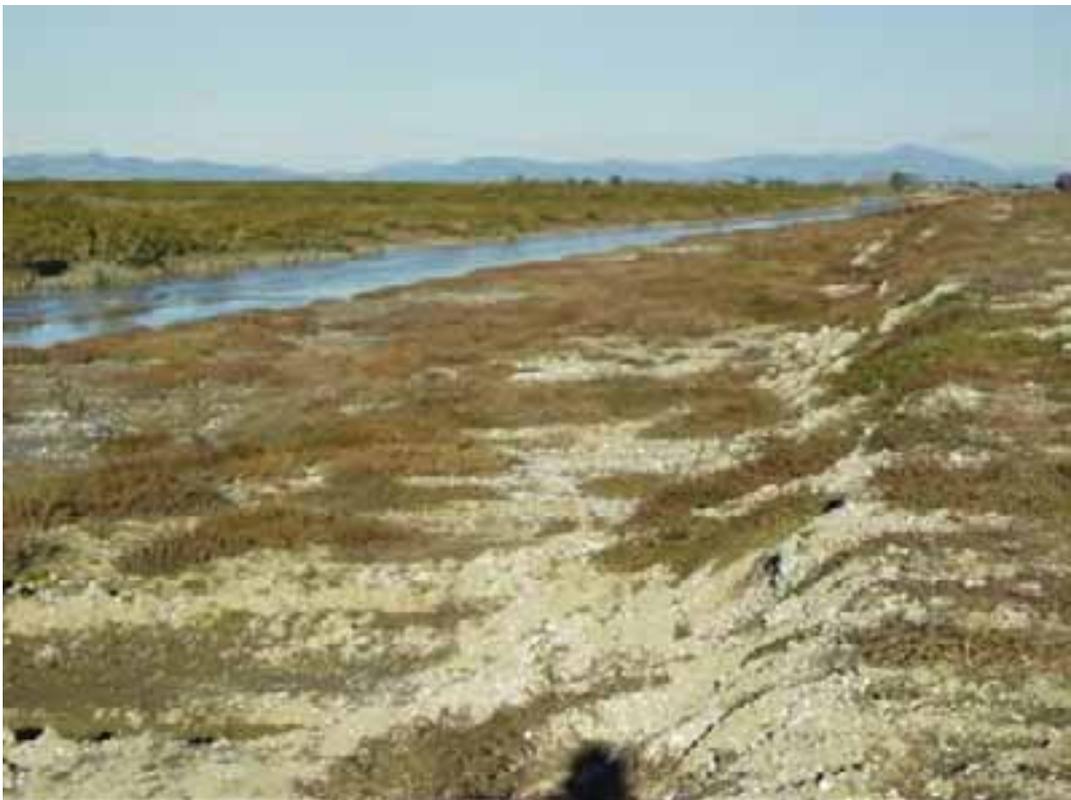
**Figure 93:** A new stopbank and drain that has been formed since 2002, which, based on undisturbed vegetation communities to the south east, has resulted in a loss of sea meadow and open mud flat.

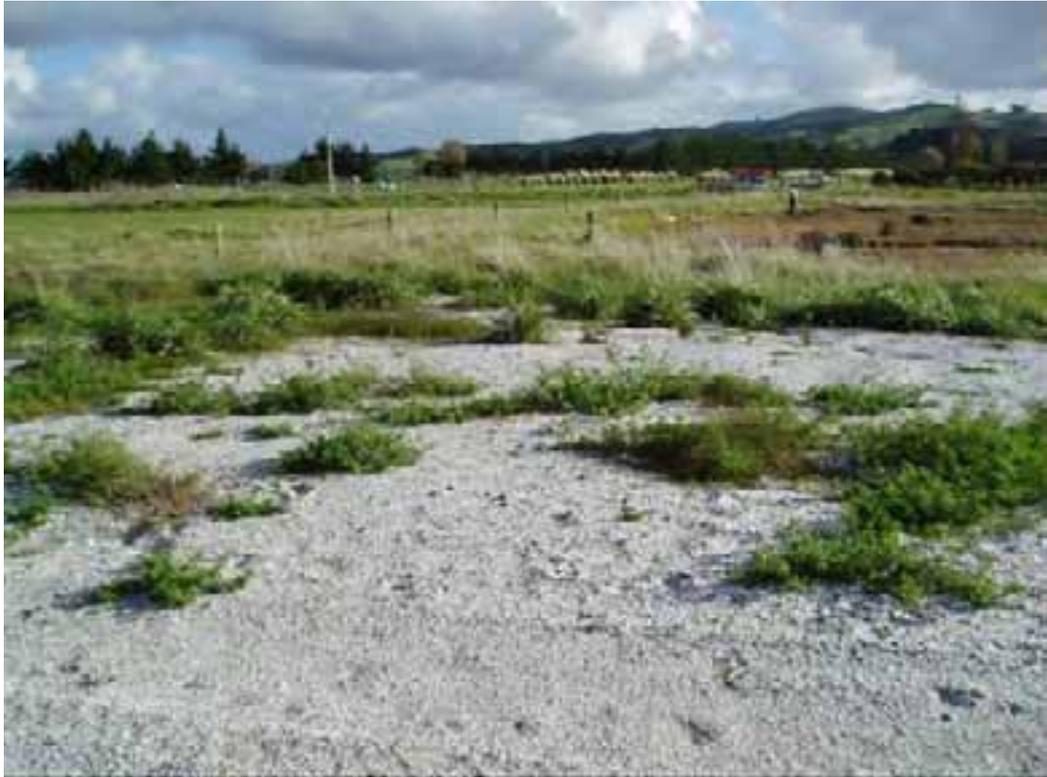
**Figure 102:** This photo shows the effect of drainage and farming on the distribution of native estuarine vegetation communities. The glasswort sea meadow on the right behind the chenier stopped suddenly at a stopbank. The low-lying land to the left of the stopbank was separated from normal tidal inundations and now supports pastoral grasses. The pine trees are beside the Miranda road.

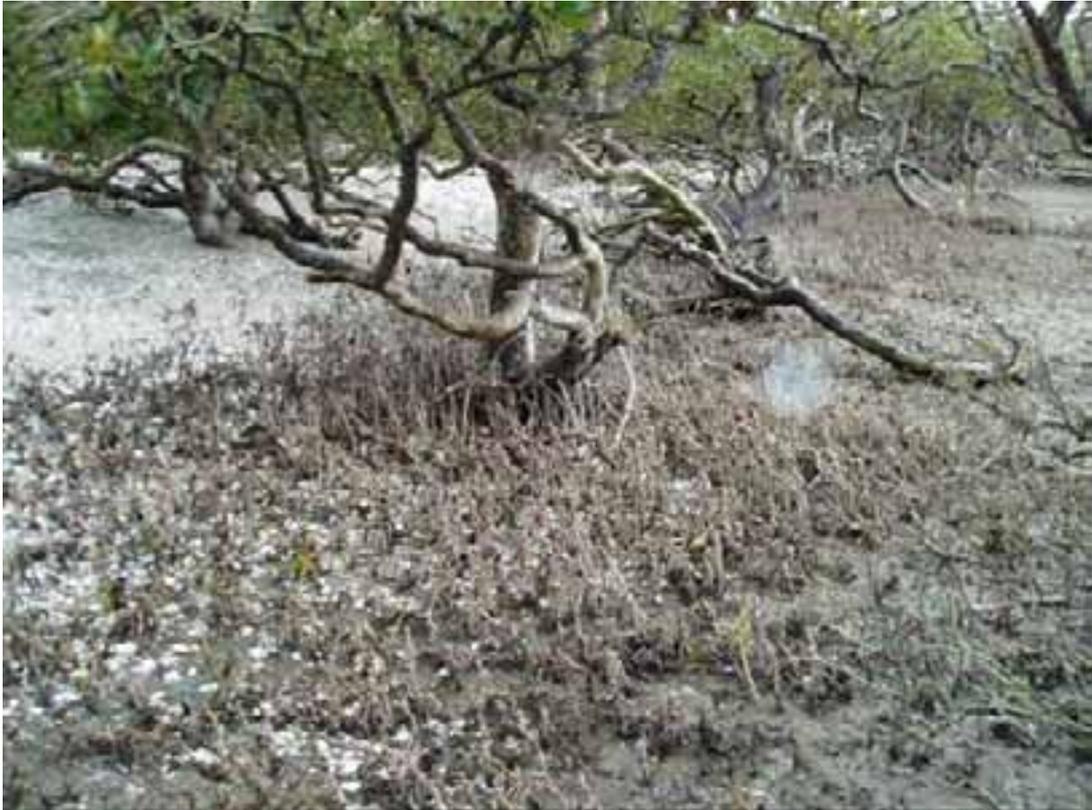
**Figure 104: Eroding mangroves on the seaward side of the active chenier ridge.**
