# Estuarine vegetation survey – Kawhia Harbour

Prepared by:  
Meg Graeme M.Sc (Marine Science)  
Natural Solutions – Marine and Terrestrial Ecologists Ltd

For:  
Waikato Regional Council  
Private Bag 3038  
Waikato Mail Centre  
HAMILTON 3240

December 2012

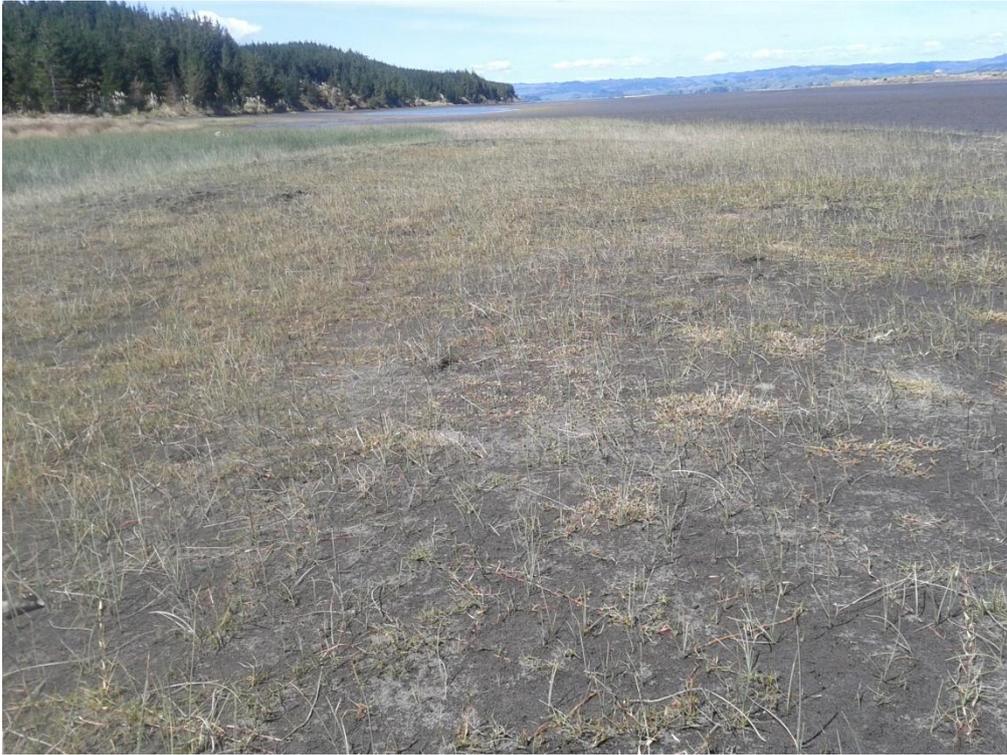
Figure 3: Sea primrose and small areas of glasswort were invaded by saltwater paspalum on a sandy ridge within Te Ariaotewiwini Inlet.

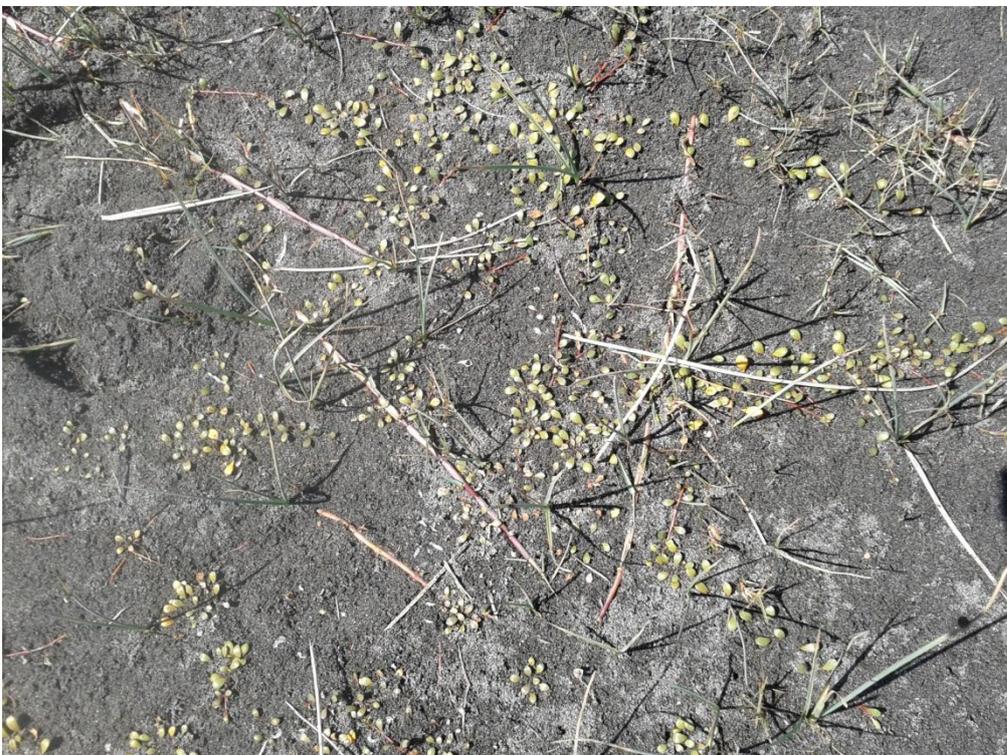
Figure 4: A close up view taken within the sea meadow bed shown in Figure 2 showing scattered sea primrose with saltwater paspalum beginning to establish.

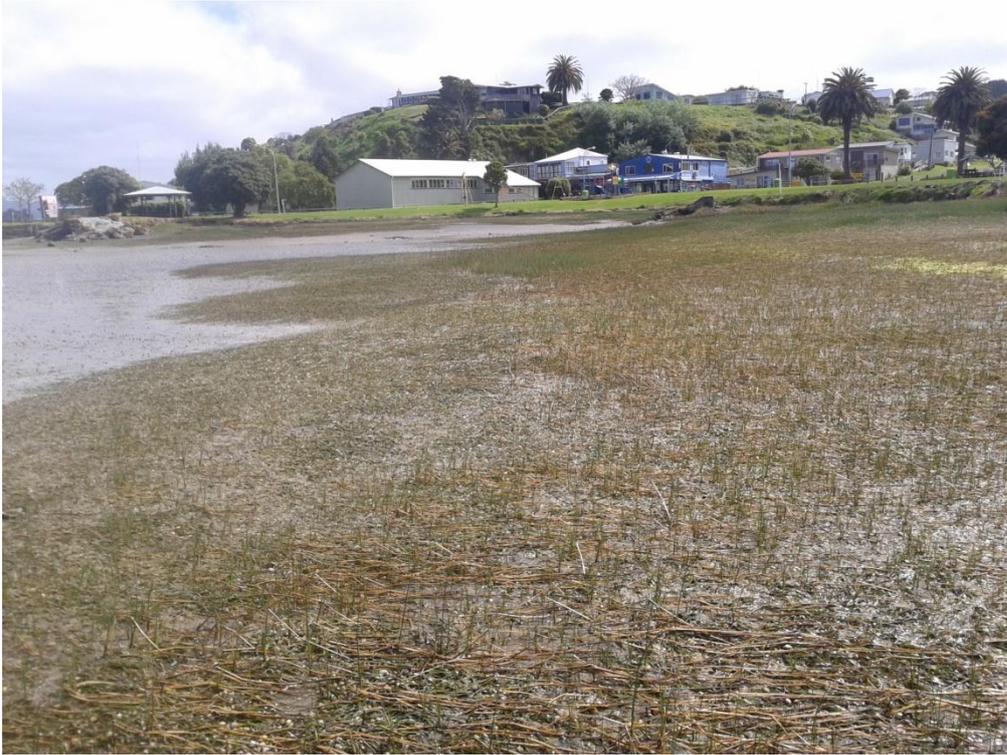
Figure 5: A view looking along the mixed interface of sea grass and three square in the village bay.

Seagrass lined the middle foreshore from **Matatua Point** past the Makatu Marae and town front to the museum. Vehicle tracks were common along the foreshore and either side of the boat ramp. Areas of seaweed (*hormosira* and *Entromorpha sp.*) were also found between the boat ramp and wharf. The upper foreshore was armoured in various forms from the Makatu marae around to the other side of town. Patches of seagrass were found in front of, or intermingled with, wide bands of three square from the indent by the museum almost to Te Puru Point (Figure 5).

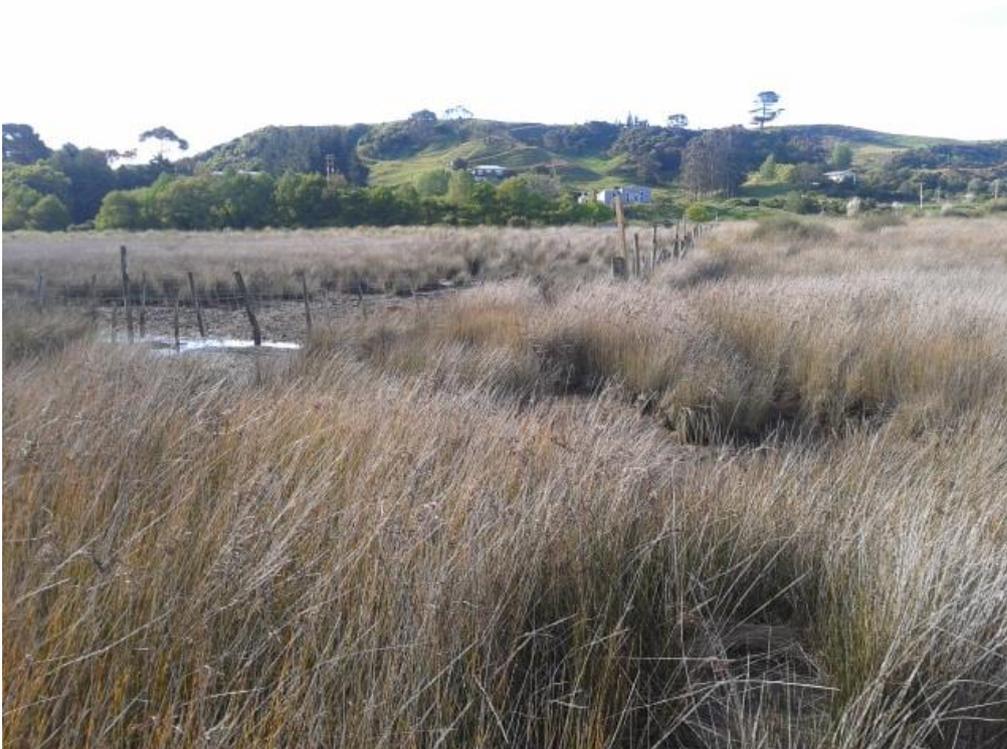
Figure 6: A fenced area of rushland where stock have access. Note the pugged sediments and lack of saltmarsh ribbonwood and oioi within the grazed area.

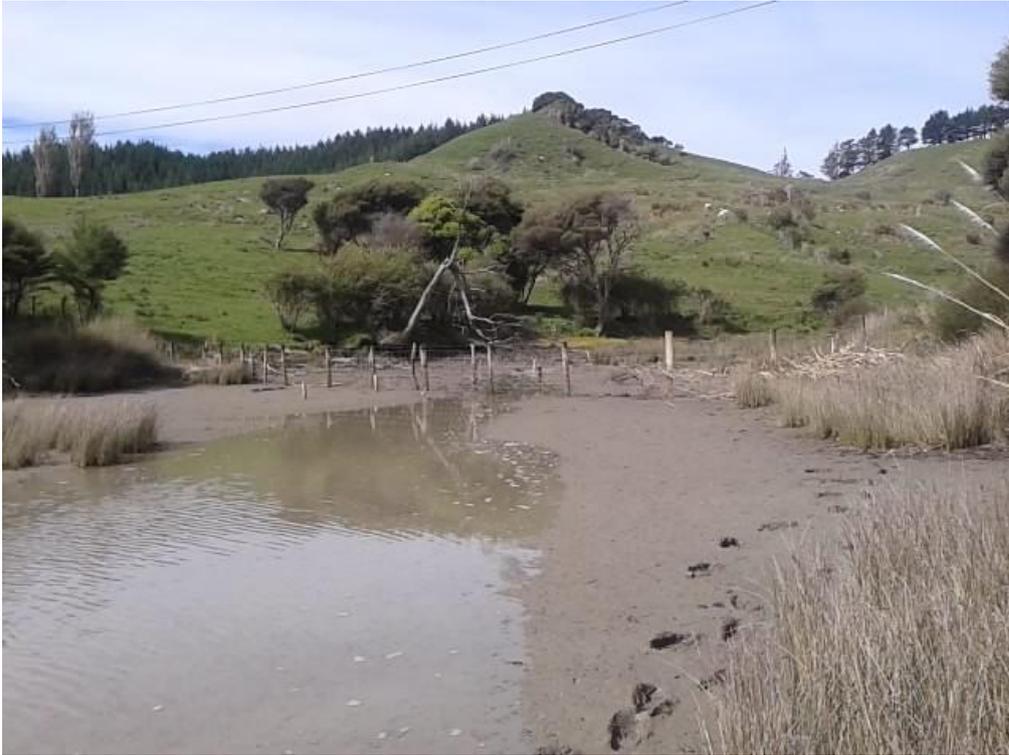
Figure 7: This is a repeat view of Figure 3 from the 2005 survey report in the upper east arm of Te Wharu Bay. The spartina had been eradicated from here but stock still had access to the harbour and had pugged the banks and flats as well as grazed and pugged the estuarine vegetation.

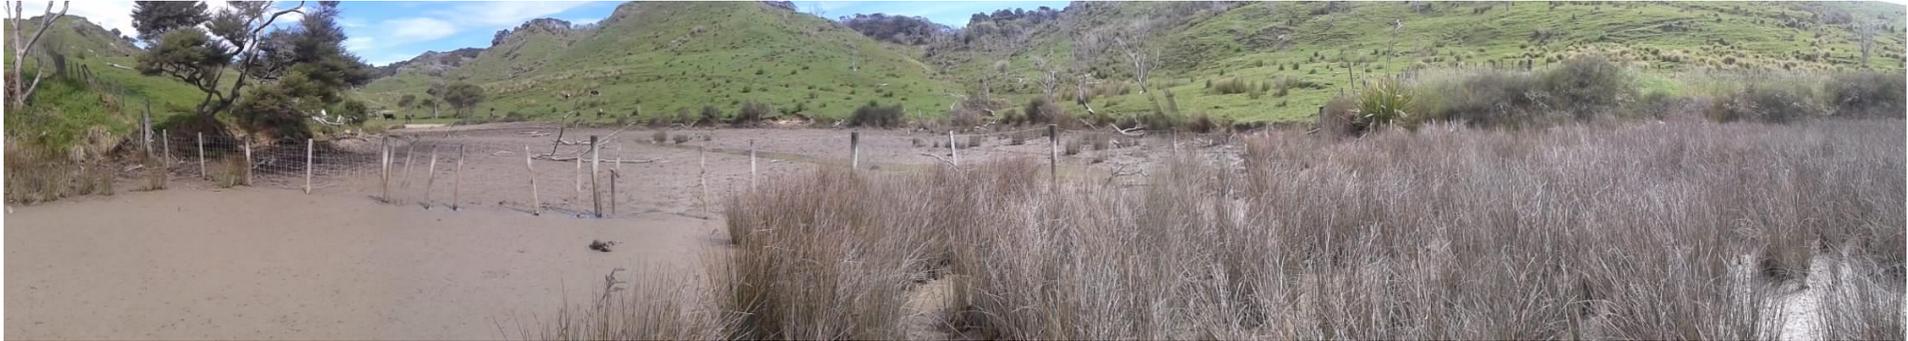
Figure 8: A panorama looking at an unprotected head of a bay. The unprotected harbour margins were characterised by eroded banks, slender clubrush communities along open high tide lines, patchy sea rush communities and grazed scattered saltmarsh ribbonwood bushes. The rushland to the right (downstream of the fence line) was protected from stock access.

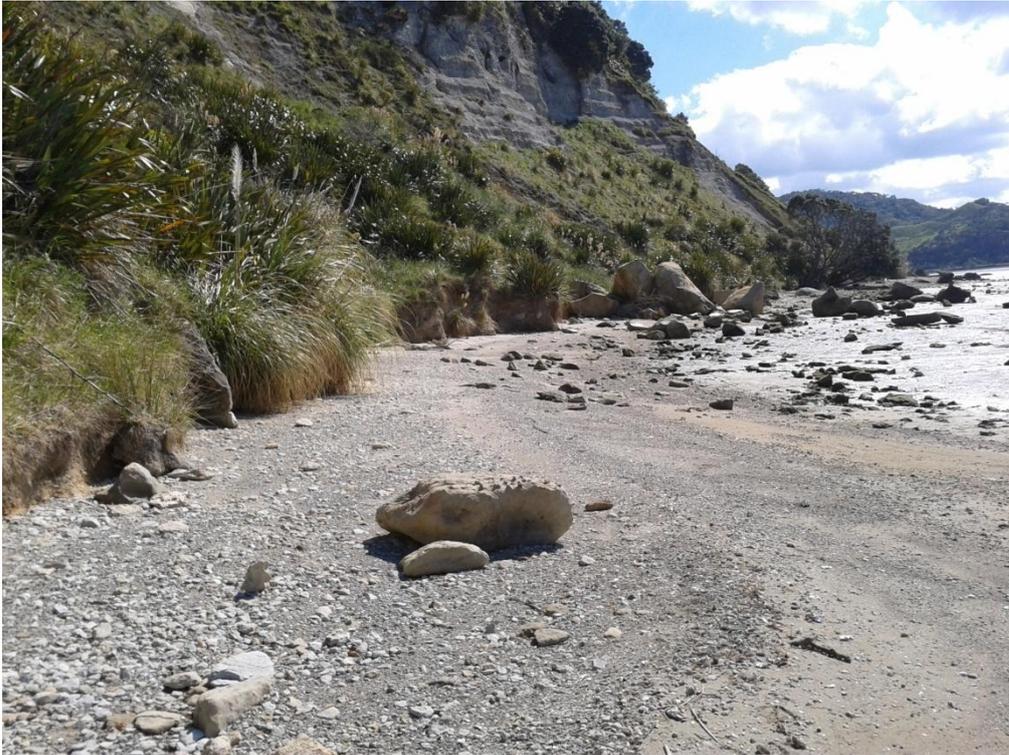
Figure 9: Flax, toetoe and pampas lined the eroding siltstone cliffs of Motutarakatua Point. The eroding siltstone beach did not support any estuarine vegetation.

The eroding siltstone tidal flats of **Motutarakua Point** did not support any estuarine vegetation. Mexican daisy was common along the exposed cliffs. Within the embayment between the two points there was a wide band of rushland including sea rush, oioi and three square with freshwater wetland species including raupo behind. Saltmarsh ribbonwood was present around the eastern stream mouth. Coast spear grass and sea primrose were common on sandy beaches/ridges along the TRB of the bay with rushland seaward. Two patches of seagrass were found out towards **Motutarakua Point**. Goat prints were common all along the foreshore. The coast line was exposed and eroded out around Motutarakua Point and along the foreshore to the oyster farm. The only estuarine vegetation was scattered coast spear grass. Mexican daisy and pampas were common along the coastal edge of Motutarakua Point but flax and toetoe became more predominant further in towards the Mangaora Inlet causeway (Figure 9). A small band of oioi and saltmarsh ribbonwood was found where equipment for the oyster farm was stored along the foreshore. Nearby was a small patch of saltwater paspalum. Vehicle tracks were noted along the foreshore. Three square was found out on the upper mid-tide flats and mixed with saltwater paspalum along the high tide beach in front of some housing. A small area of rushland, sea meadow and a saltmarsh ribbonwood bush were found at the mouth of a stream. Saltwater paspalum continued to dominate the high tide beach towards the causeway until it graded into pure *Carex pumila*.

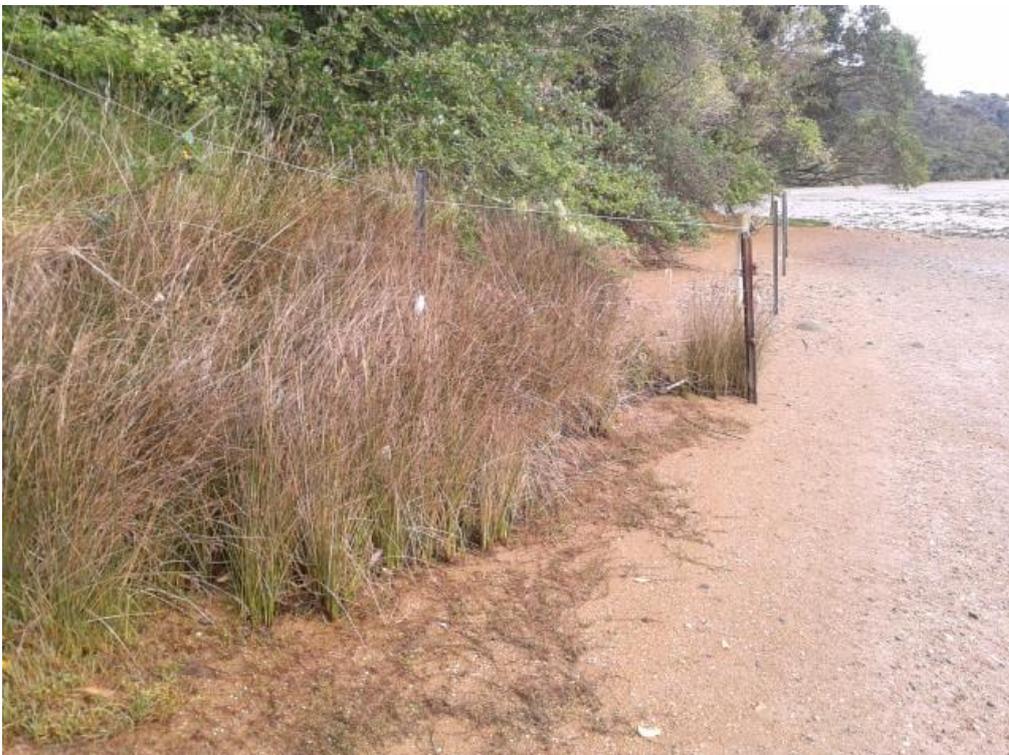
Figure 10: A repeat view of Figure 5 from the 2005 survey report showing an old fence line with sea rush, sea primrose and some glasswort in the foreground. At the end of the sandy beach there was a large patch of healthy glasswort and sea primrose.

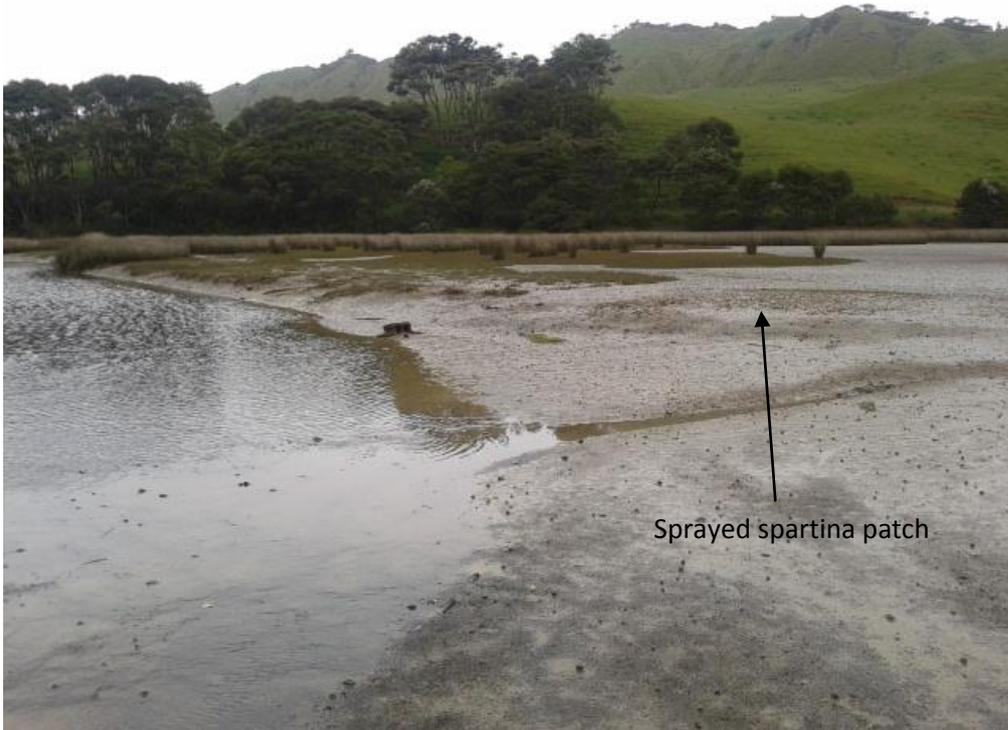
Figure 11: A repeat view of Figure 6 from the 2005 survey report looking over the remains of a sprayed spartina patch. The healthy sea primrose and arrow grass behind intermingled with the seaward sea rush community at the mouth of the Mangaora Stream.

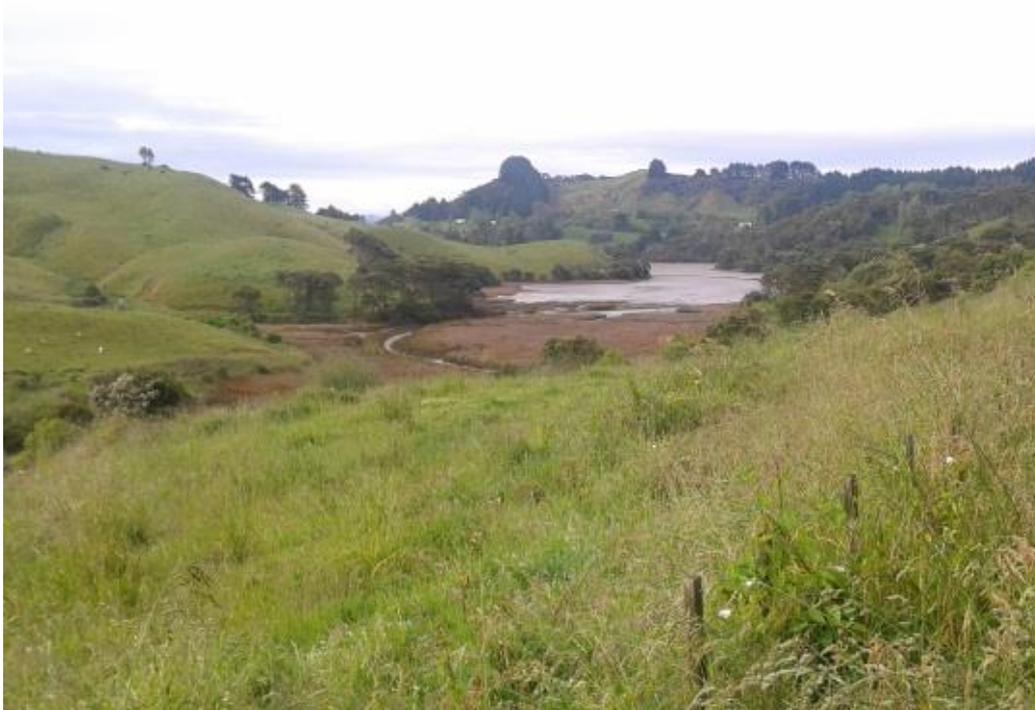
Figure 12: A repeat view of the head of the Mangaora Inlet as shown in Figure 7 of the 2005 survey report. Saltmarsh ribbonwood lined the upper channel edge and was scattered primarily around the TRB of the rushland.

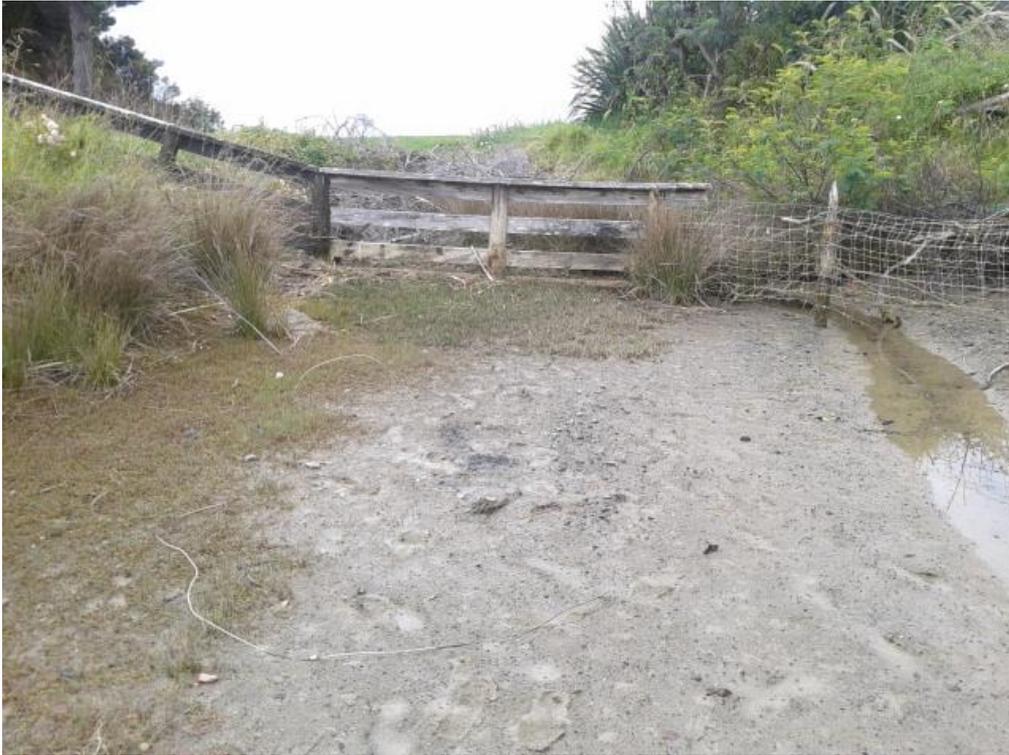
Figure 13: Some short spartina was found by the wooden fence at the end of the road rest area. Sea rush, sea primrose and arrow grass line the left foreground.

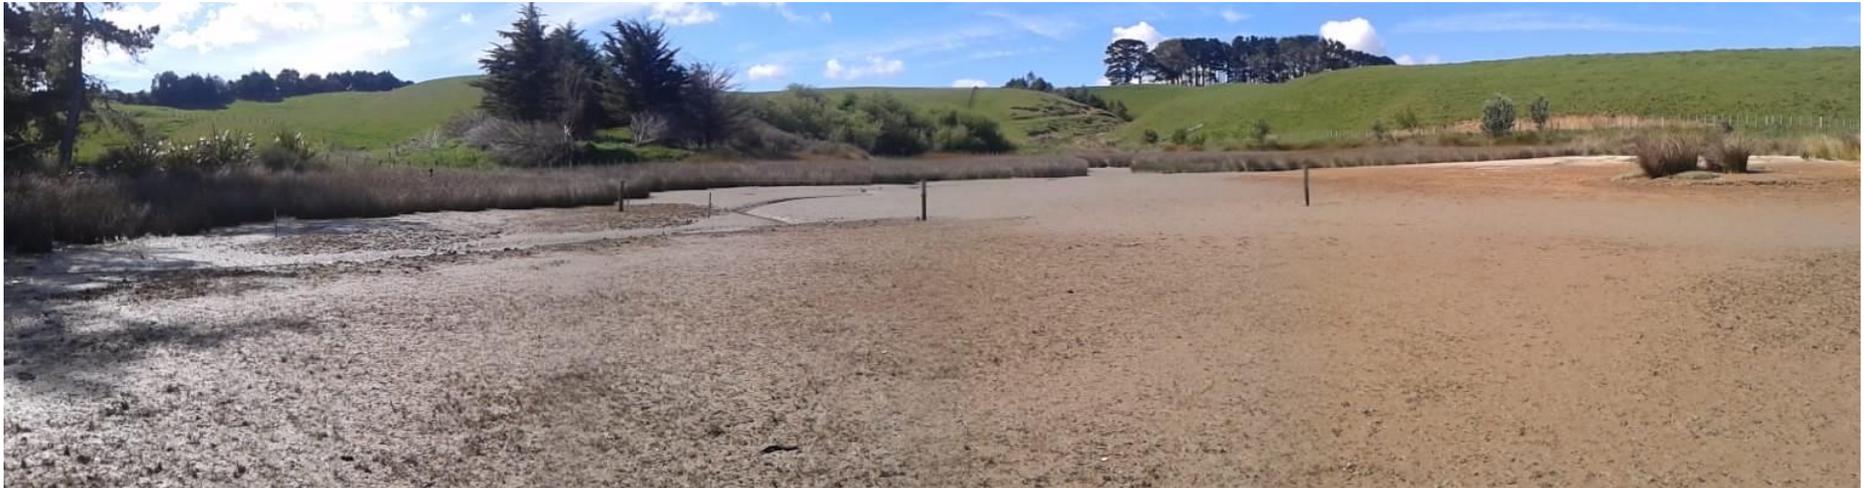
Figure 14: A small indent within the Kawaora Stream arm has remnant root masses of a spartina patch in the foreground. The rushland was fenced around the landward edge, replacing the fence line that crosses the harbour flats.

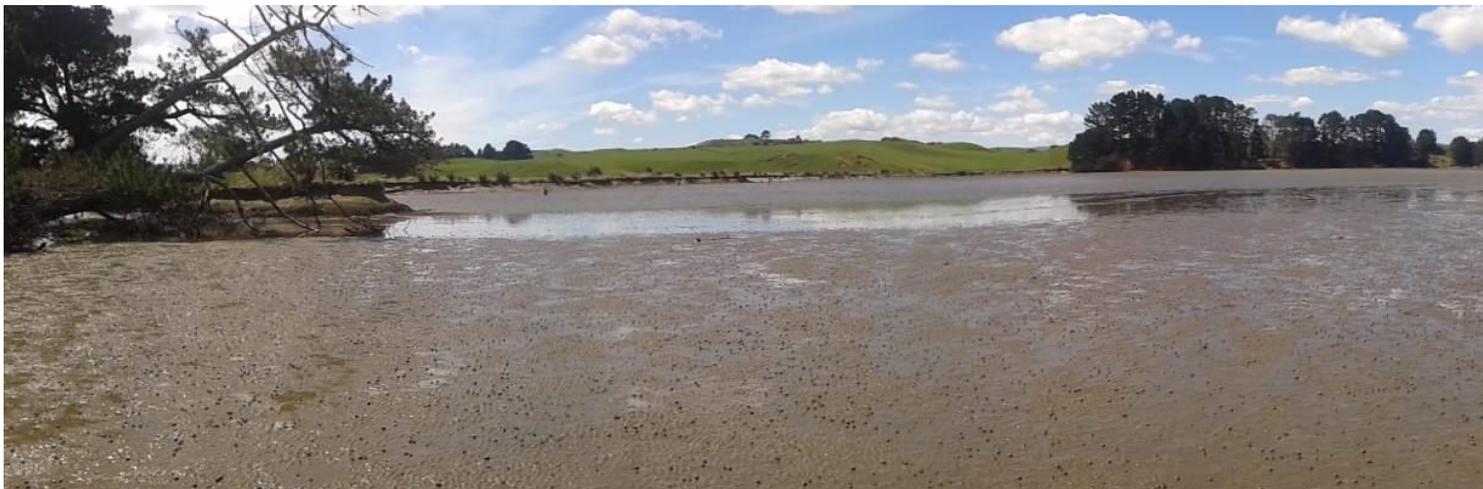
Figure 15: A view along the eroded coastline at the head of a south-west facing embayment. The only estuarine vegetation present was rushland up along inland creeks or overwash areas and thin bands of sea meadow and saltwater paspalum along the eroded edge.

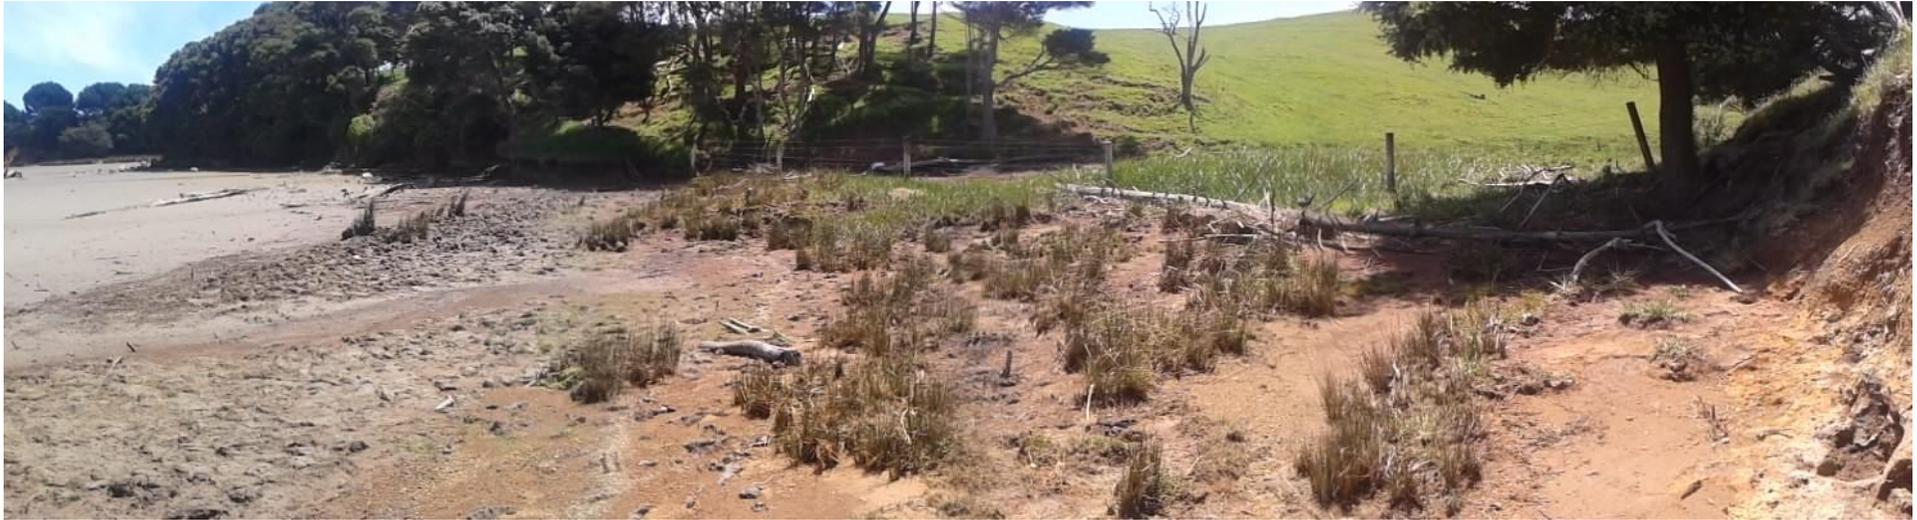
Figure 16: Severely pugged sediments, rushland and sea meadow communities were present where a gap in the fencing allowed stock access to the harbour. A bachelor's button and marsh clubrush wetland was present landward of the fence.

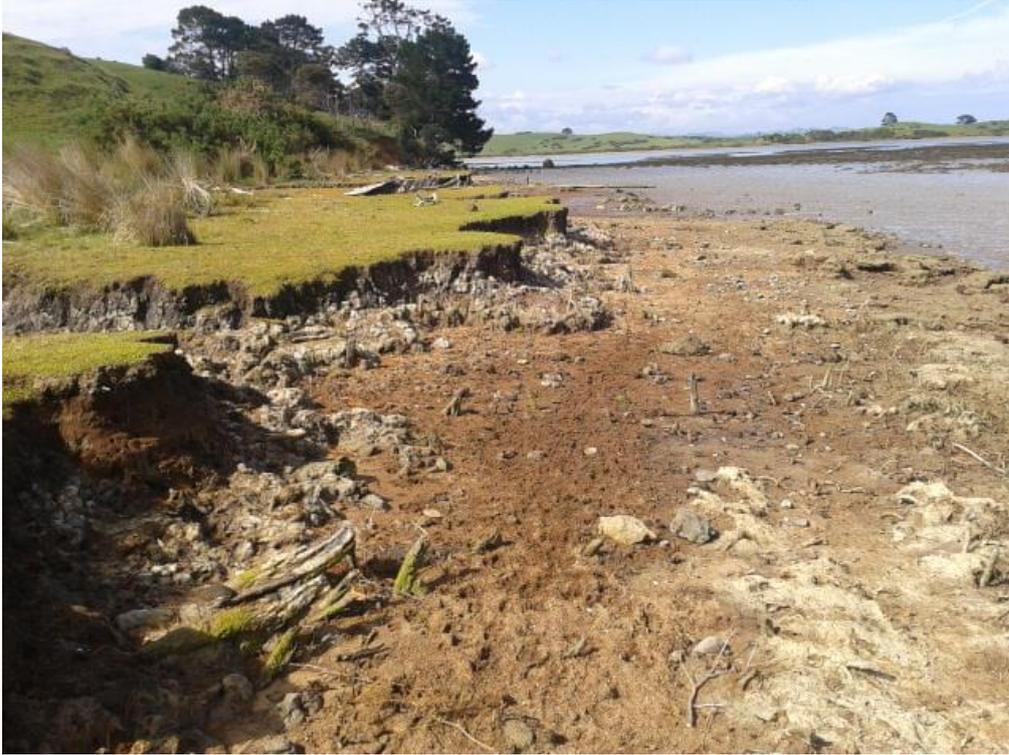
Figure 17: An eroding coastal edge along the outer TLB of the Oparau River embayment with heavy pugging along the high tide beach and a sea meadow community on the upper wave-swept flats.

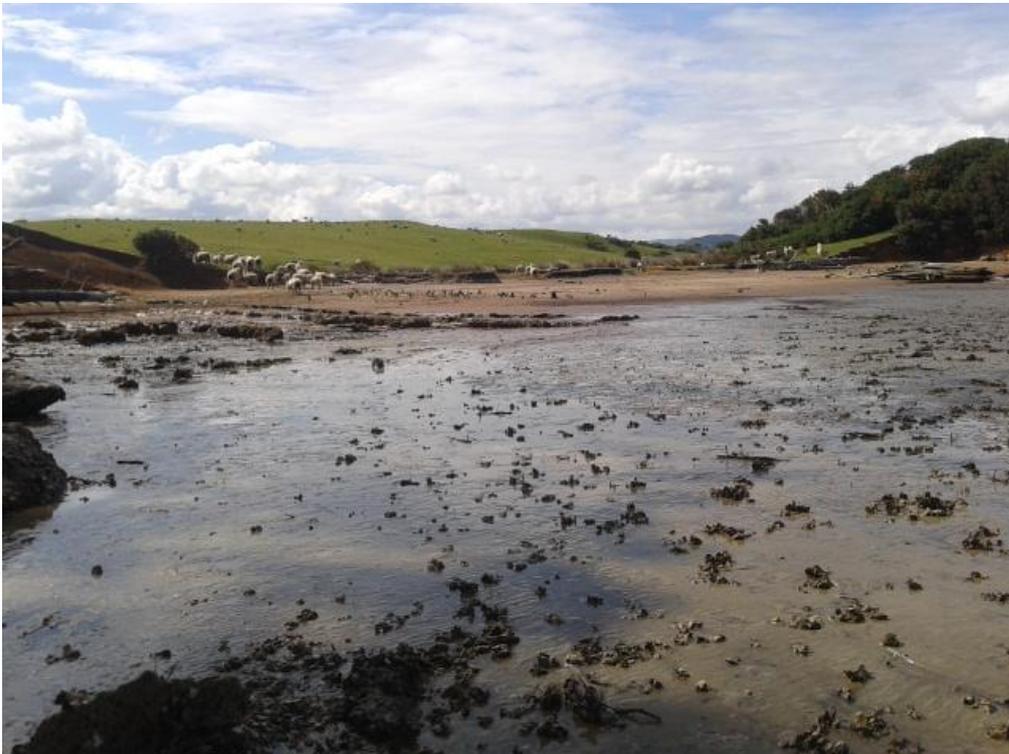
Figure 18: A flock of sheep disturbed on a sandy unfenced beach. The eroded low flats at the head of the beach supported grazed sea meadow communities including *Leptinella dioica*, *Plantago* sp., bachelor's button and saltwater paspalum.

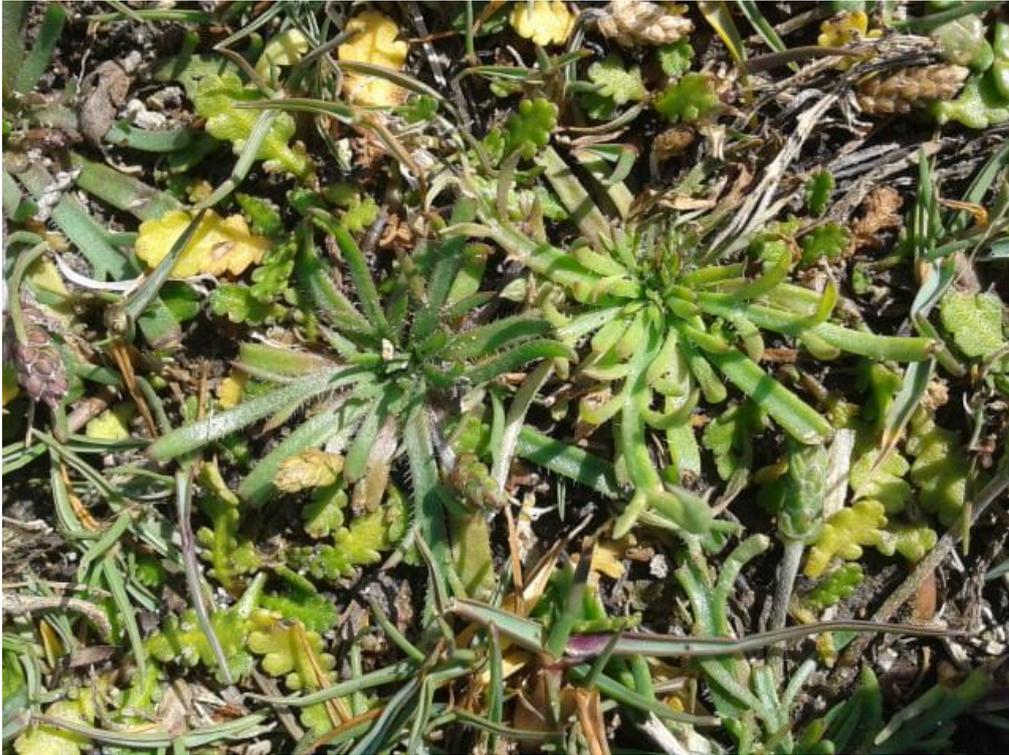
Figure 19: *Leptinella dioica* and a *Plantago* species.

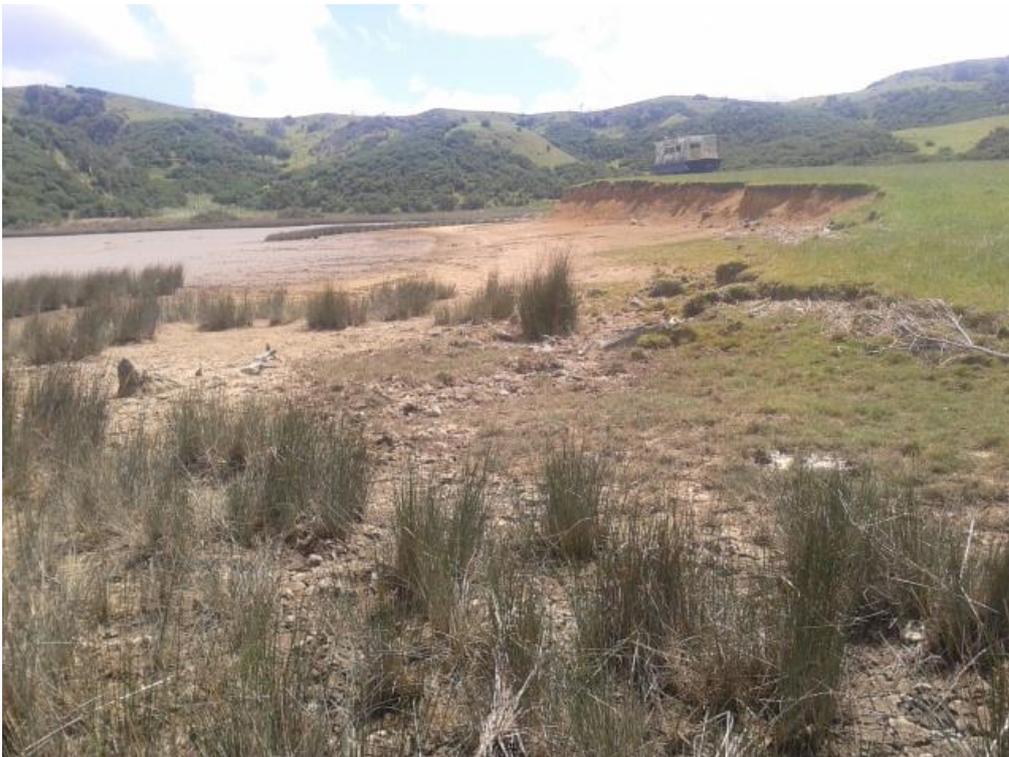
Figure 20: A view looking over a pugged area of sea rush that extends landward into saltwater paspalum with some sea meadow and three square present. Marsh clubrush, raupo and willow extended further inland. Papakura Stream embayment.

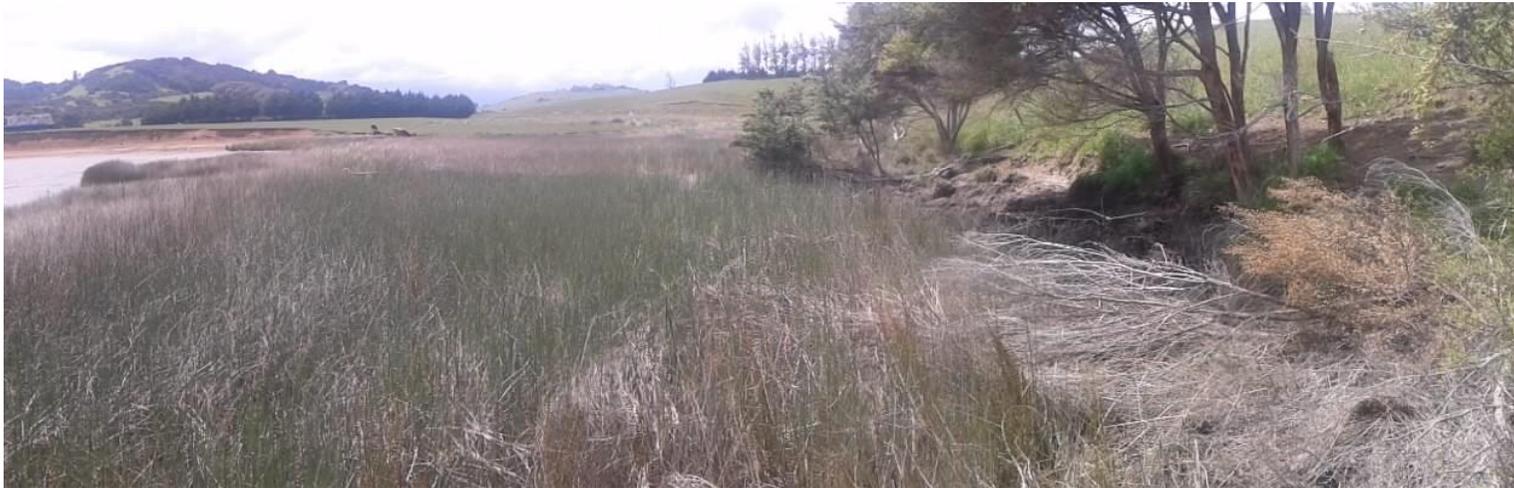
Figure 21: Stock tracking and pugging along the coastal edge was a common occurrence in this bay. Saltwater paspalum was present along the land edge here as well as mixed rushland and sea meadow communities, with oioi and three square seaward. Two cows and their calves were in the background rushland.

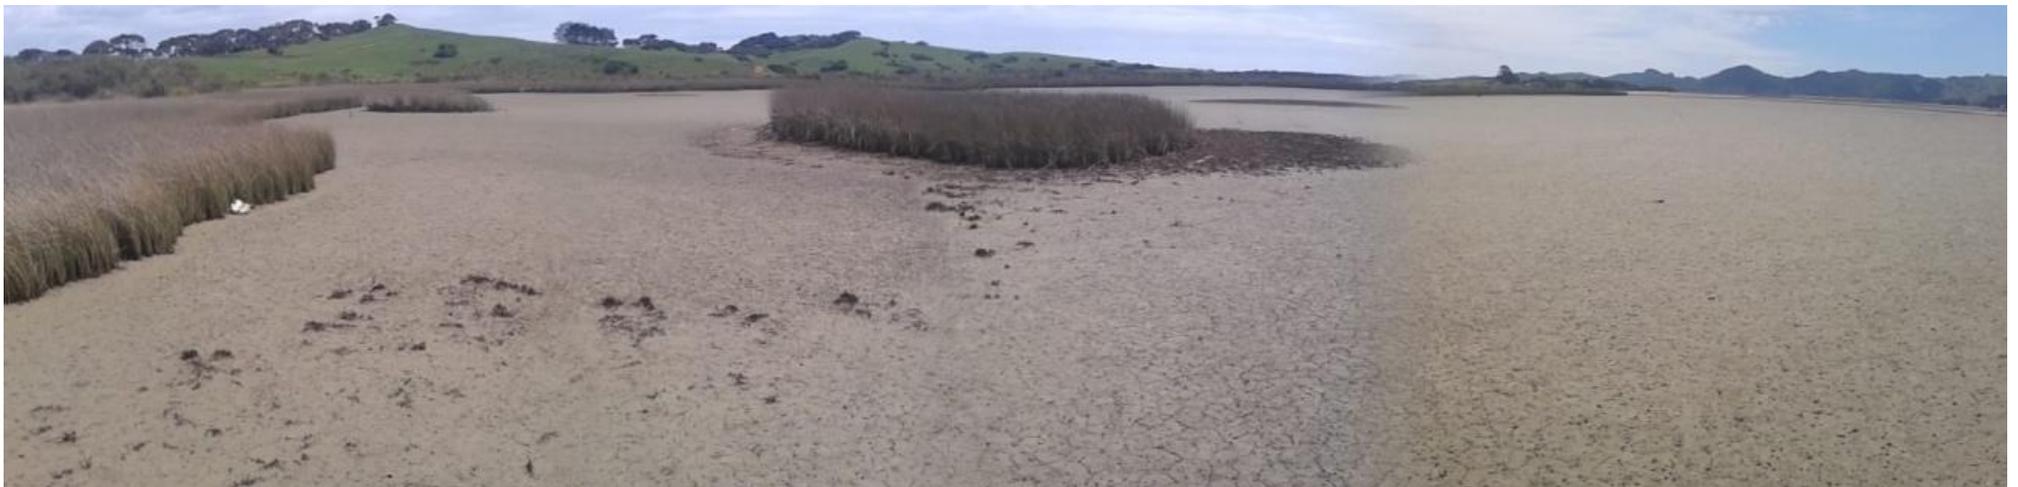
Figure 22: A view looking over rushland along the Tiritirimatangi Peninsula causeway to rush islands showing areas of die-back. Die-back of the central sea rush island was mainly restricted to the northern seaward side but the two rush islands behind and either side of the central island had died back completely.

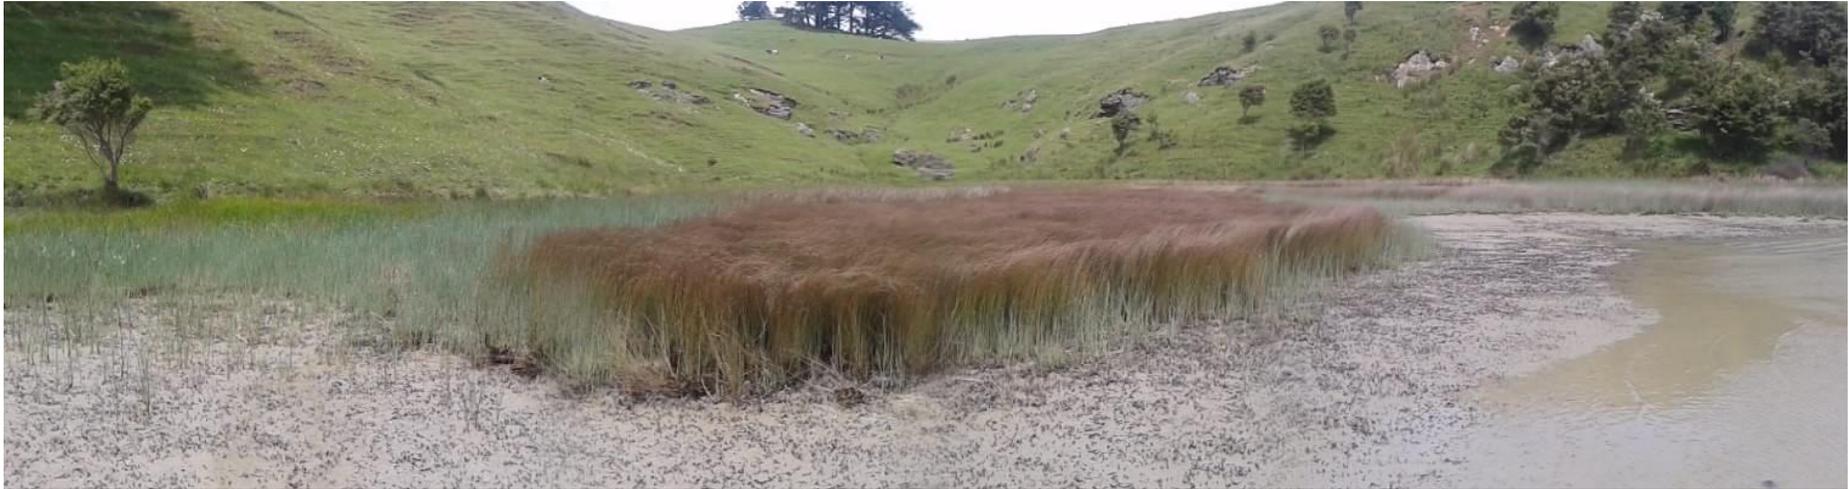
Figure 24: A photo of mixed rushland - bright green marsh clubrush in the left background, blue-green three square and golden oioi in the foreground, light brown sea rush in the right background and a zone of dead root masses fringing the seaward edge of the rushland.

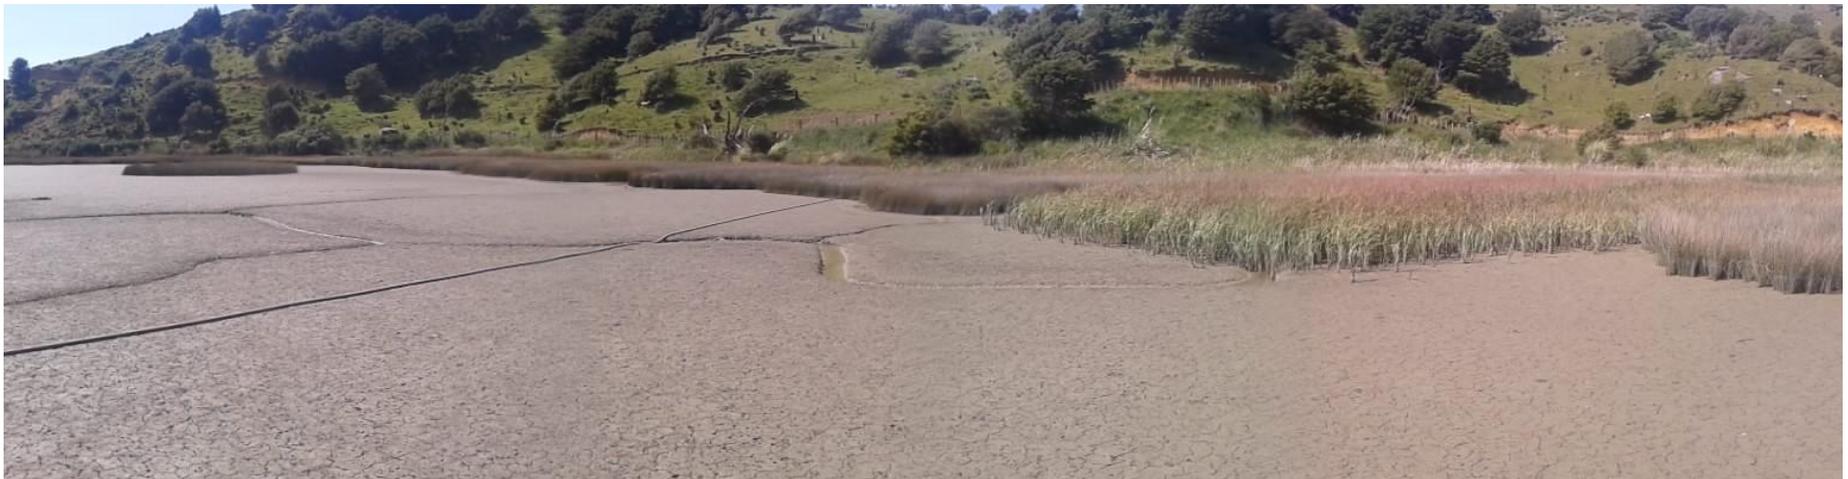
Figure 25: A view looking over healthy patches of sea rush and oioi and a large patch of spartina (centre right) at the head of the arm between the Awaroa River and Waikorire Creek.

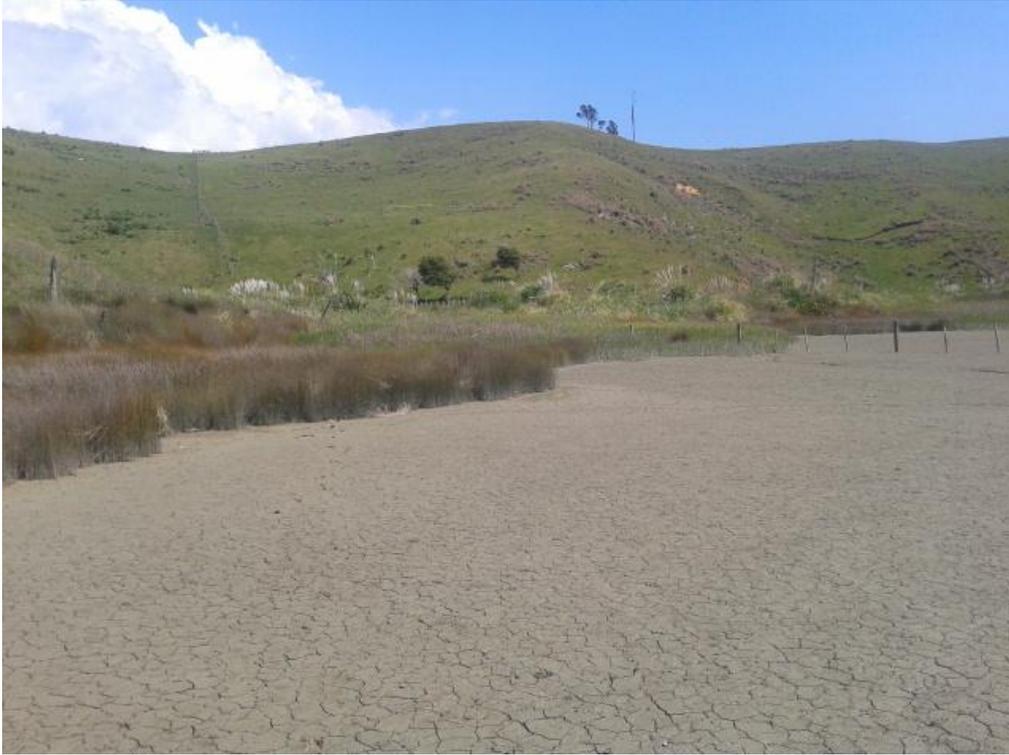
Figure 26: In this repeat photo of Figure 10 in the 2005 survey report the rushland with oioi and marsh clubrush looked the same. The only difference was that the mangrove in the 2005 photo had gone.

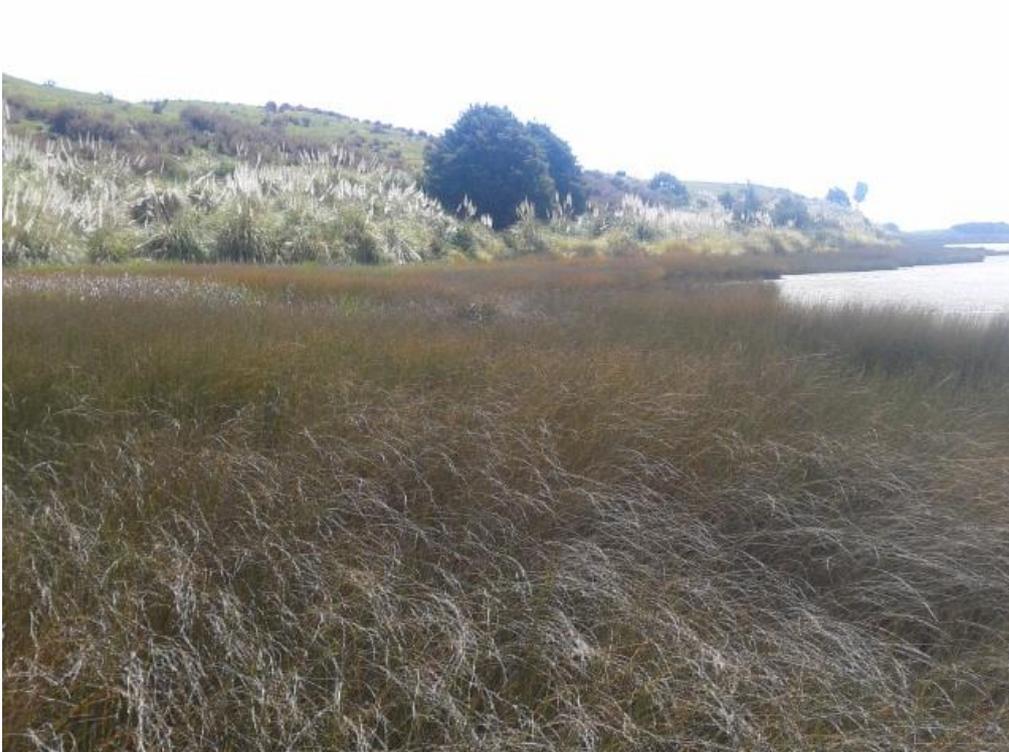
Figure 27: A repeat of Figure 11 from the 2005 survey report. There was no sign of stock damage in the rushland in November 2012.

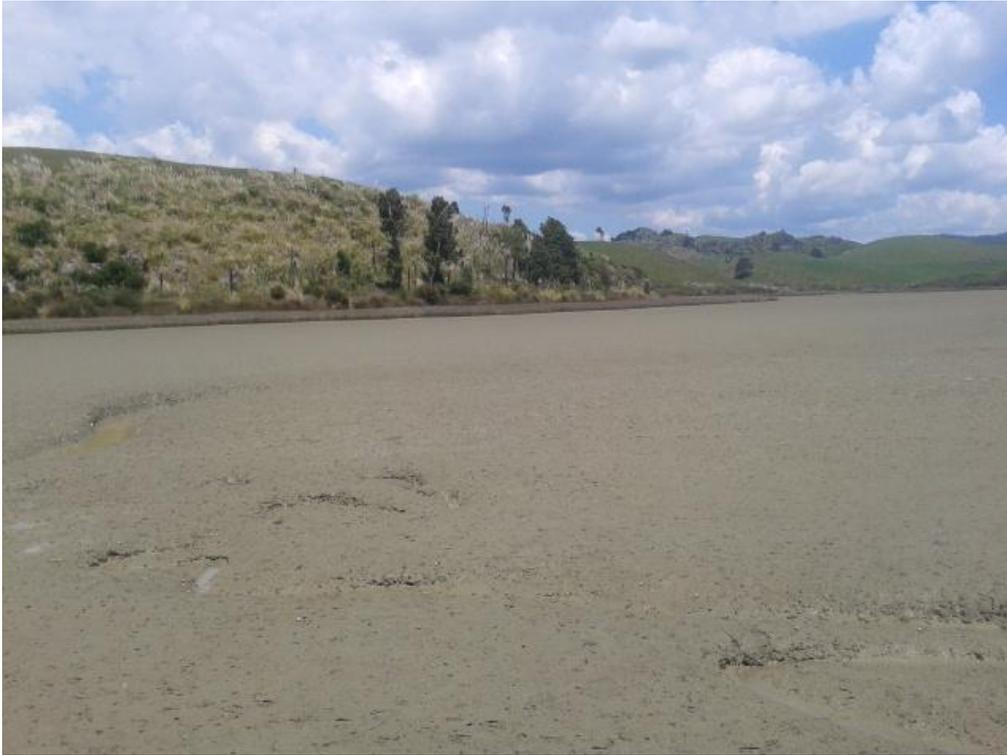
Figure 28: A repeat of Figure 12 in the 2005 survey report. The coastal margin was fenced well back from the harbour edge and dominated by pampas. Scattered native riparian vegetation was also present.

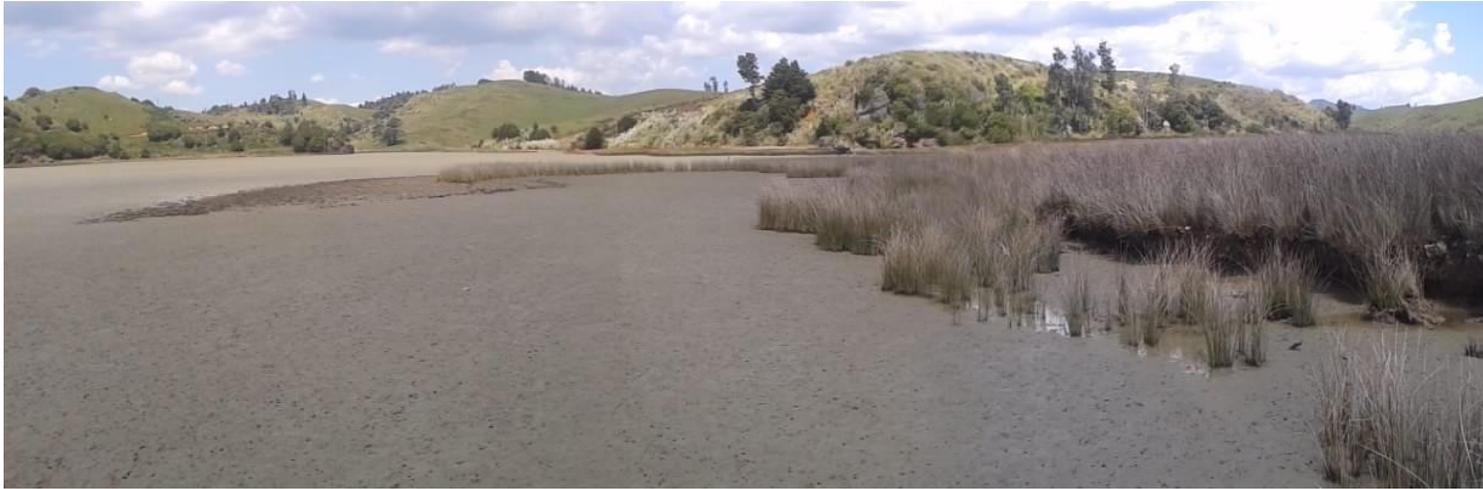
Figure 29: Sea rush die-back at the tip of Mahoe Point.
