# Estuarine vegetation survey – Kawhia Harbour

Prepared by:  
Meg Graeme M.Sc (Marine Science)  
Natural Solutions – Marine and Terrestrial Ecologists Ltd

For:  
Waikato Regional Council  
Private Bag 3038  
Waikato Mail Centre  
HAMILTON 3240

December 2012

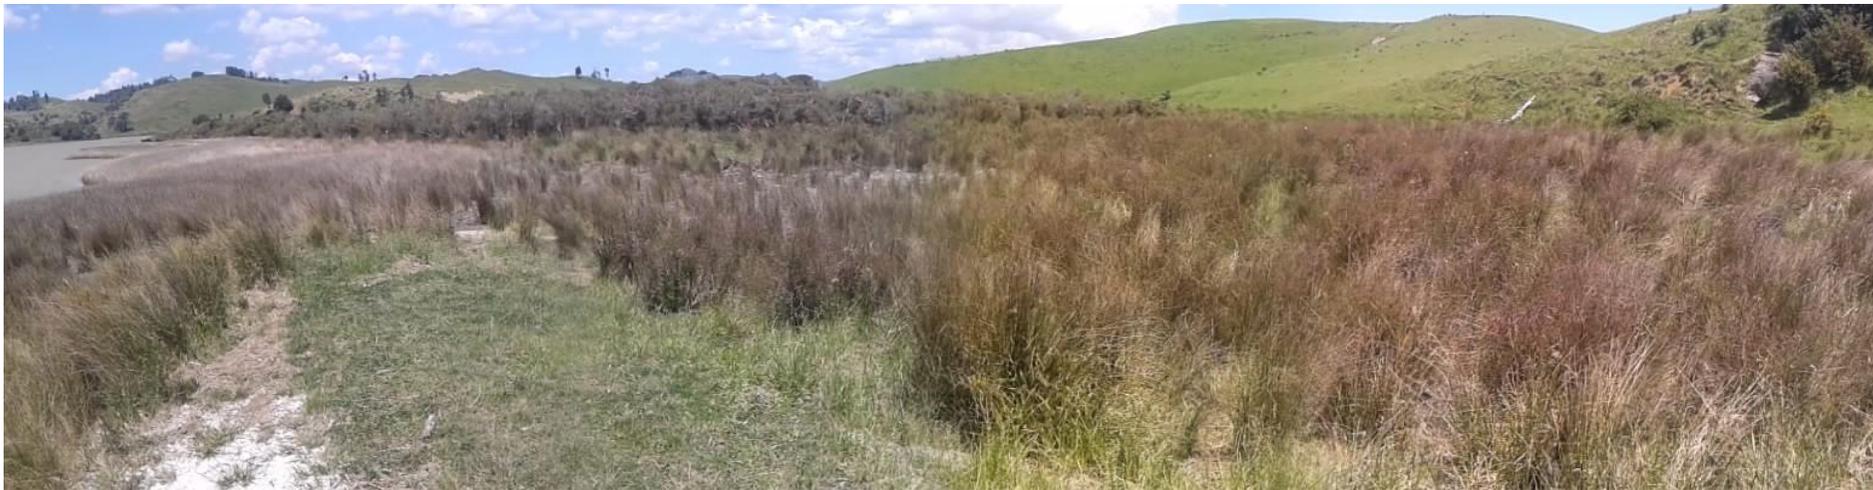
Figure 30: The northern end (towards Kopapaihekei Point) of a significant freshwater and estuarine wetland sequence that had a stock access problem. The rushland, saltmarsh ribbonwood (inland of the grassed spit) and freshwater wetland communities were badly pugged and grazed.

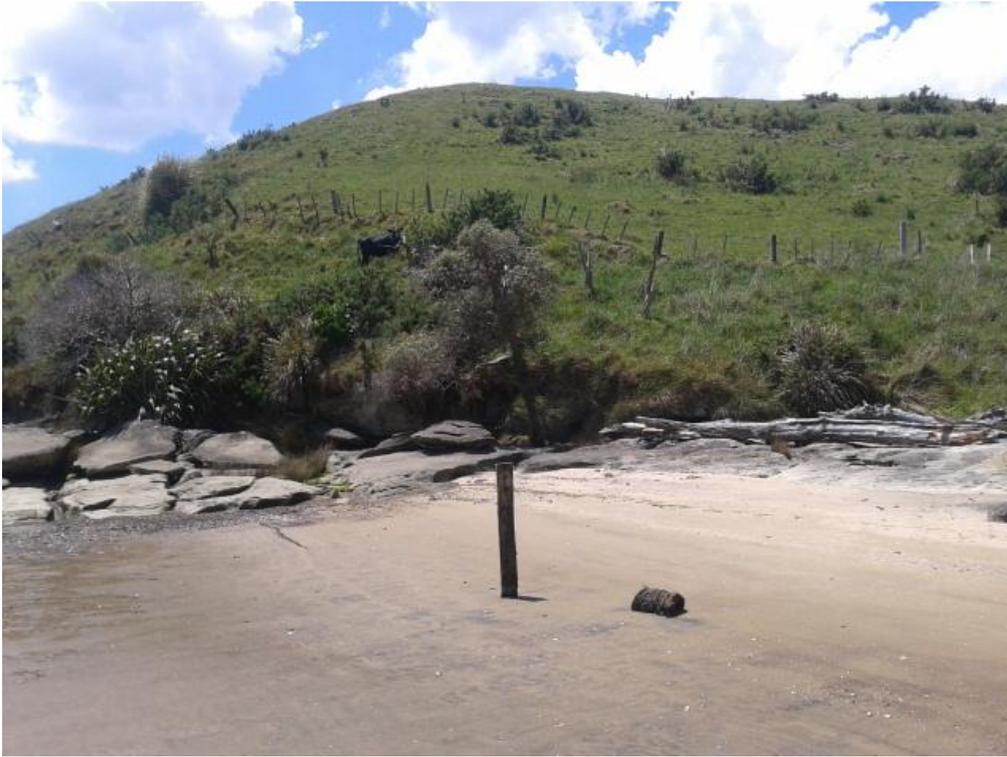
Figure 31: A cow grazing in the riparian margin around from Okehu Point. Note the rocky coastline and the few patches of rushland in the shelter of the boulders.

Around **Okehu Point** there was a cow grazing within the riparian margin (Figure 31). The fence line was not in good condition here.

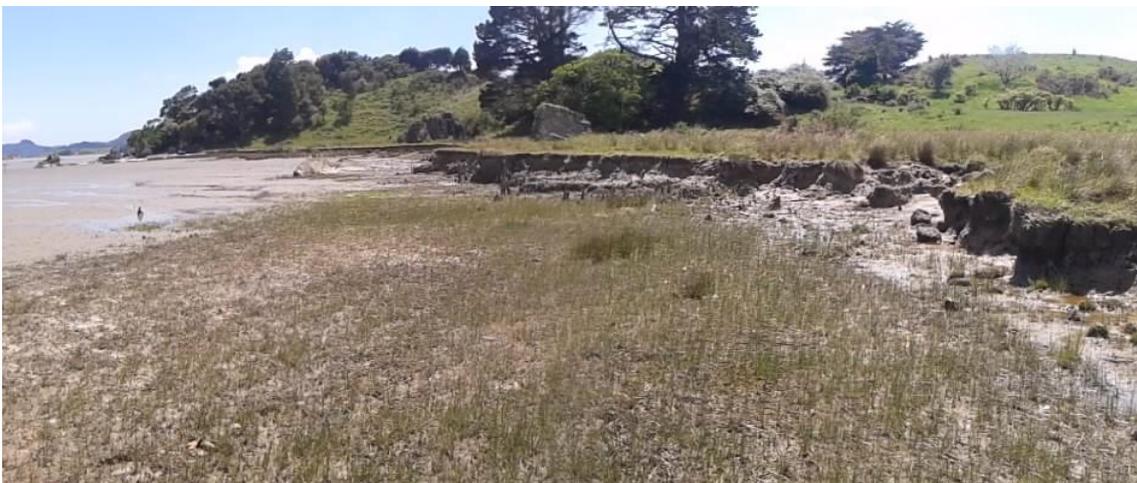
Figure 32: Along this exposed section of coastline there were old tree roots exposed and dead rush root bases with live short three square growing amongst them. Sea rush was present in the distance in the more sheltered corner.

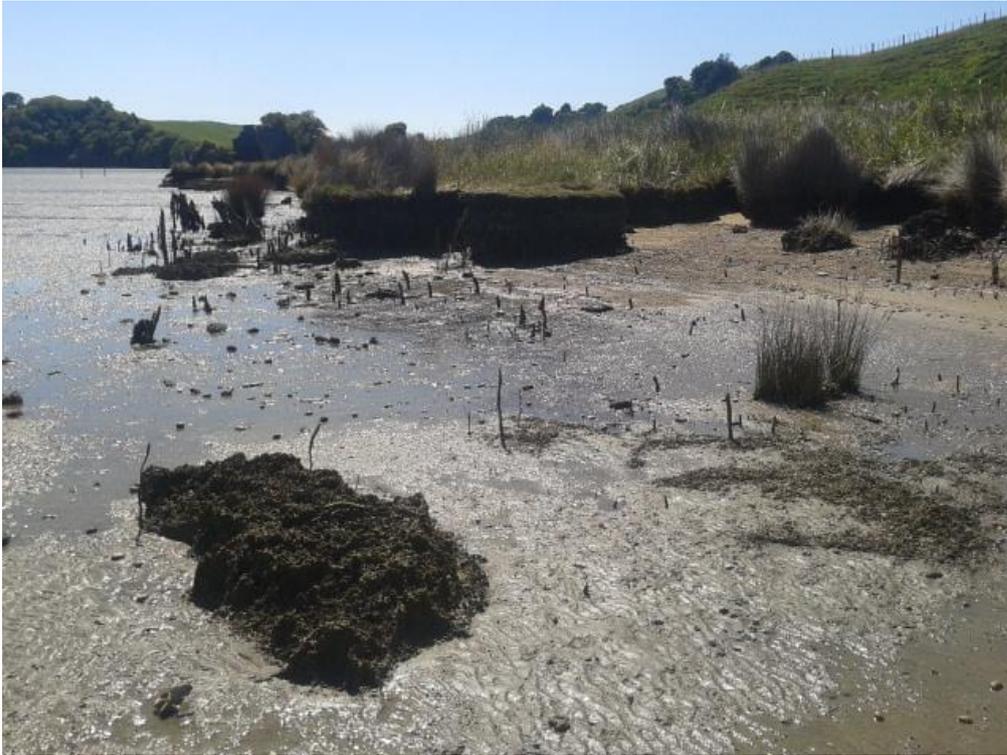
Figure 33: A view of the eroding coastline with a limestone island in the middle background. Note the old tree roots out in the flats.

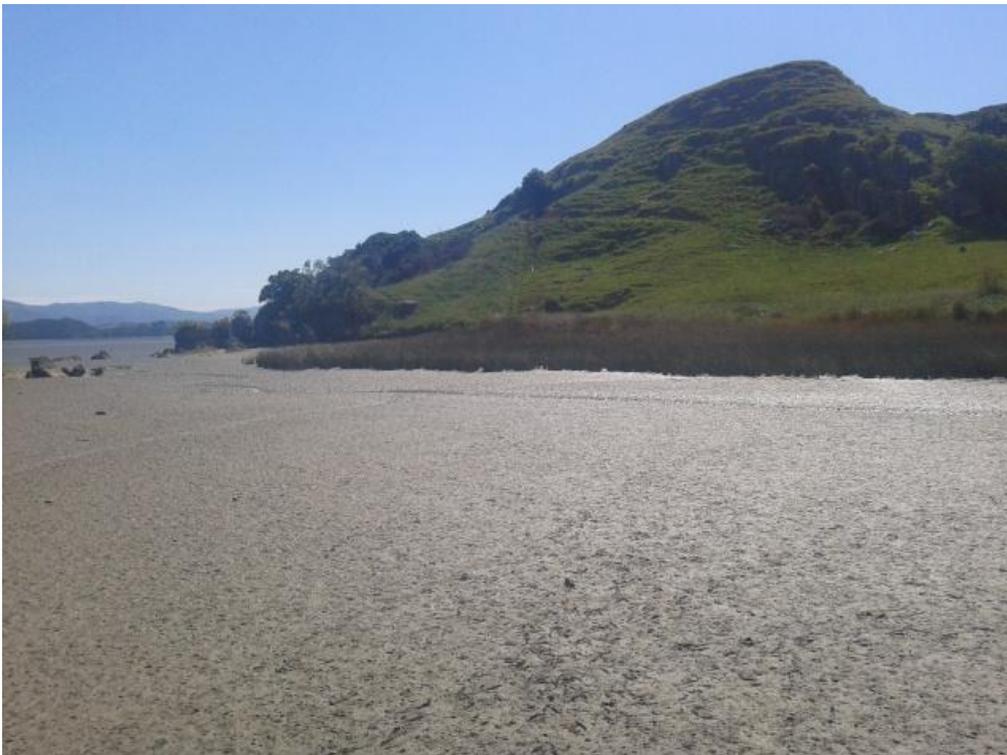
Figure 34: Te Aute Point in the background has excellent riparian management with a large set back from the coastal edge protecting the remnant coastal forest and allowing further riparian forest regeneration.

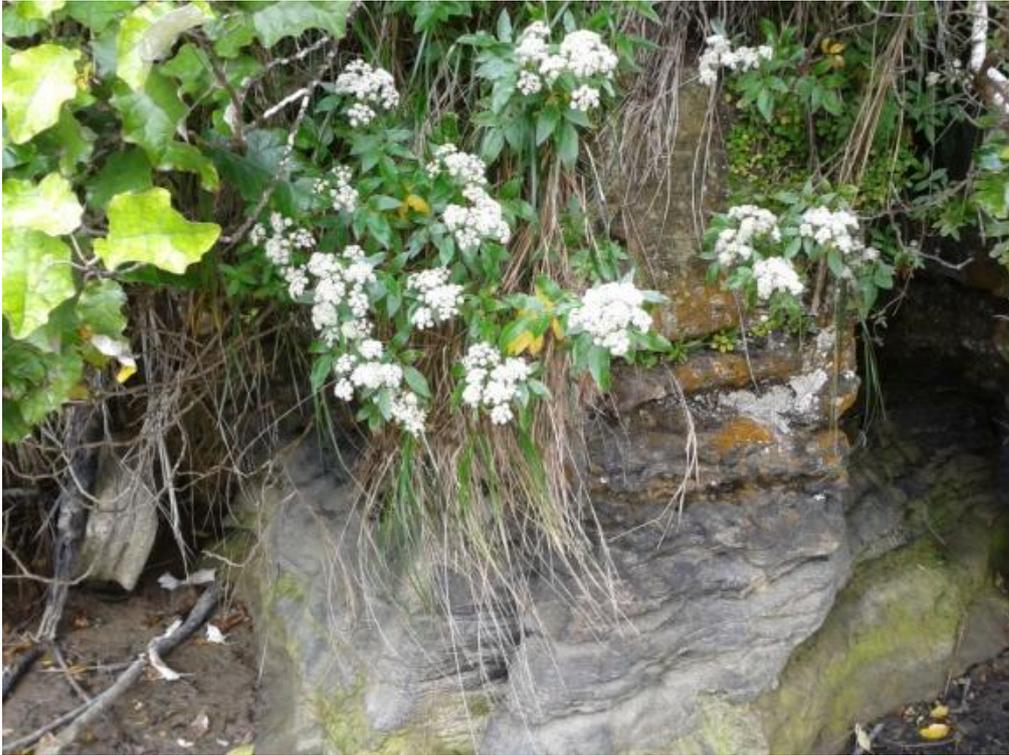
Figure 35: A number of plants of the threatened species *Scandia rosifolia* were found along the coastal cliff edges of the Rakaukeke Creek arm near the Narrows.

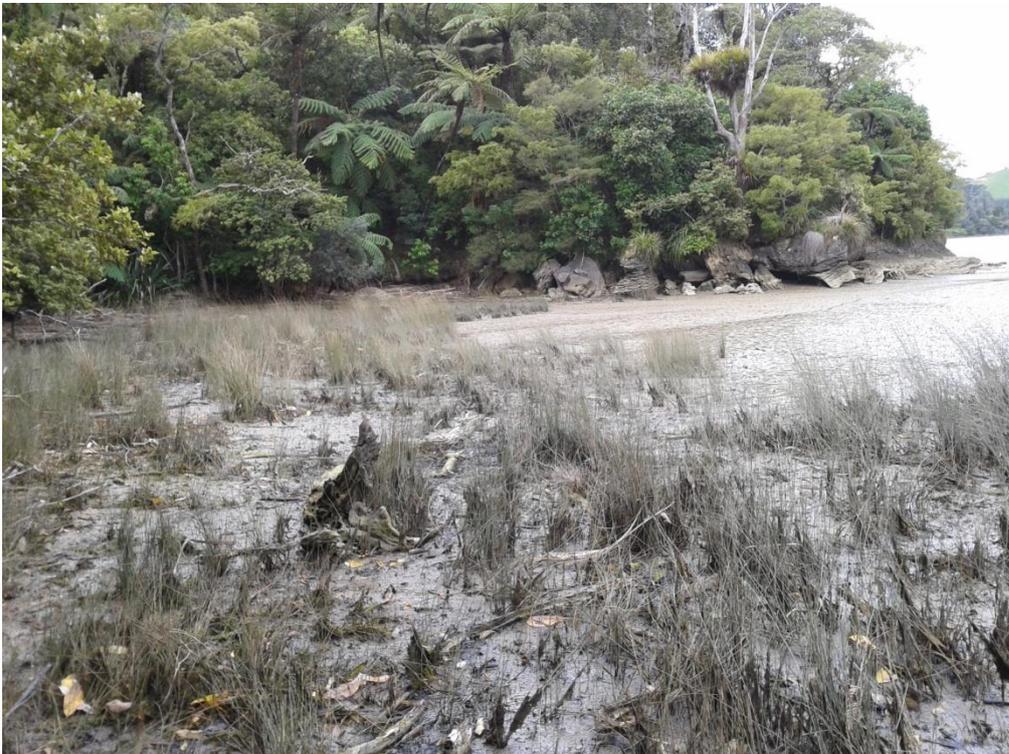
Figure 36: An example of poor quality rushland with clumps of oioi and dead oioi root masses, signs of grazing of oioi and animal prints in the mud (goat?).

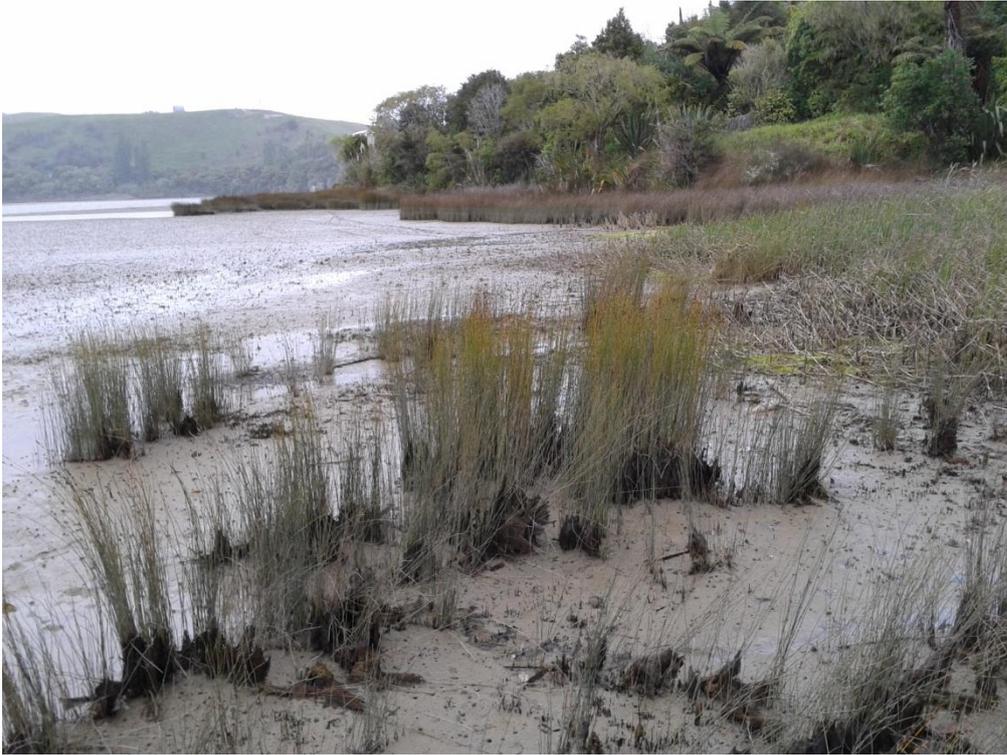
Figure 37: Behind the sparse oioi patches in the foreground was a mat of dead spartina roots. Marsh clubrush and oioi lined the foreshore.

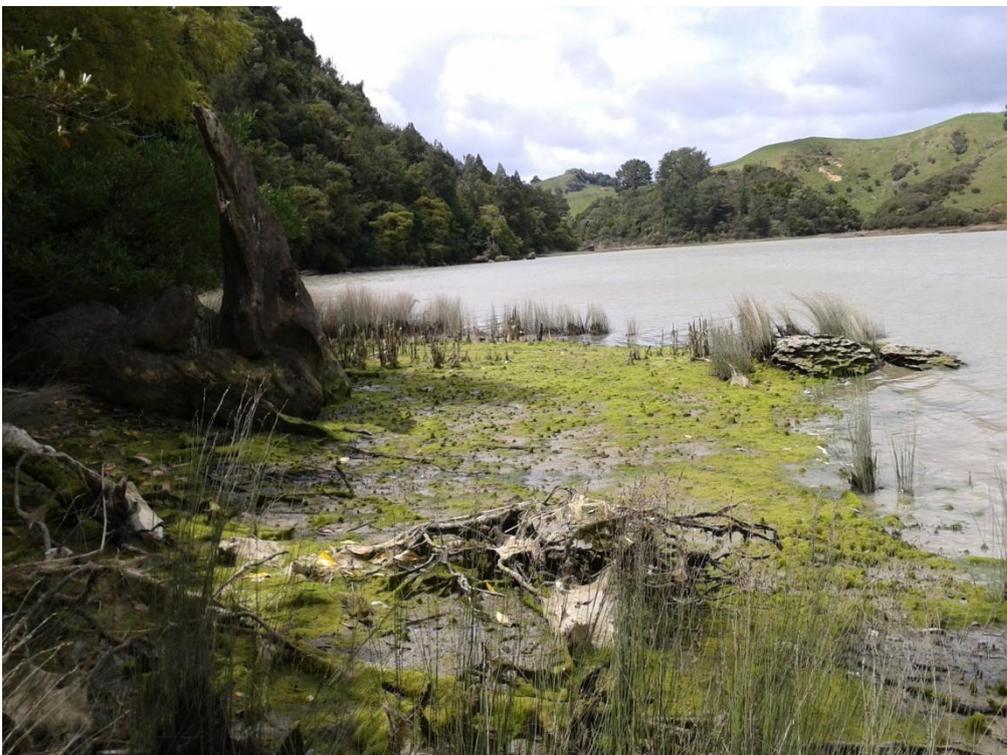
Figure 38: A sprayed spartina site covered in seaweed (*Entromorpha sp.*) with sparse oioi at either end. Some dead oioi bases were also present.

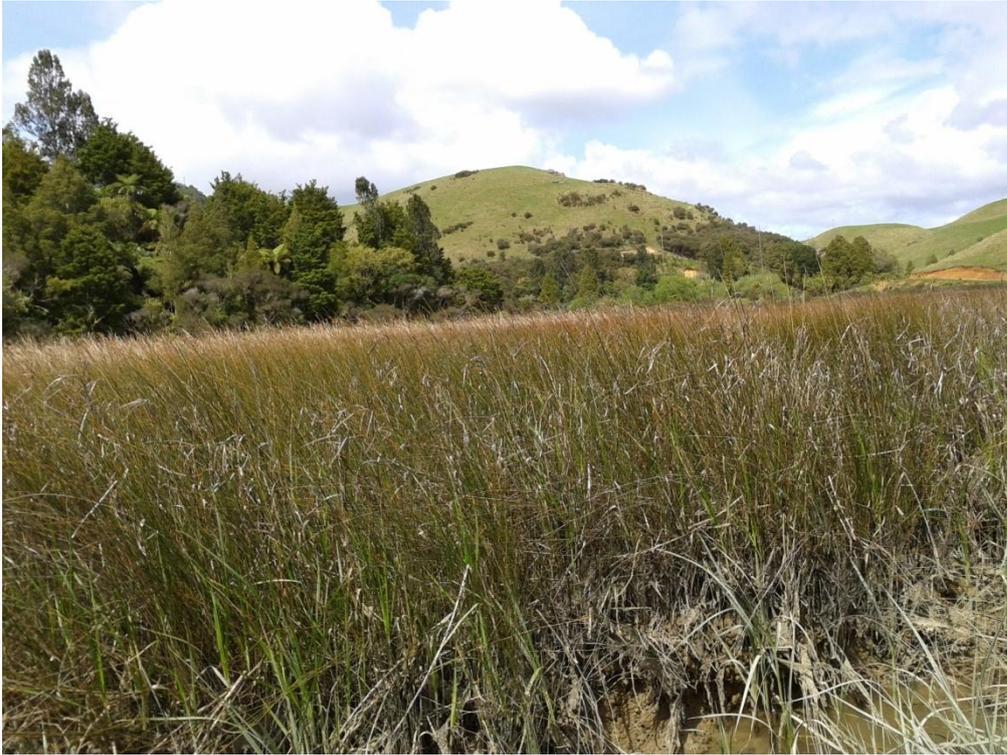
Figure 39: A repeat of Figure 17 in the 2005 survey report looking over a mix of oioi and marsh clubrush with coastal forest and farmland in the background.

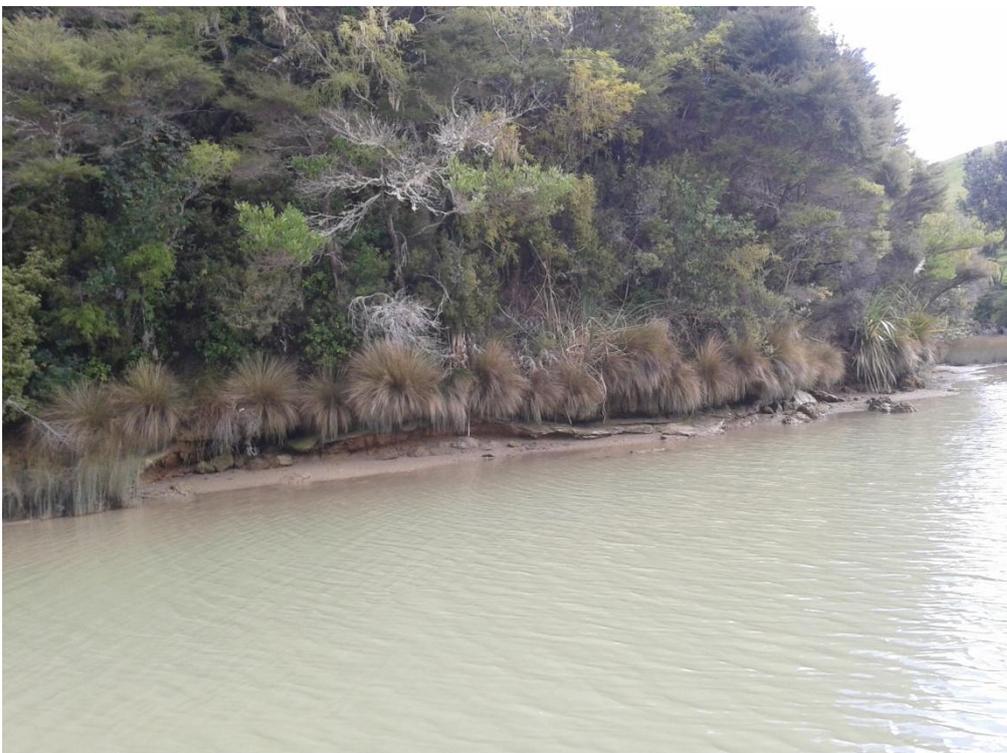
Figure 40: A repeat photo of Figure 18 in the 2005 survey report showing a mixed coastal forest edge including live kanuka and possibly a dead kanuka amongst kowhai and akeake. Coast spear grass (silver tussock) lined the intertidal edge with rushland to the left and right.

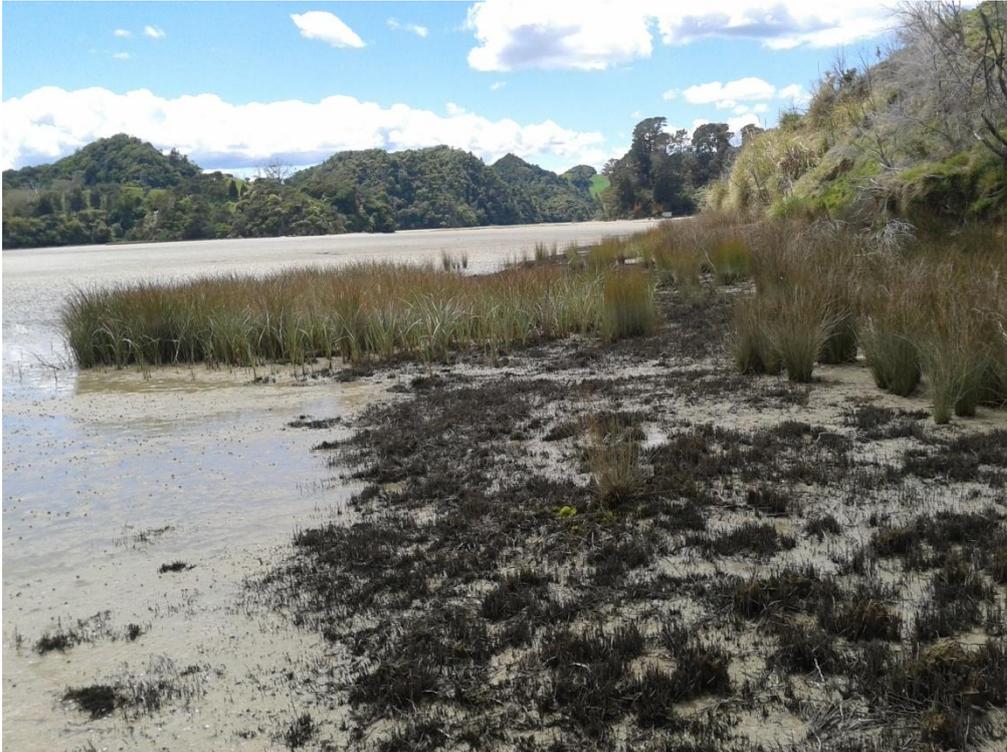
Figure 41: A patch of live spartina extending seaward of a dead rush zone. Scattered oioi plants were present seaward and within the dead oioi root mass. Oioi, sea rush and marsh clubrush were present along the landward edge.

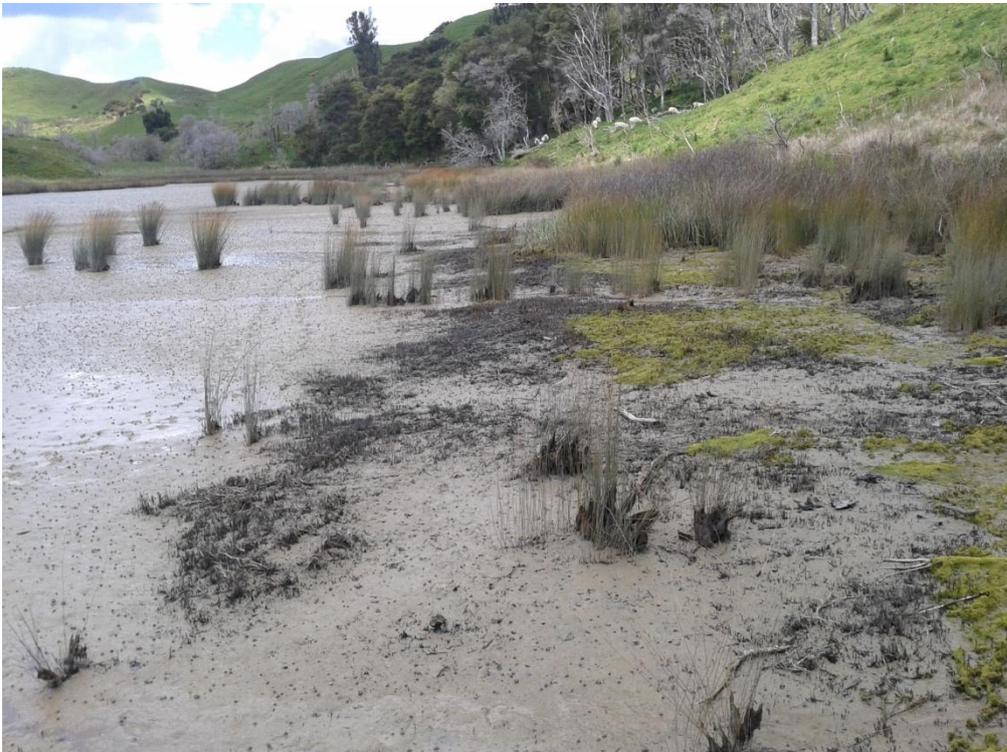
Figure 42: Dead rush bed mats with healthy oioi seaward and landward. Marsh clubrush was in the background and the pasture was not fenced from the coast.

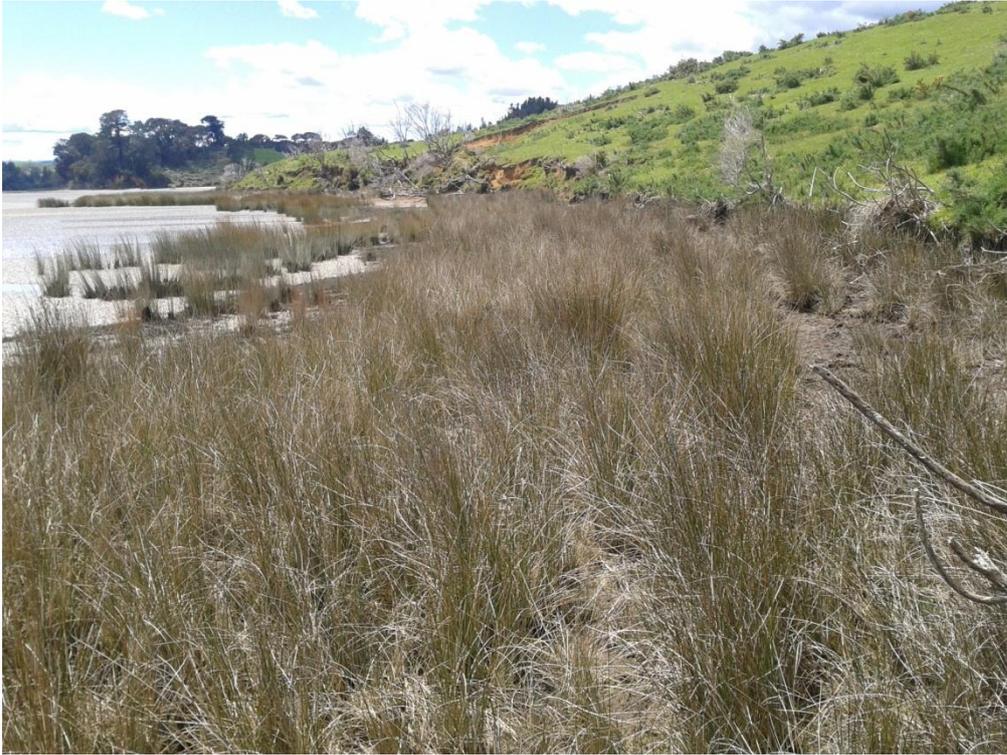
Figure 43: Tracked rushland at the high tide zone and sprayed kanuka along the riparian margin with no fencing. Dead root masses of oioi are visible along the seaward edge of the rushland.

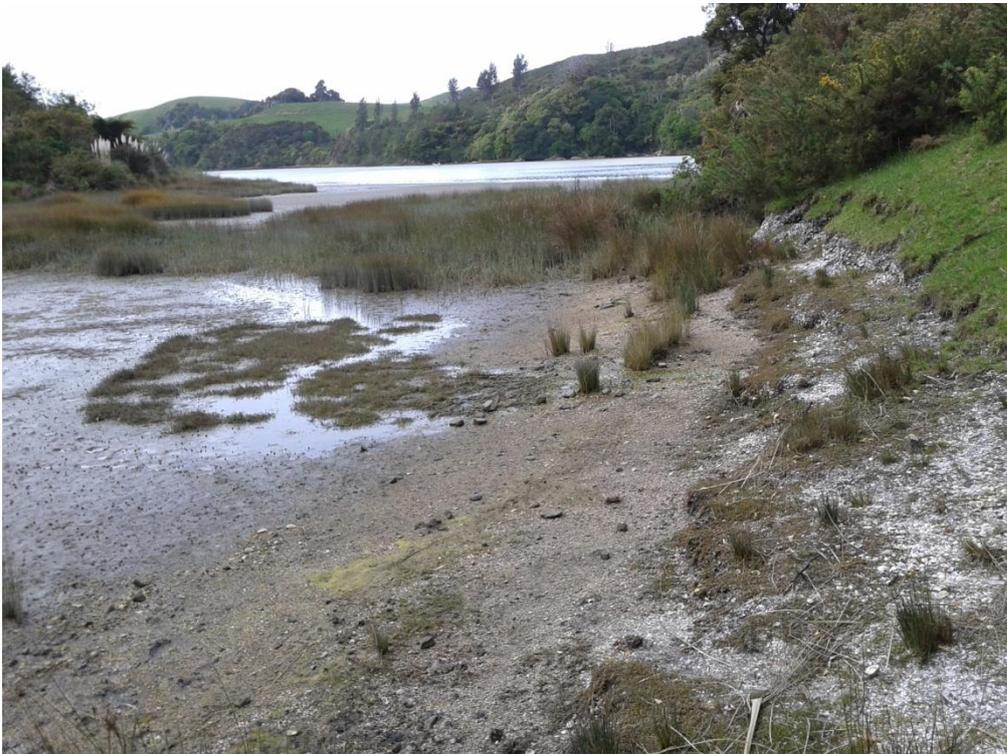
Figure 44: A small unfenced indent along the eastern side of Tuapu Island with a grazed edge of sea meadow (sea primrose and slender clubrush) and sea rush in front of the pasture. A small patch of seagrass was found lower on the tidal shore abutting a sea primrose bed. The rushes in the background were mainly three square and oioi.

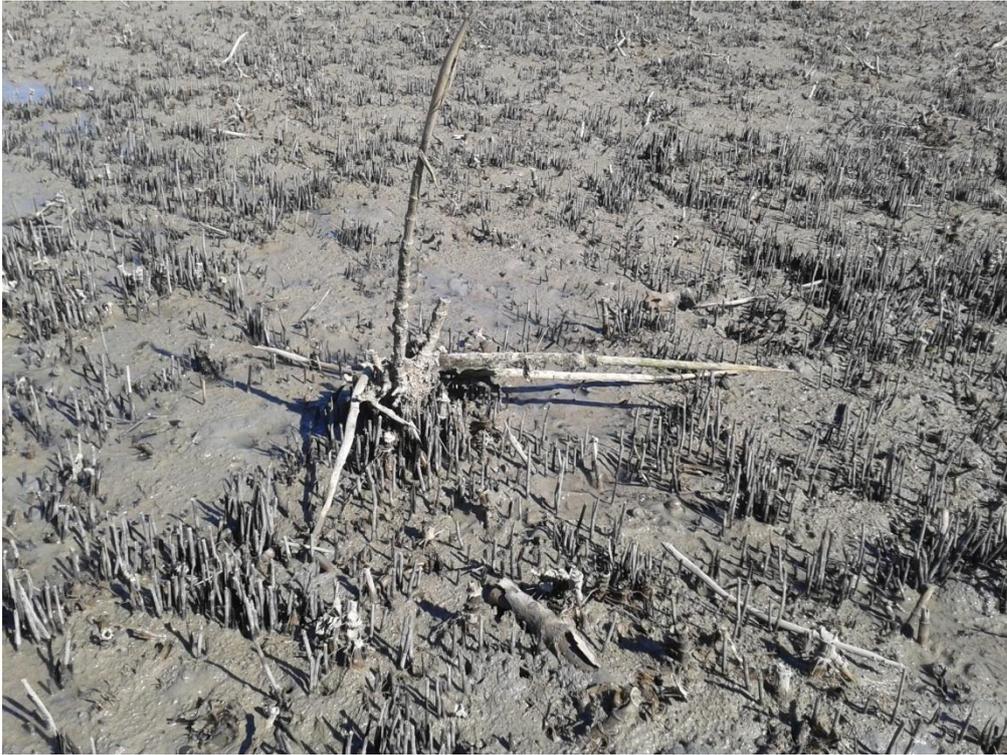
Figure 45: The remains of a spartina plant sitting on top of a mass of dead oioi roots indicating the amount of sediment build up and subsequent loss.

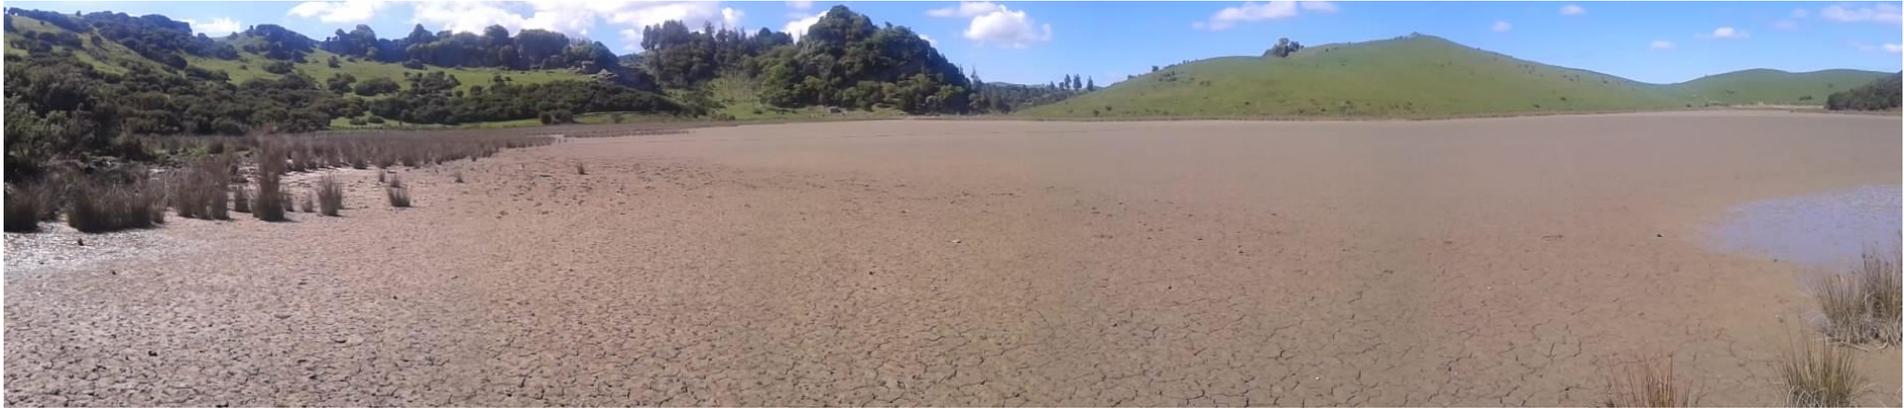
Figure 46: The western side of Tuapu Island had stock pugging out over the flats and grazed oioi (and some sea rush) along the landward margin of the rushland. The pasture on the right side of the photo is the mainland.

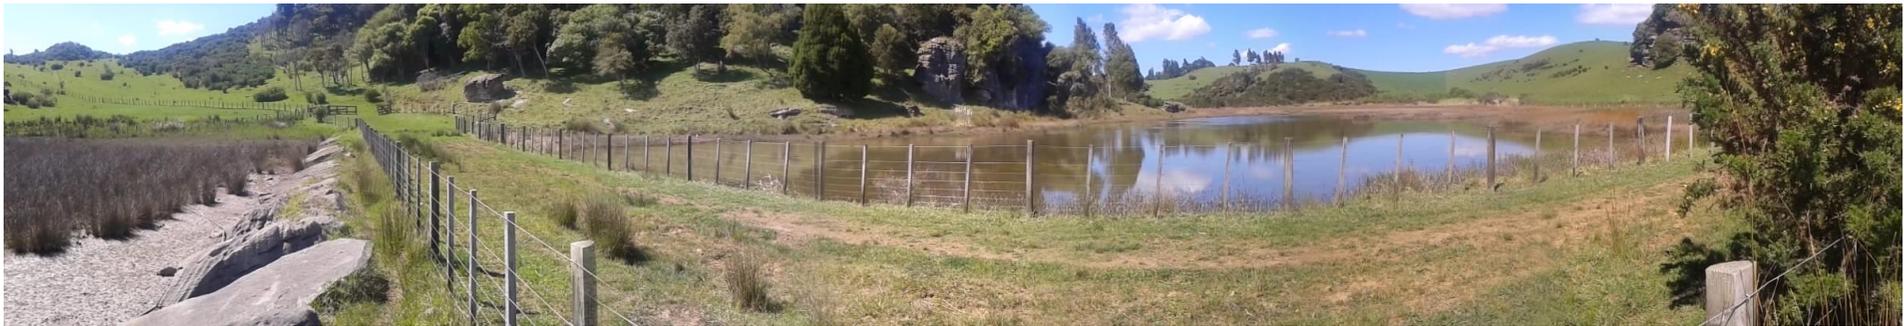
Figure 47: A view over the end of the Tuapu Creek embayment with sea rush and a patch of saltwater paspalum to the left. Across the causeway there is extensive saltwater paspalum beds lining the 'pond' either as a mono-specific fringe or mixed with sea rush or oioi. Marsh clubrush was present as well as raupo behind the 'pond' and edged with manuka and willow.

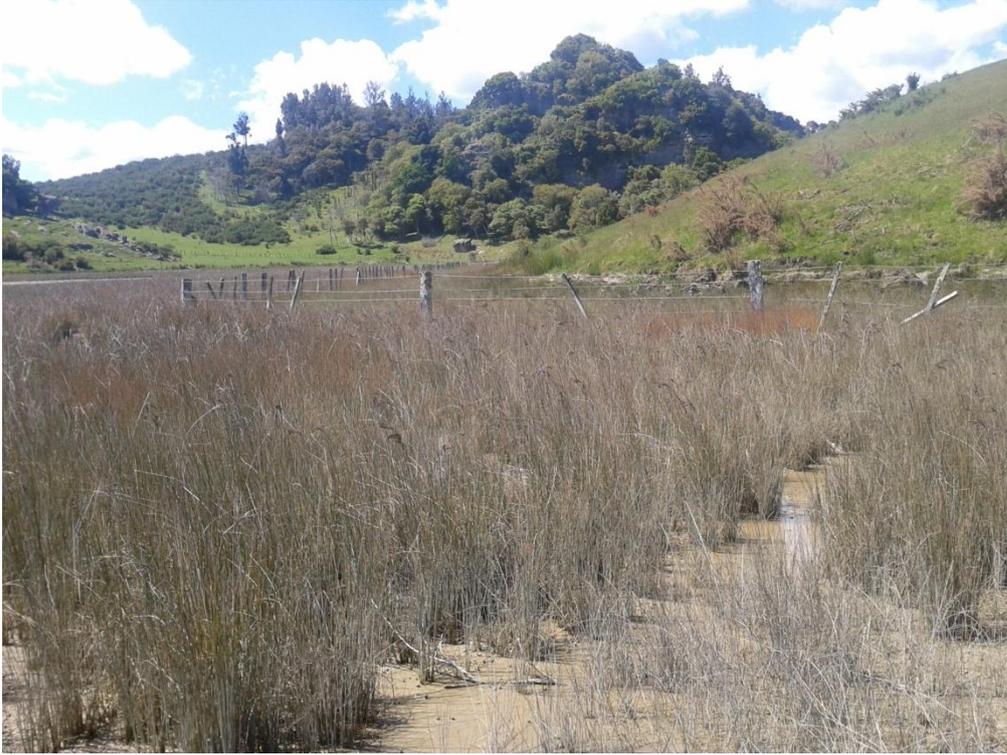
Figure 48: Ungrazed rushland next to short grazed rushland fenced within a paddock at the head of the Tuapu Creek.

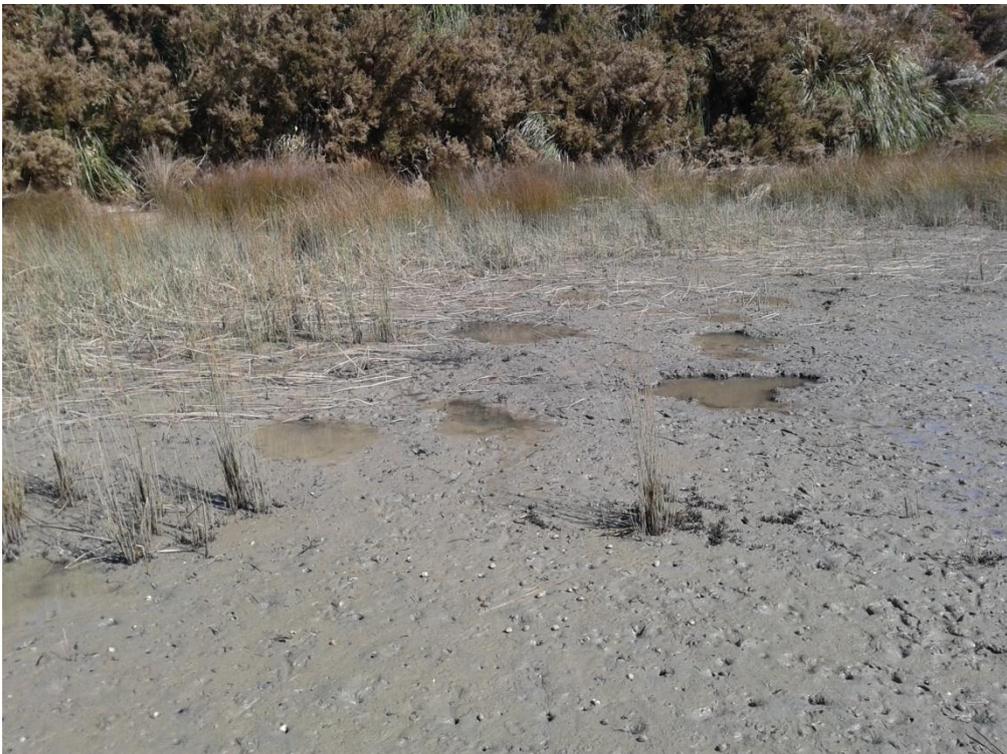
Figure 49: Clumps of dying oioi in the foreground have large holes in the nearby sediment with goose footprints around them. Three square and oioi were in the background.

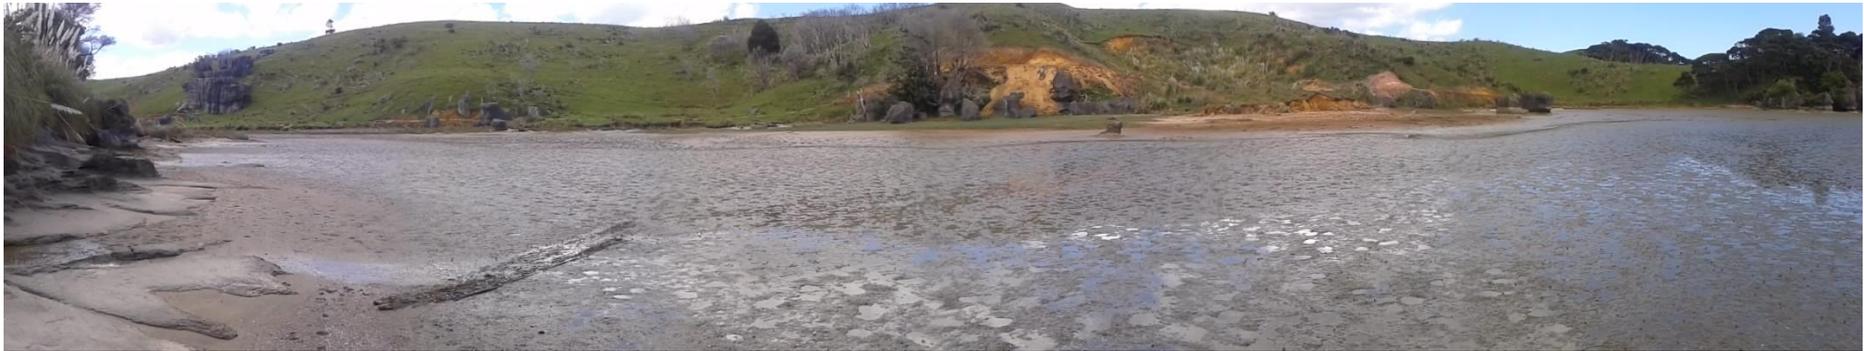
Figure 50: An embayment with pugging over the flats and a new fence line currently being established along the coastline

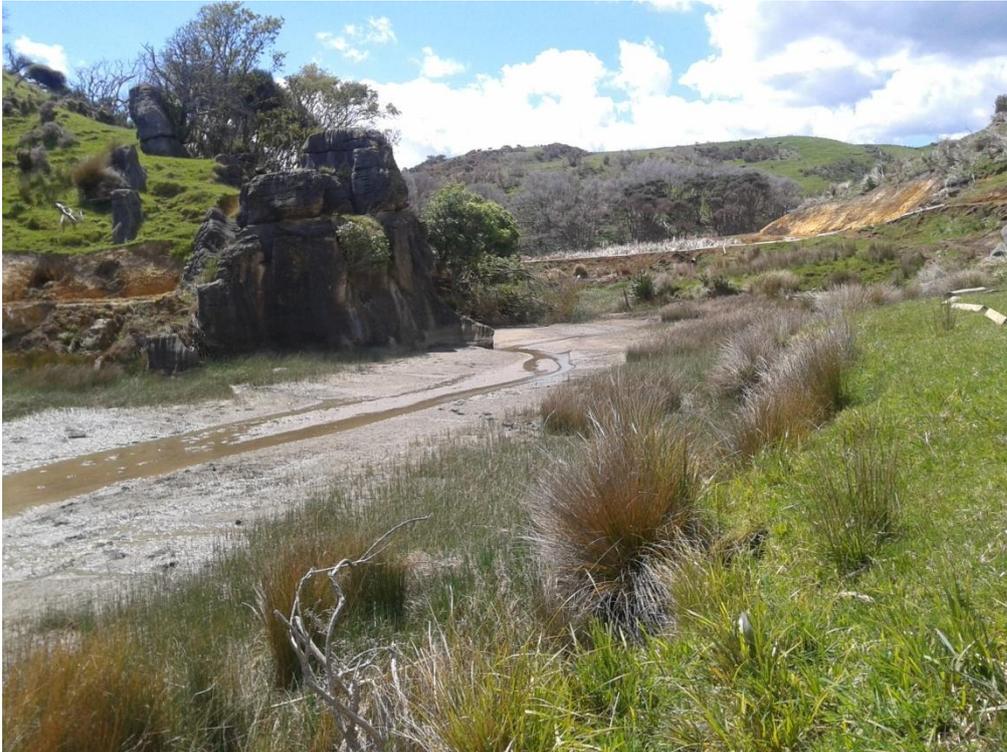
Figure 51: Three square and sea rush line the head of this arm with some oioi in the foreground. In front of the three square along the near bank is a dark patch of dead root bases.

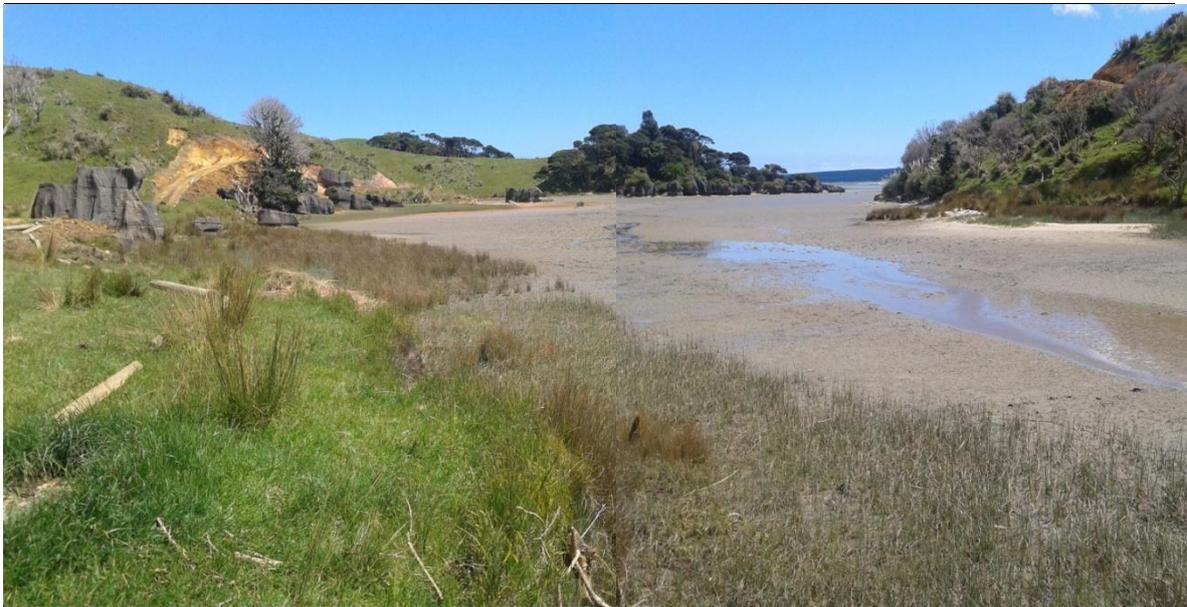
Figure 52: A view looking out of the arm over a three square band and then a sea rush band. Stock tracking, pugging and defecation was common in the harbour here. Note the bulldozed track and fence posts laid out for the new fence line which will address the stock access problem.

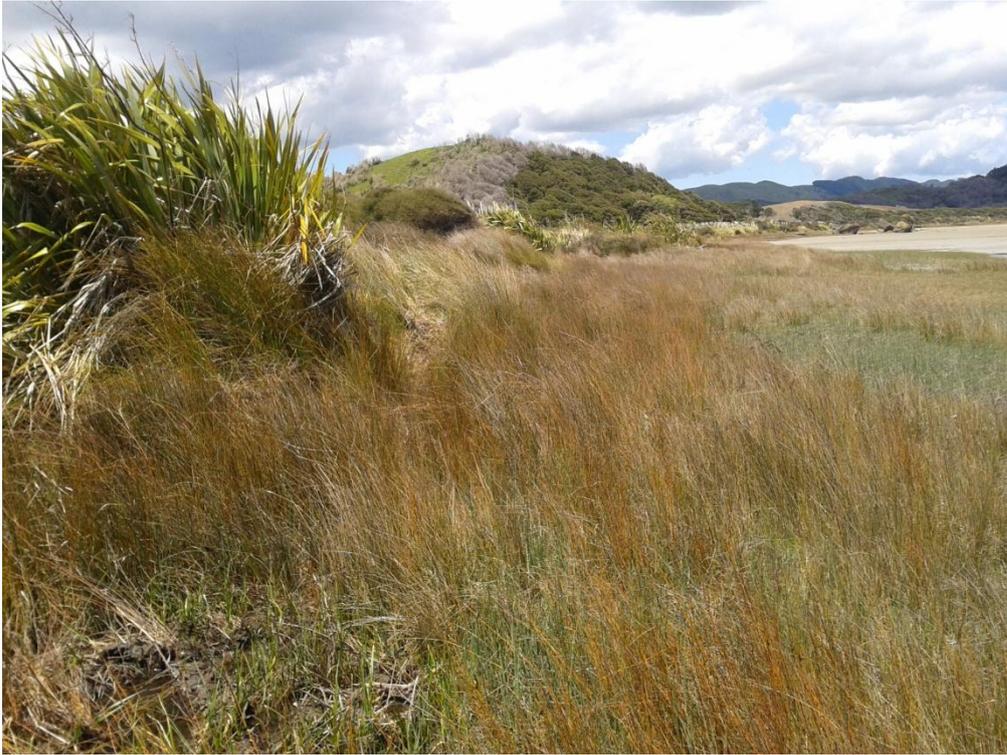
Figure 53: A view of rushland composed of three square, sea rush and oioi up into a margin with patches of saltmarsh ribbonwood, flax, swamp coprosma, manuka and some coastal swamp daisy. The corner of a large wallow within oioi and marsh clubrush is visible in the bottom left corner.

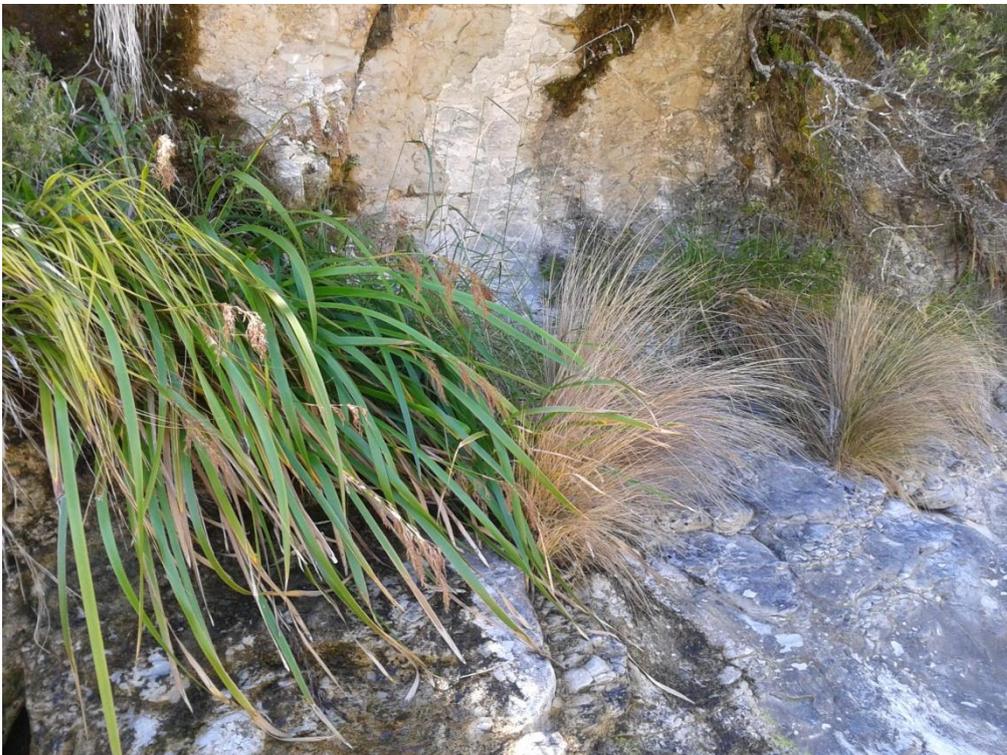
Figure 54: *Machaerina sinclairii* with coast spear grass along the high tide mark south of Te Umuroa Point.

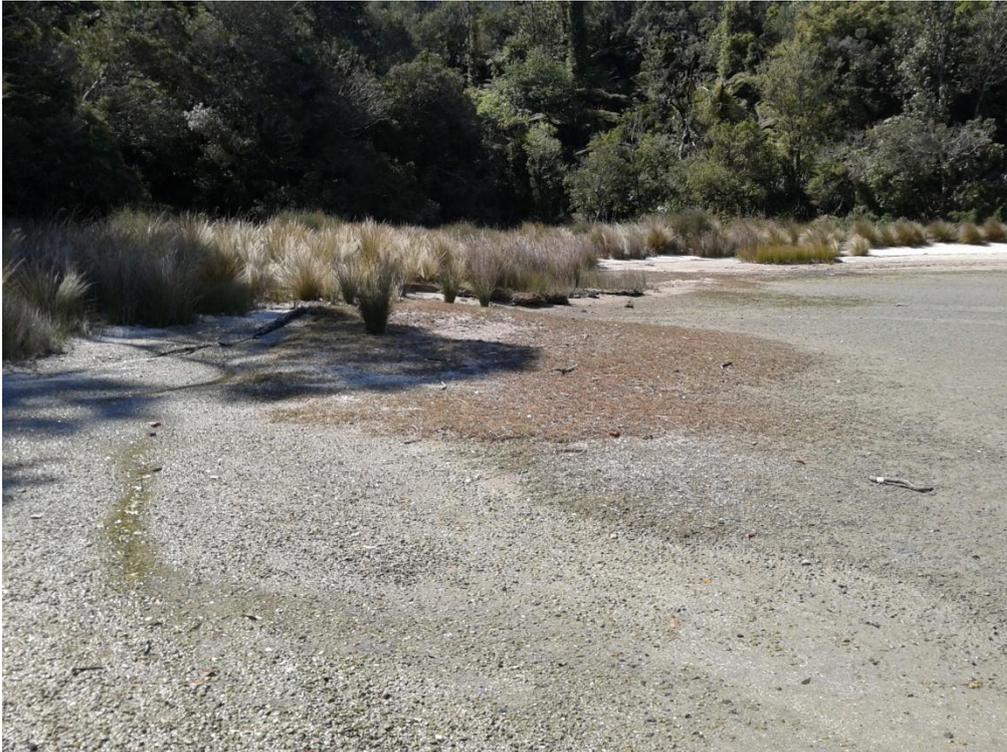
Figure 55: A view showing saltwater paspalum (reddish colour) backed by sea rush, coast spear grass and some saltmarsh ribbonwood in a small bay between Te Umuroa Point and Pakingahau Point. Seagrass fringes the edge of the flats. There is new sea rush in the central saltwater paspalum bed and a new patch of oioi in the distant right compared with Figure 22 from the 2005 survey report.

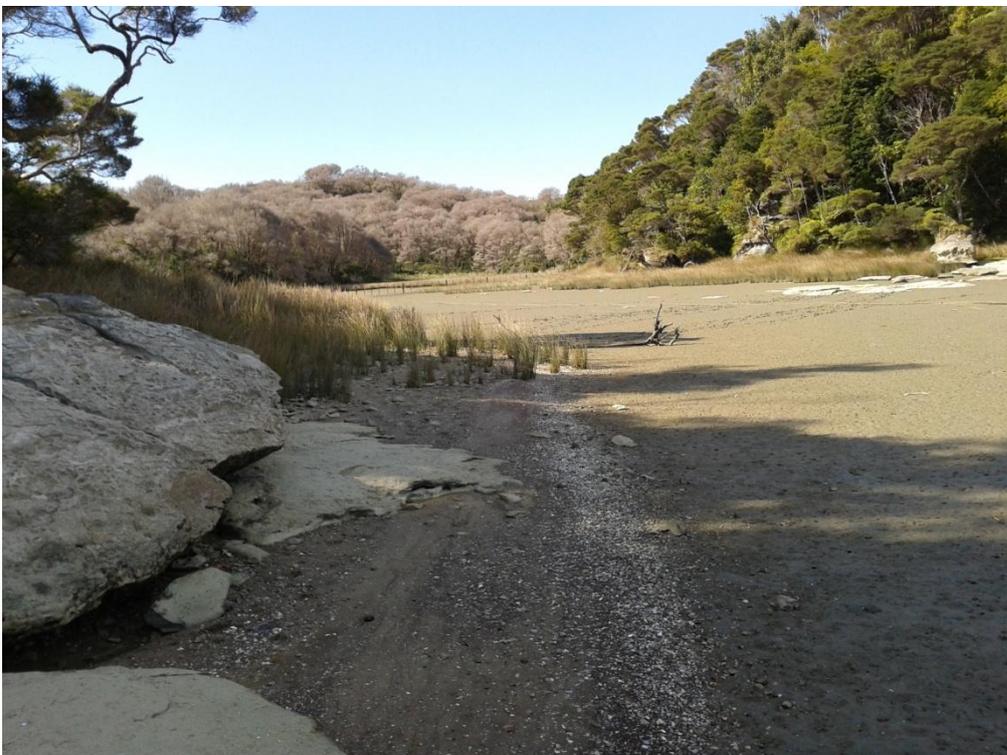
Figure 56: Rushland fringes this embayment with raupo often behind. Riparian kanuka had unfortunately been sprayed at the head. Animal tracks (goat) were common over the seaward flats seaward of the fence line crossing the embayment.

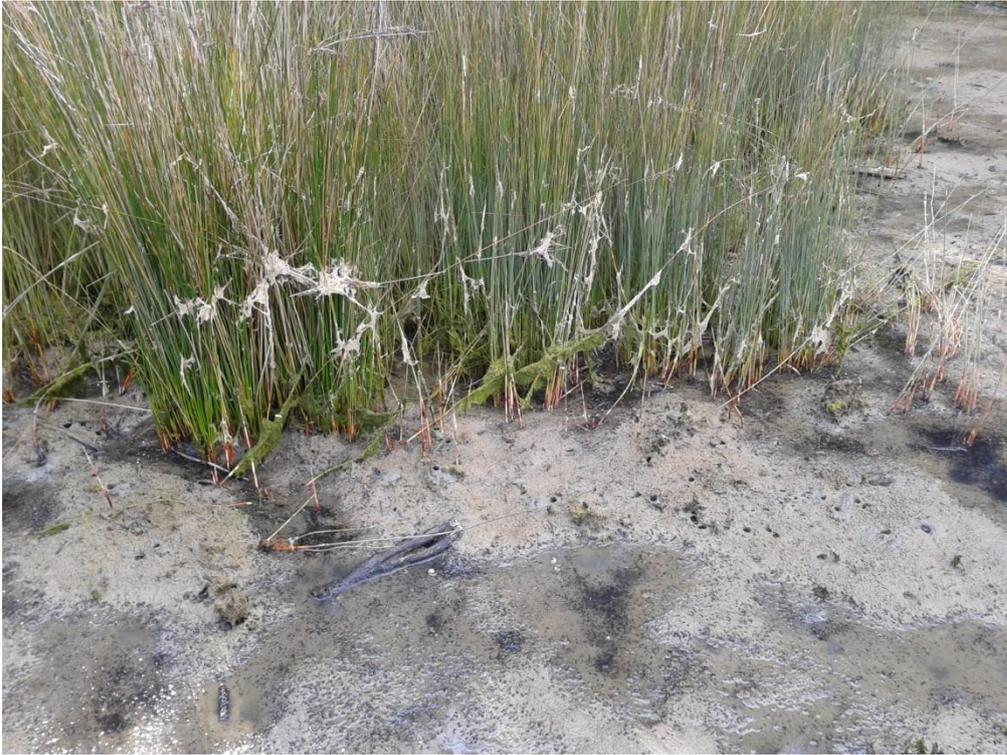
Figure 57: Exposed bases of sea rush and *Baumea junecea* behind an area of sprayed spartina. Note the soft anoxic sediment which had a strong sulphur smell.
