# Estuarine vegetation survey – Kawhia Harbour

Prepared by:  
Meg Graeme M.Sc (Marine Science)  
Natural Solutions – Marine and Terrestrial Ecologists Ltd

For:  
Waikato Regional Council  
Private Bag 3038  
Waikato Mail Centre  
HAMILTON 3240

December 2012

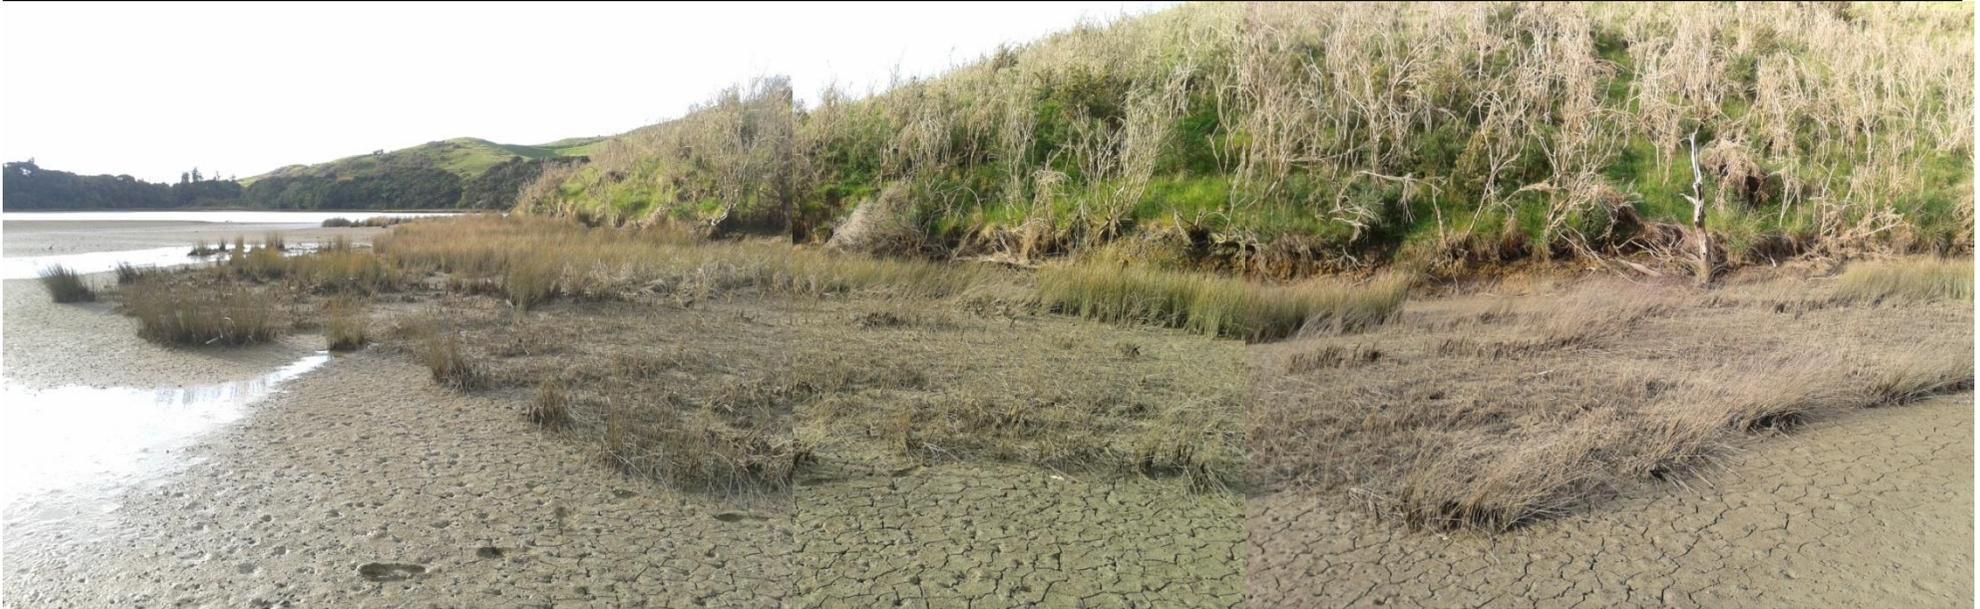
Figure 58: An area of dying oioi with sprayed spartina patches seaward. The landward edge was unfenced and the back of the rushland pugged by stock.

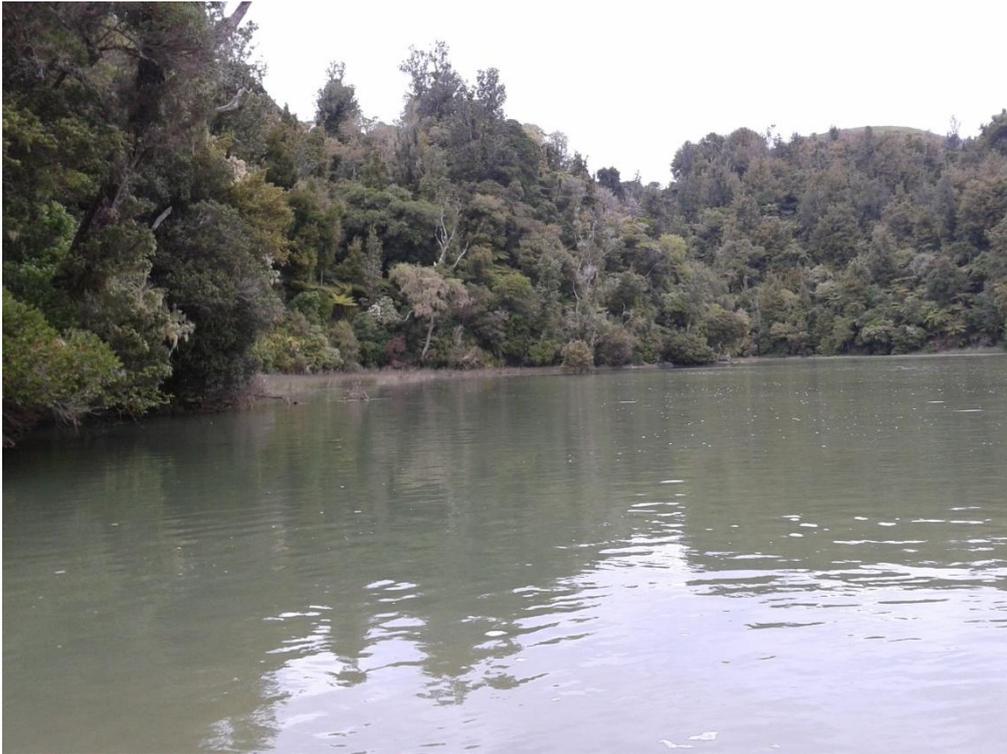
Figure 59: Native forest riparian margins along the upper tidal reaches of the Waiharakeke Stream. In this view looking upstream there is a lone mangrove out in front of a band of marsh clubrush with a thin fringe of oioi and sea rush.

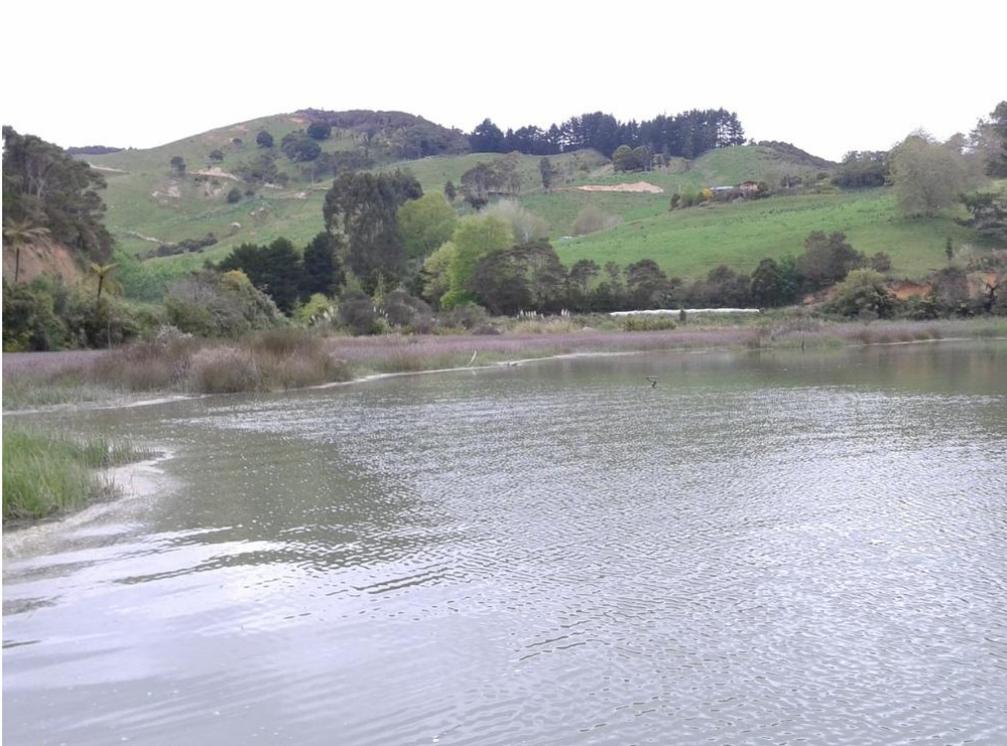
Figure 60: This view is a repeat of Figure 25 from the 2005 survey report looking upstream at a marsh clubrush wetland with some saltmarsh ribbonwood on the TRB and the odd fringe of oioi and sea rush. Waiharakeke Stream.

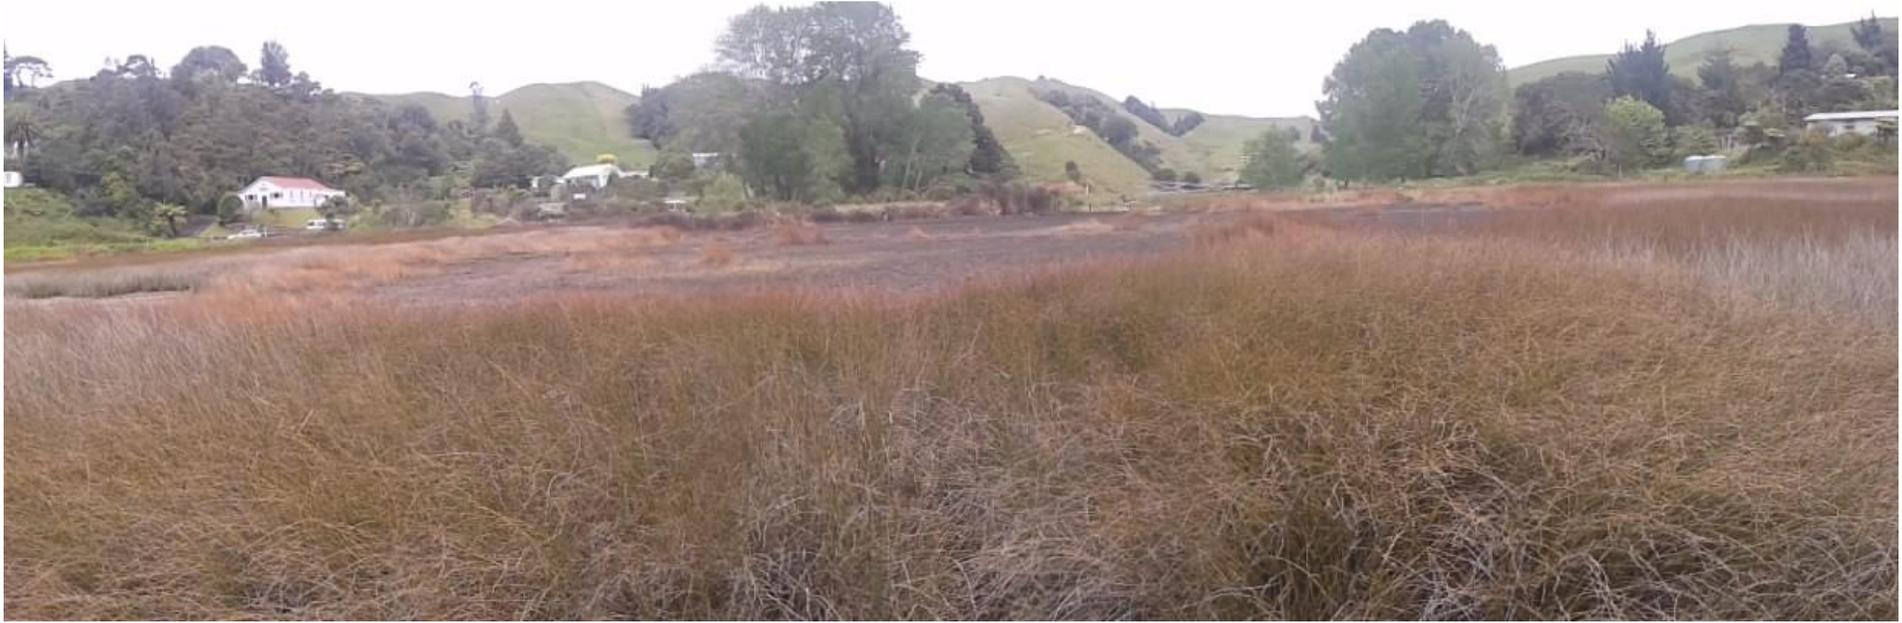
Figure 61: A burnt area of oioi and a thin fringe of manuka in the background. Kinohaku hall and school are visible to the left.

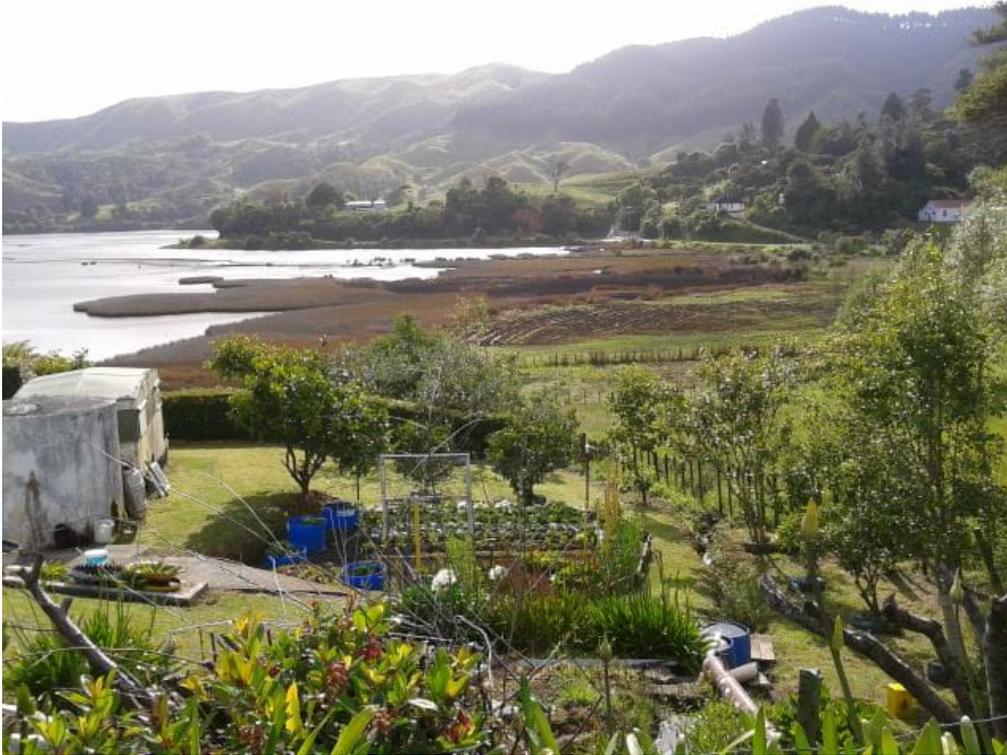
Figure 62: A view looking over the rushland at the head of Kinohaku Bay. The blackened area is where a fire had burnt a large area of oioi back to a manuka fringe. The furrowed land is a wet area of rushland and freshwater wetland that has been farmed or cultivated.

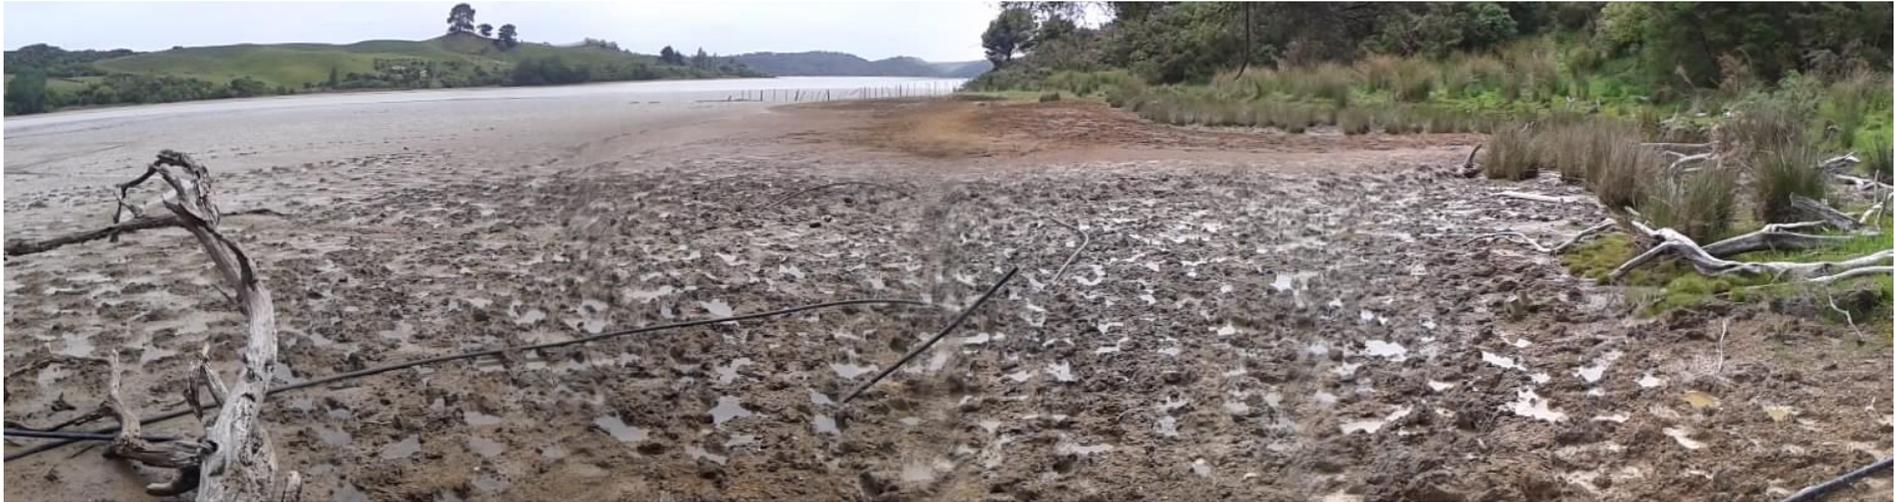
Figure 63: A view looking seaward over a highly pugged stream mouth. Sea rush lies in behind a sandy ridge and to the right is sea rush mixed with slender clubrush and bachelors button.

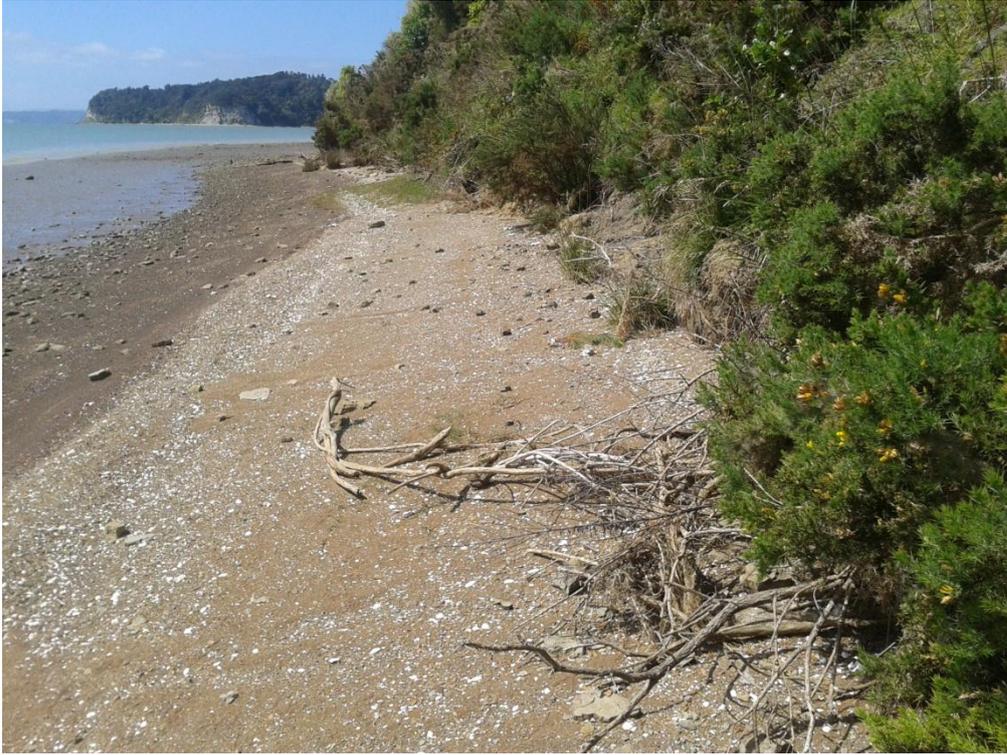
Figure 64: This sandy stretch of foreshore had a couple of patches of saltwater paspalum (the larger patch being ~9x3m wide). There was also the odd patch of sea rush and sea meadow. The forested headland in background is Te Rangiora Point.

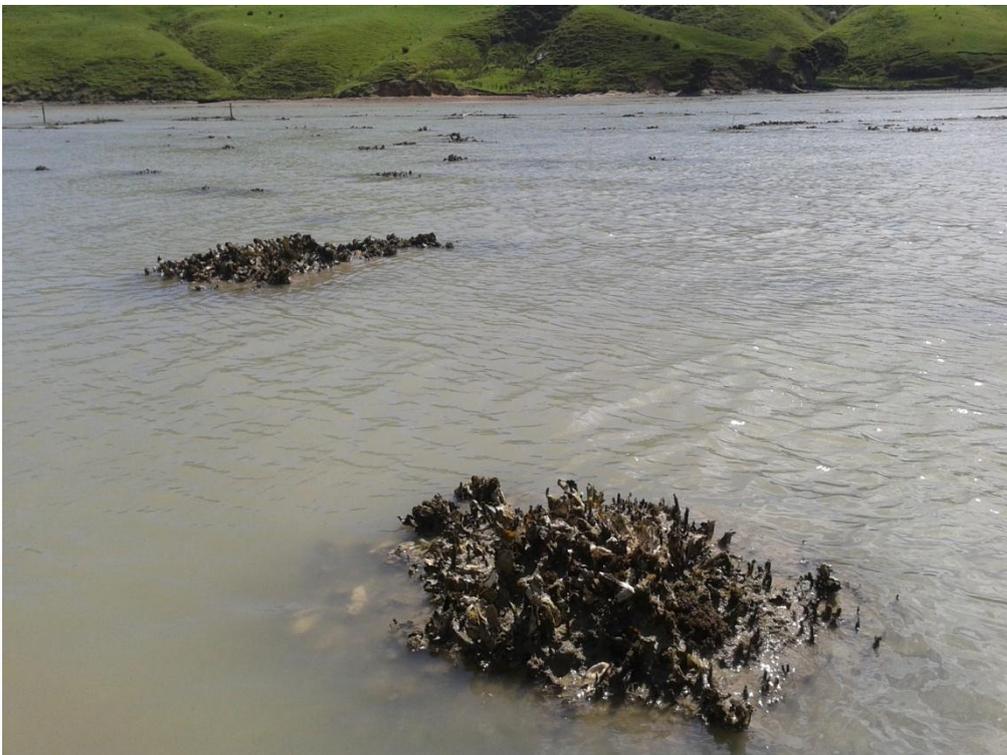
Figure 65: Pacific oyster patches around remnant spartina root clumps.

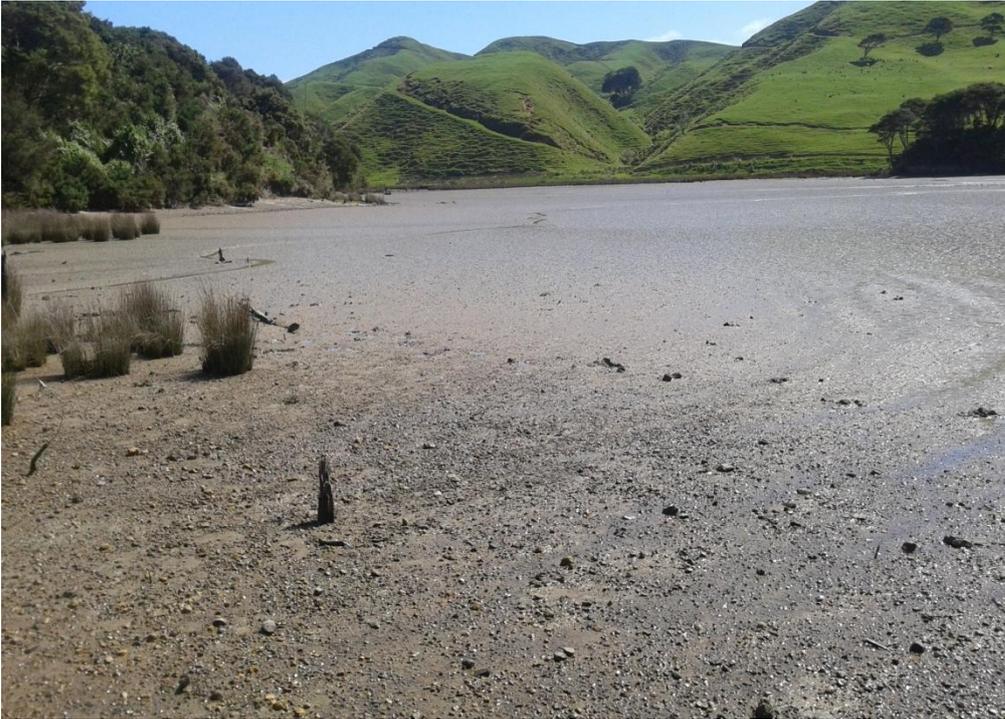
Figure 66: A repeat of Figure 29 in the 2005 survey report taken beside a gate in a fence that extended across the harbour flats. There were stock footprints in the mudflats on the upstream side of the fence however the sea rush in the foreground looked a bit healthier in comparison to 2005.

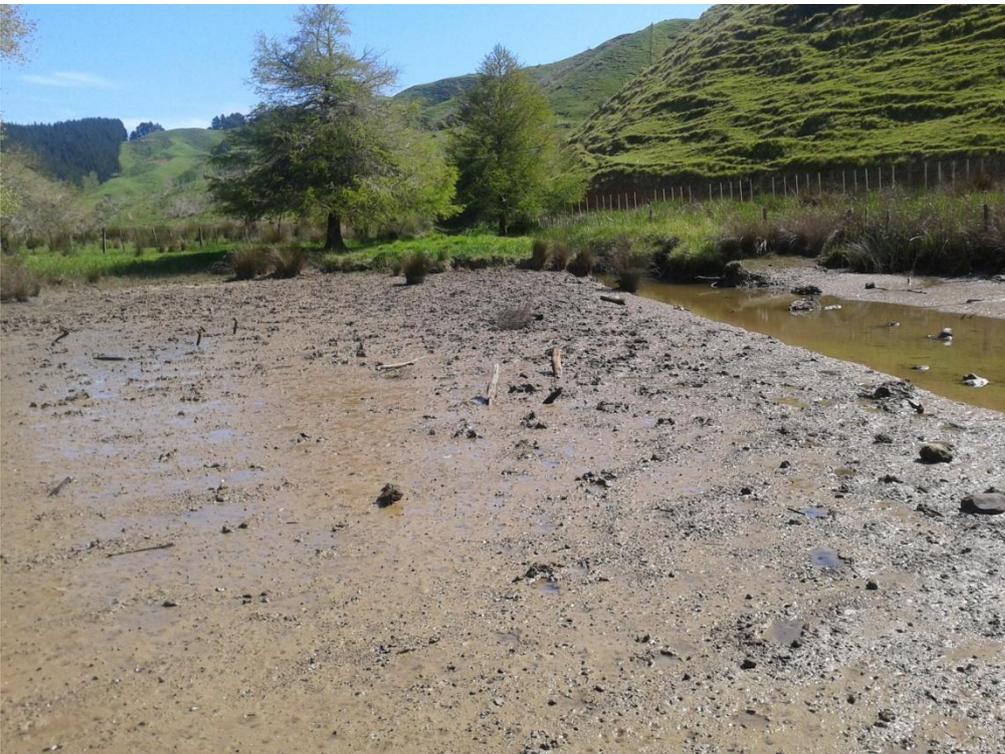
Figure 67: The mouth of this stream had heavy pugging around it and the sea rush and arrow grass was invaded by saltwater paspalum. Marsh clubrush dominated inland of the rushland.

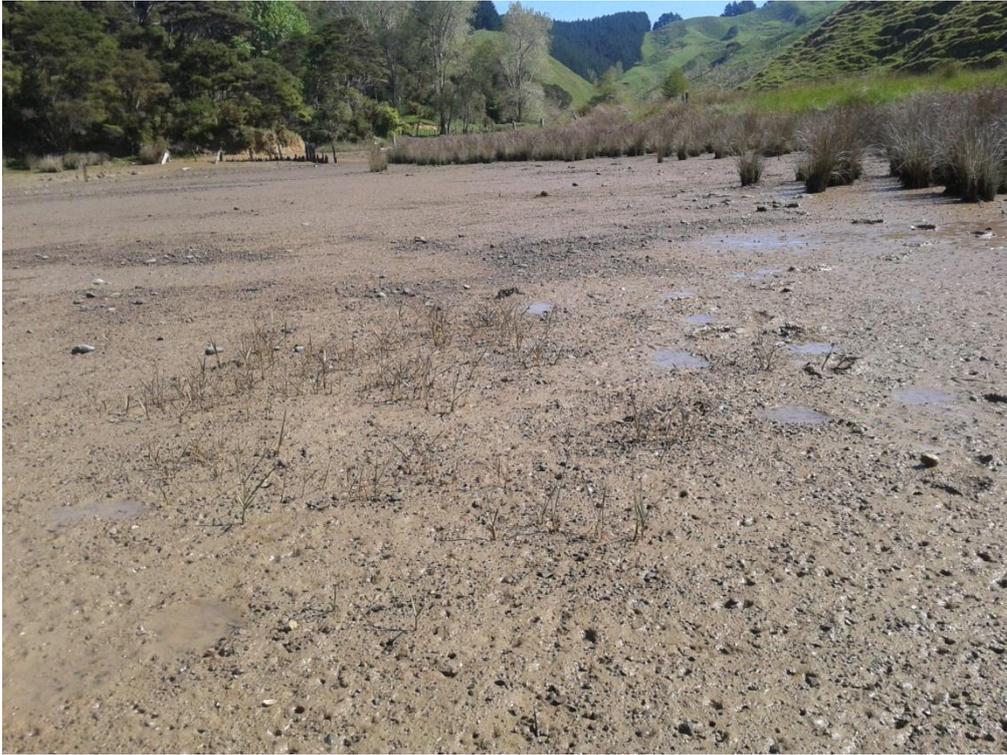
Figure 68: Short sparse spartina was found on the mudflats (in foreground) near Ohau Stream. Tall spartina was also found behind and to the right of the photo mixed with sea rush and oioi.

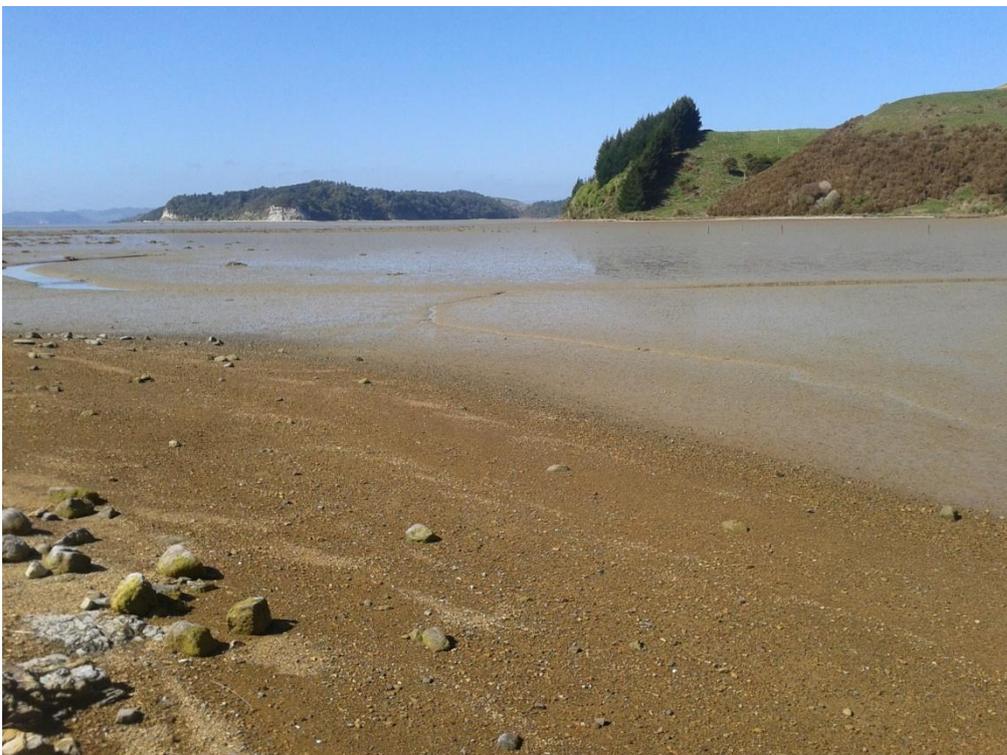
Figure 69: A repeat of Figure 30 in the 2005 survey report looking across towards Te Waitere peninsula with the forested headlands of Te Rangiora and Pakingahau Points in the background. There wasn't any current stock tracking visible however the coastal edge wasn't fenced off and stock pugging and dung was common further out along the bay.

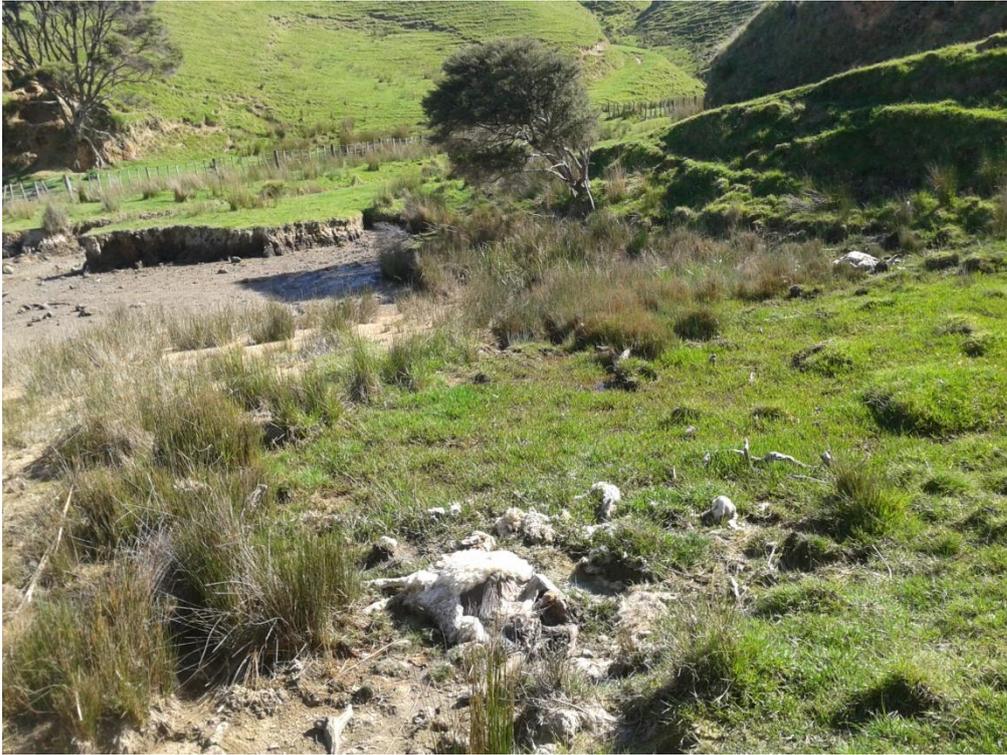
Figure 70: A patch of rushland with some spartina within the shelter of an indent. Two dead sheep were found along this unfenced coastal edge.

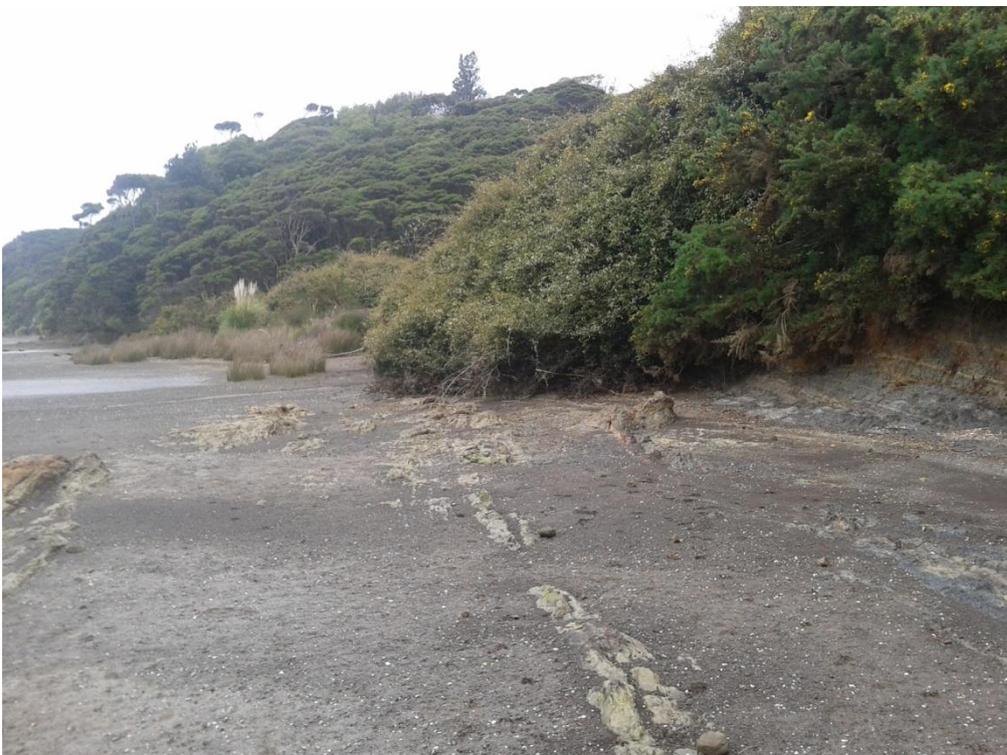
Figure 71: Sea rush, some sea meadow (slender clubrush and sea primrose) and saltmarsh ribbonwood were found in between two large eleagnus plants. Regenerating kanuka coastal forest lines the coastal edge with some kowhai.

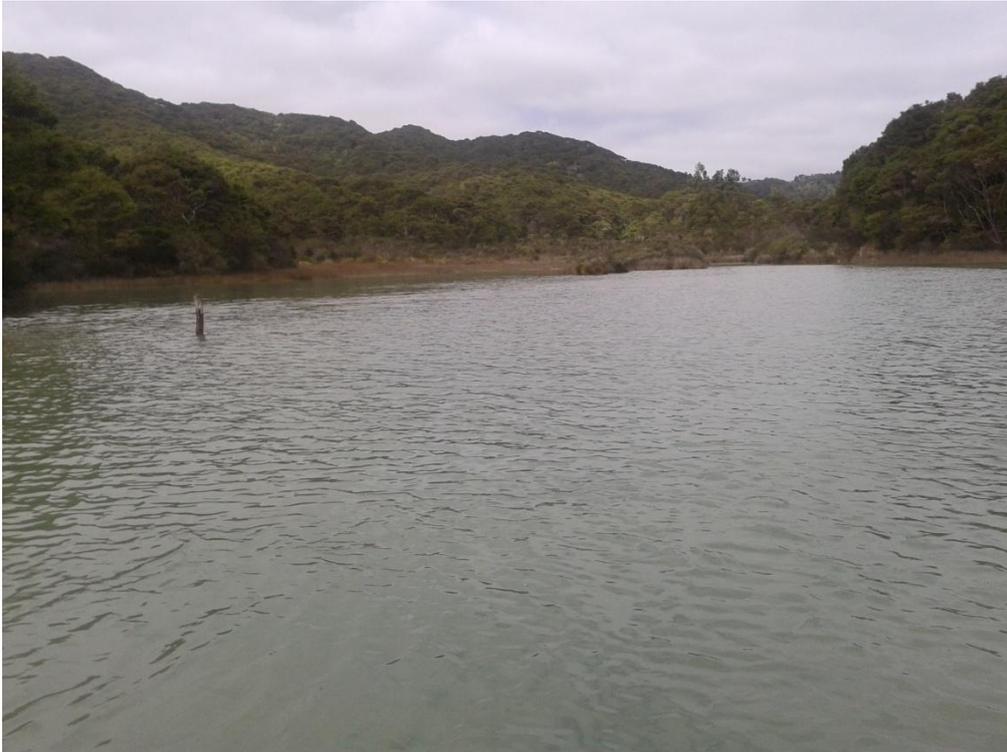
Figure 72: An enclosed arm at the mouth of the Waikiekei Stream with saltmarsh ribbonwood islands and sea rush and oioi behind. Flax and manuka are common around the edge.

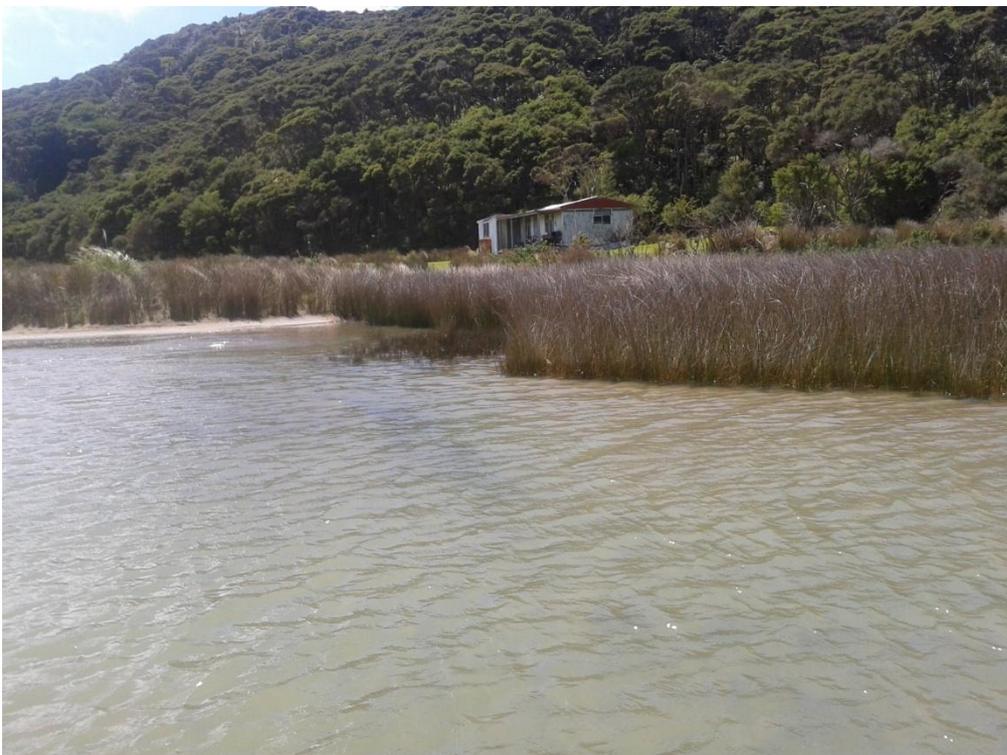
Figure 73: A sea rush band with a patch of oioi in front. The oioi looked like it has been 'mown' as all the tops were missing. Another similar patch was also found in this estuarine arm.

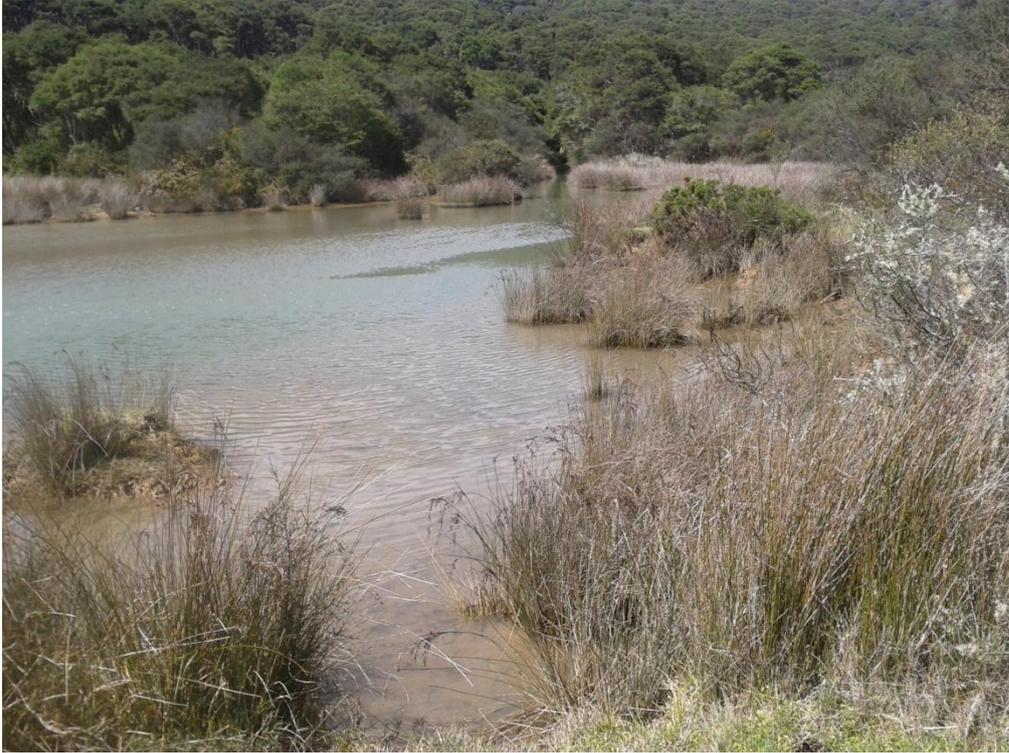
Figure 74: This is a repeat of Figure 32 in the 2005 survey report looking up towards the mouth of the Opango Stream. The estuarine vegetation looked similar to that in 2005 however the regeneration of the coastal forest in the background has increased over time, some sea rush appeared to have died back a bit in foreground but grown in the background. Sea meadow mixed with pasture grasses around the edges.

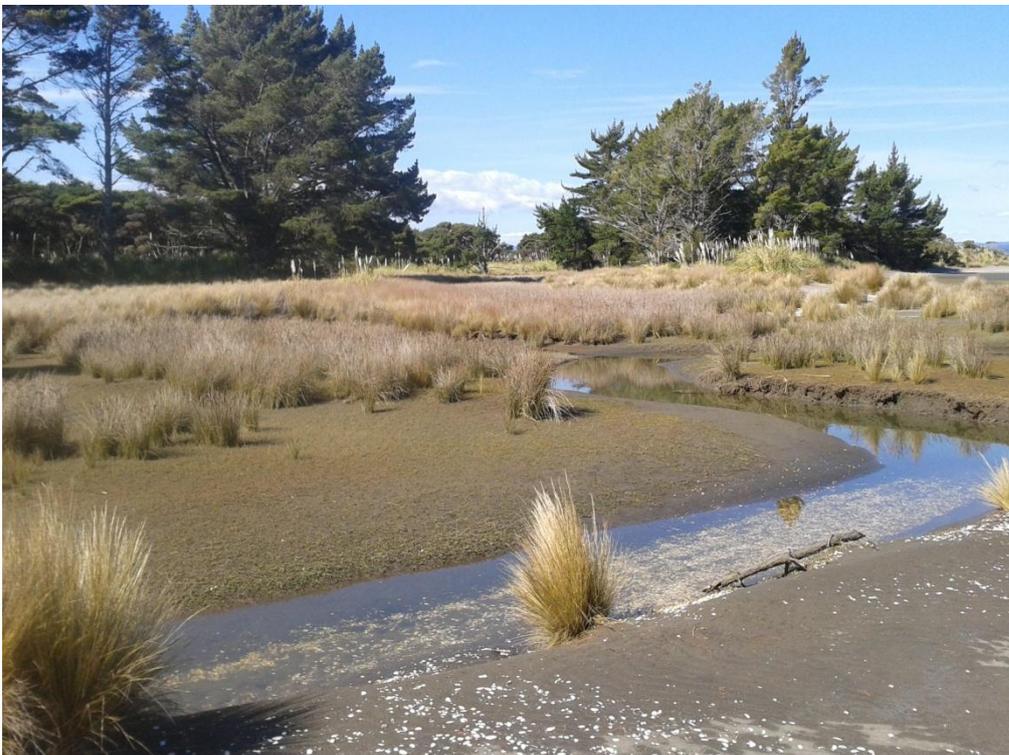
Figure 75: A repeat of Figure 31 from the 2005 survey report showing coast spear grass and sea primrose along the stream banks with coast spear grass and sea rush in the background.

Out in the middle of the lower harbour there is a sand island **Te Motu** which sheltered a large, healthy mixed rushland/sea meadow community (Figure 75 and Figure 76). Coast spear grass dominated on drier high sand ridge and also mixed with sea rush and oioi on the lower tidal flats together with sea primrose. Some areas had denser coast spear grass than rushland while other areas were dominated more by rushland. Out in front of the enclosed rushland community there were large concentric patches of sea primrose with scattered coast spear grass and glasswort on the open flats. Most of the sand island had an eroded coastline and was dominated by pampas, knobby clubrush, short kanuka and pines. There was a small patch of saltwater *Paspalum* together with *Carex pumila* along the eastern exposed foreshore. The north-western side of the island supported a black-backed gull colony.

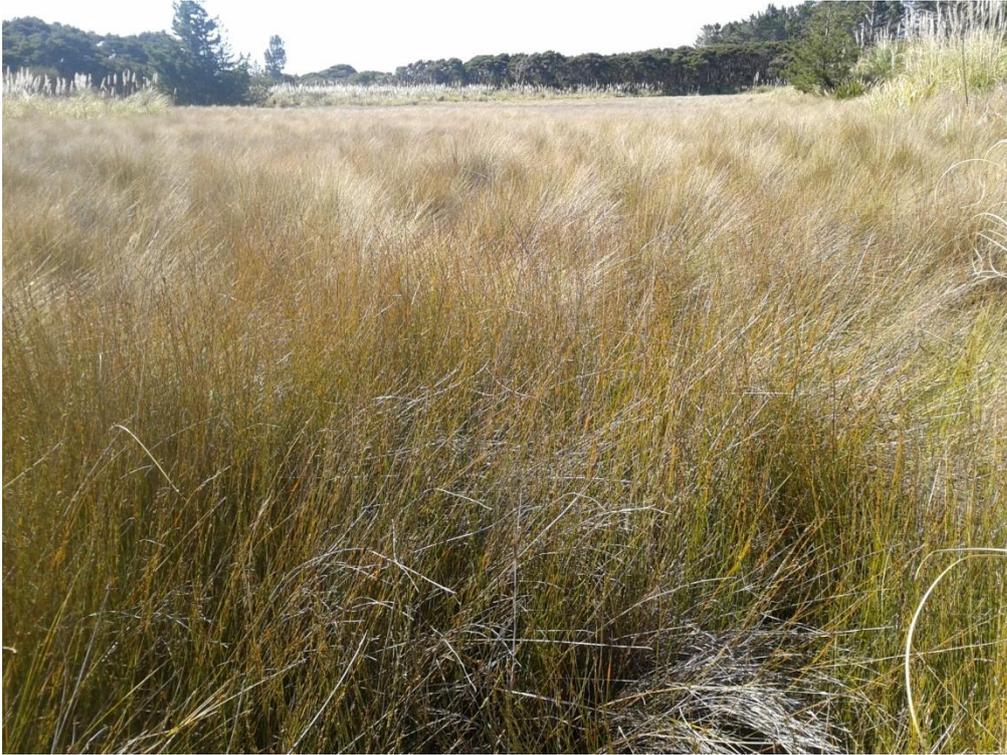
Figure 76: A view over the large mixed rushland/sea meadow community within the shelter of Te Motu. Sea primrose is also common (but not visible) amongst the rushland.
