*Middle Waikato Bed Degradation  
Investigation Stages III & IV.*

*Contract number: AM2004/5-30*

**Proposed Middle Waikato River  
Bed Degradation Management  
Strategy - Appendices**

Mid-Waikato Bed Degradation Investigation Stages III and IV  
River Bank and Infrastructure Condition Photographs - May 2005

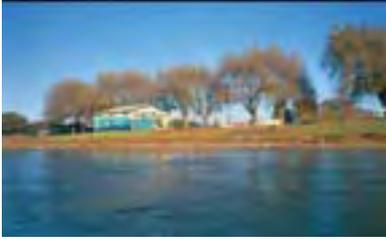
km 95.5L

95.3	3.7		No		Waipa confluence			
95.5	3.7	WP302	Yes	L	50-m length of riprap revetment	Property	Slight	
95.7	3.7		Yes		NIMT Railway Bridge 267 and SH1 Road Bridge, Ngaruawahia	Infrastructure	Severe	Two piers in river, two piers close to top of bank. Review record drawings for impact of any bed degradation.

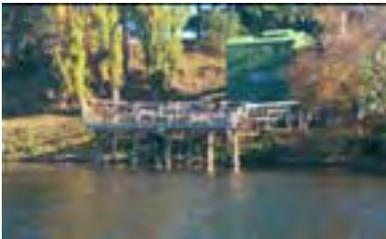
km 101.0L

101.0	3.4	CS81	Yes	L	Meatworks water intake	Infrastructure	Moderate	Review record drawings for impact of lower bed and water levels
102.5	3.4	CS82	Yes		Horotiu Road Bridge	Infrastructure	Slight	Arch springs from foundations set back from river edge

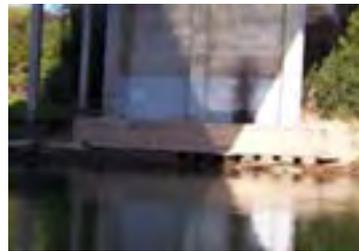
km 109.6bL

109.6	3.1	CS56	Yes	L	1 m dia outlet structure	Infrastructure	Slight	Outlet is largely submerged, so unlikely to be affected by bed degradation in the medium term.

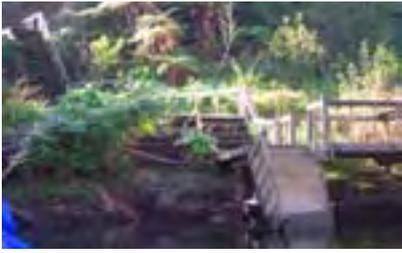
km 110.8R

110.8	3.0	WP169	Yes	R	Private landing	Property	Moderate	Steps failing, would need extending.
111.0	3.0	WP170	Yes	L	50-m long gabion wall below covered walkway at golf course	Property	Moderate	Gabion mattress toe protection will need extending.

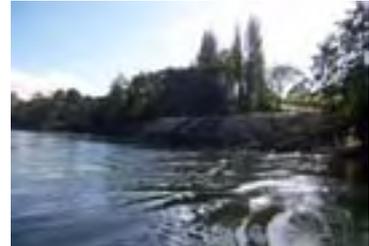
km 111.1bR

111.1	3.0	WP171	Yes	L	10-m long gabion wall below walkway	Property	Slight	May need gabion mattress toe protection
111.1	3.0	WP171	Yes	R	30-m long riprap revetment, with concrete steps to above water level	Property	Moderate	Riprap will need top-up, and steps extending as river degrades.

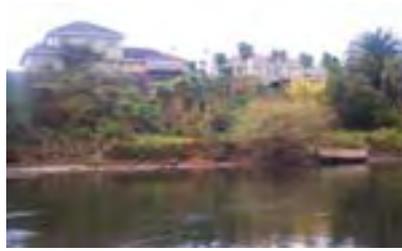
km 113.3R

113.3	2.9	WP188	Yes	R	75-m long timber retaining wall, set back from water's edge	Property	Slight	Probably no action required
113.5	2.9	CS61	Yes		Fairfield Bridge	Infrastructure	Severe	Two piers in river. Review record drawings for impact of bed degradation
