# Estuarine Vegetation Survey : Inner Firth of Thames

Prepared by:  
Meg Graeme M.Sc,  
Natural Solutions  
Marine & Terrestrial Ecologists Ltd

For:  
Environment Waikato  
PO Box 4010  
HAMILTON EAST

June 2006

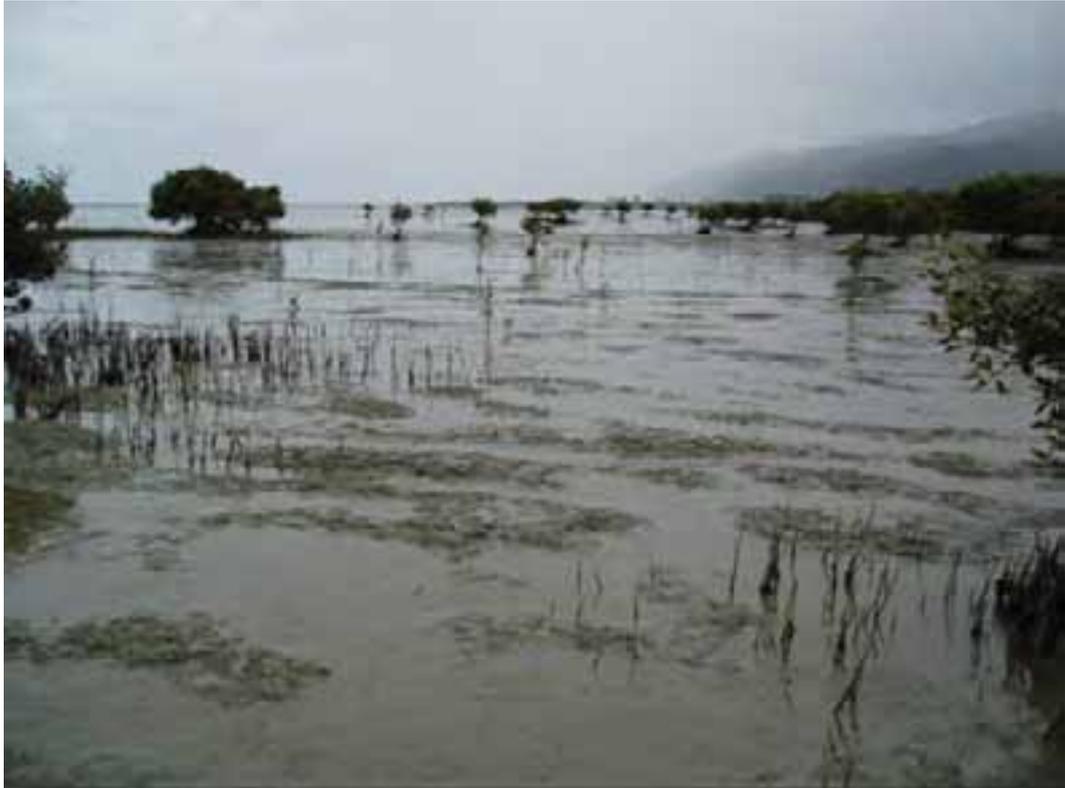
**Figure 2:** Looking over thick mud and scattered mangroves along the outer edge of the mangrove-lined Thames foreshore (Goldfields playing fields landward).

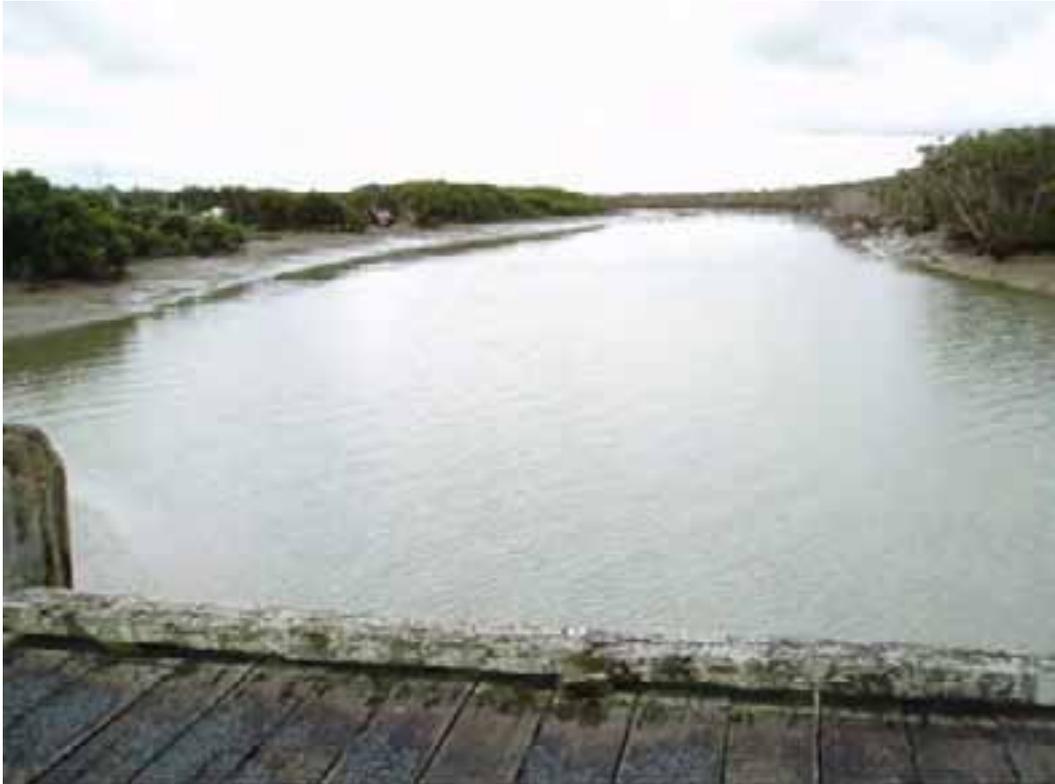
**Figure 4:** View from Thames wharf looking up the Kauaeranga River. Boat moorings dissected the mangal on the left.

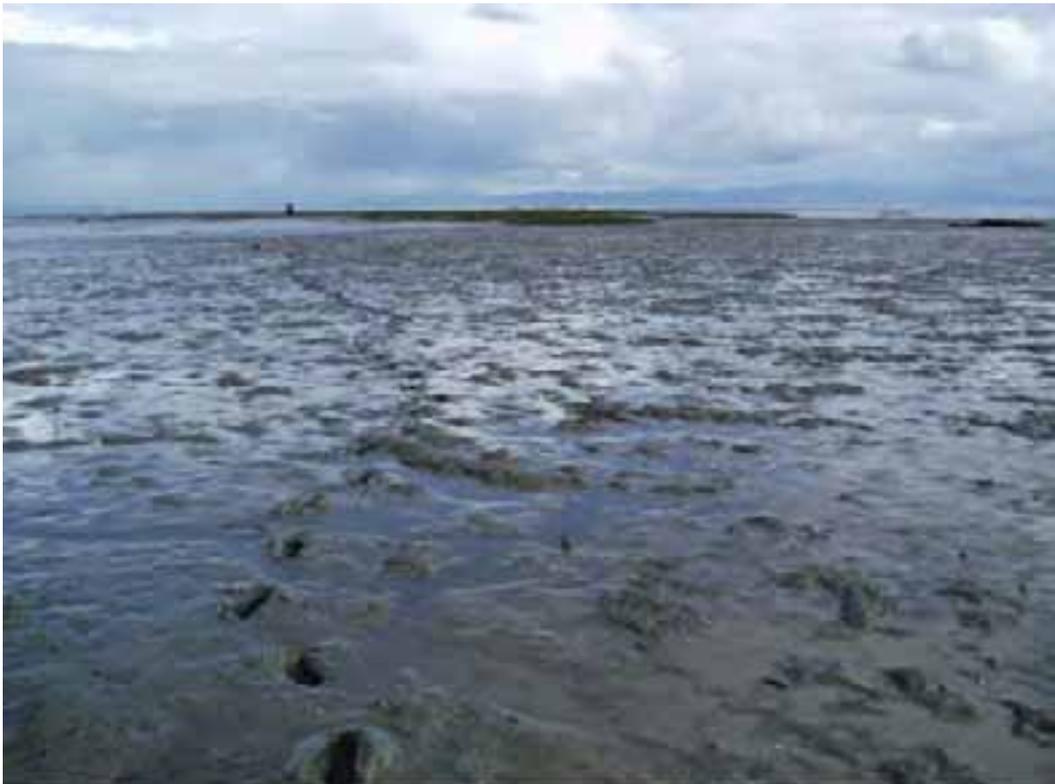
**Figure 5:** Thick mud and large patches of spartina in background (mouth of Kauaeranga River).

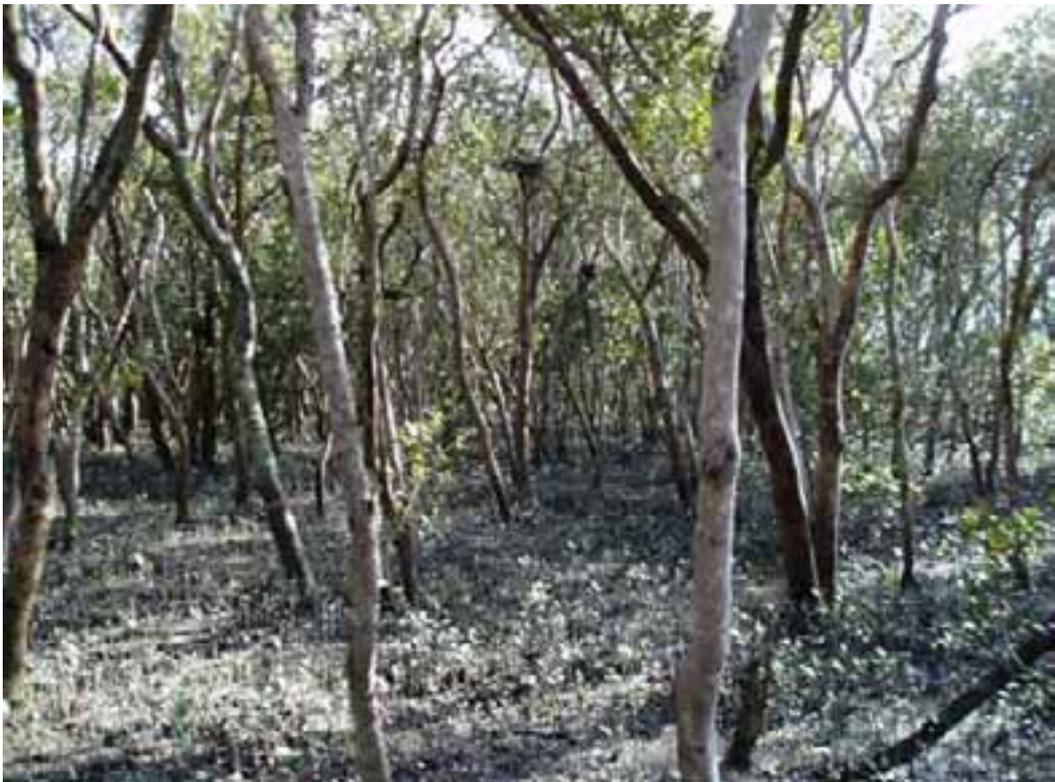
**Figure 7:** Shag nests in the mangal beside the Thames Toyota factory on the true right bank of the lower Kauaeranga River.

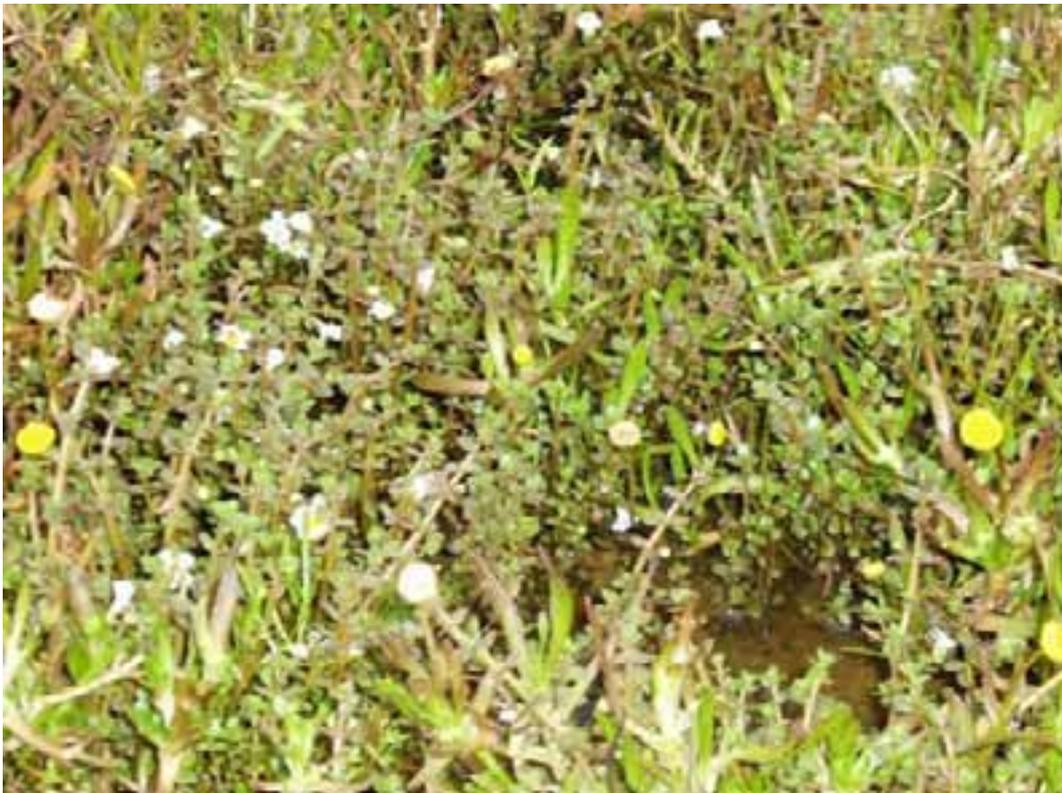
**Figure 12:** The threatened Maori musk (*Mimulus repens*) amongst bachelor's button in a sea meadow patch on the true left bank floodplain of the lower Kauaeranga River.

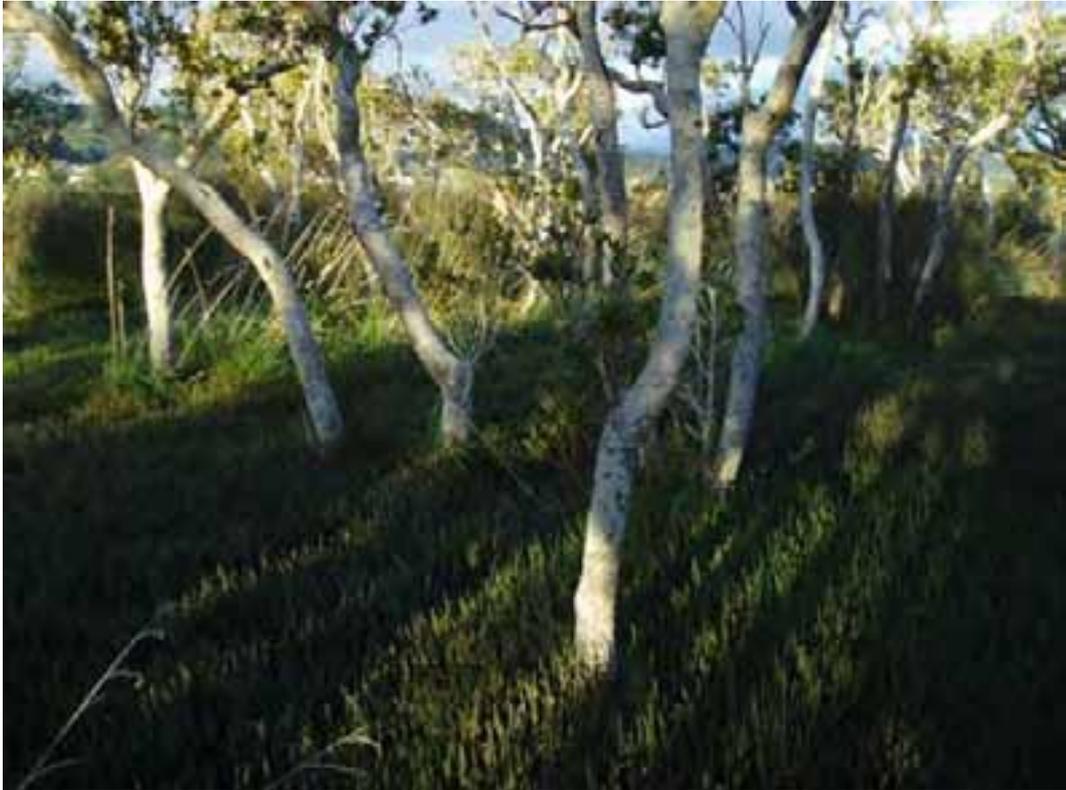
**Figure 14:** Saltmarsh ribbonwood lined the landward edge of this old mangal on the true left bank of the Kauaeranga River mouth. Tall fescue extended landward, while glasswort covered the ground under the mangroves.

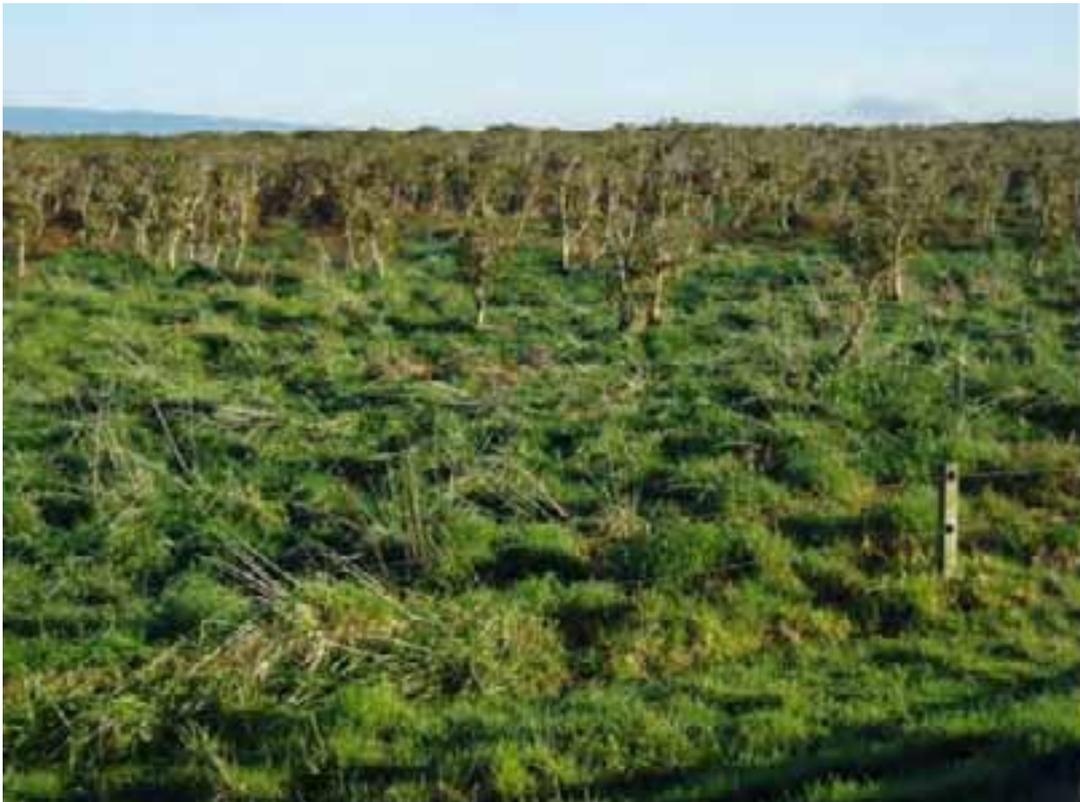
**Figure 15:** The landward edge of the mangal near the Thames gun club stopbank with tall fescue and swamp clubrush (golden clumps) mixing with the outer sparse mangroves.

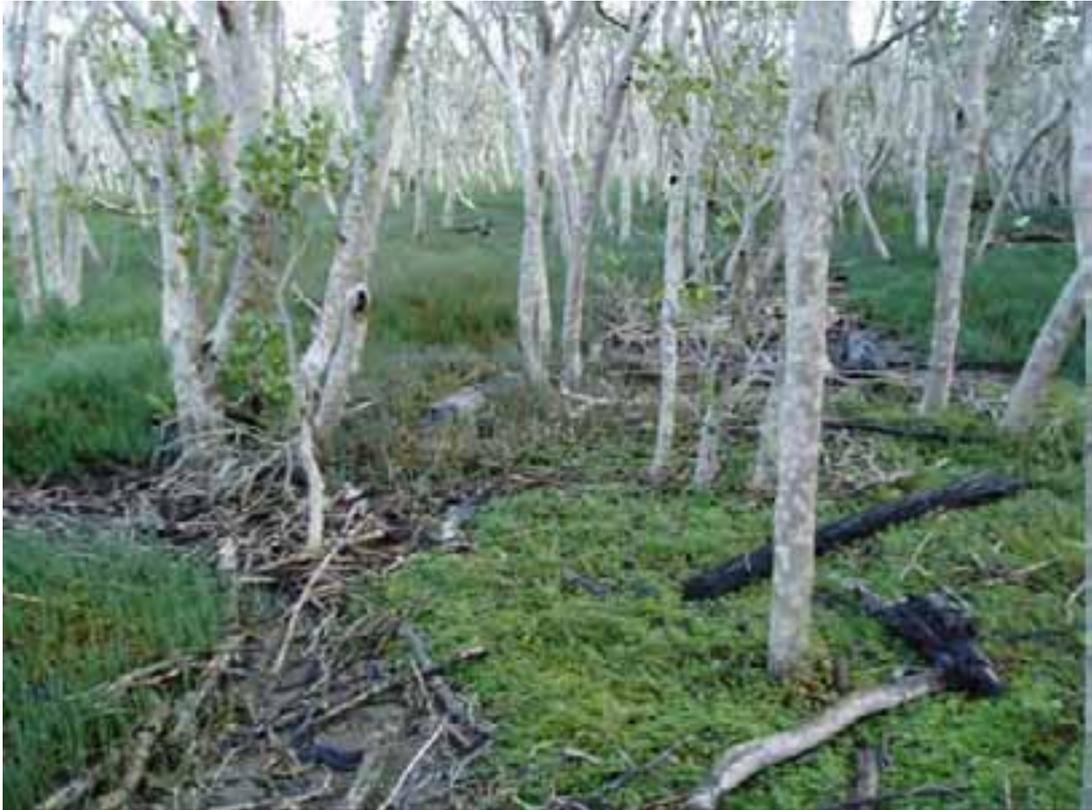
**Figure 16:** Glasswort and sea primrose patches under an open ~5 m high mangrove canopy. Lower true left bank of the Kauaeranga River.

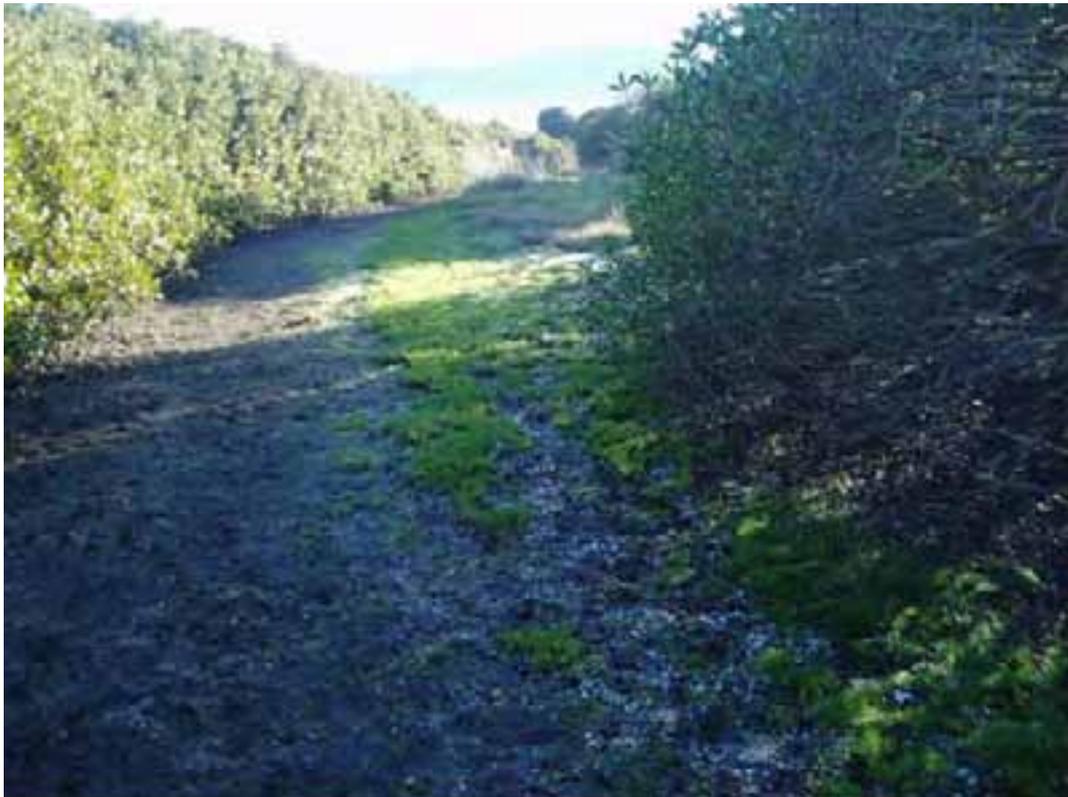
**Figure 17:** Large ngaio which could be self grown abutted the mangal edge near Thames airfield along with planted flax, broadleaf, lemonwood and pohutukawa.

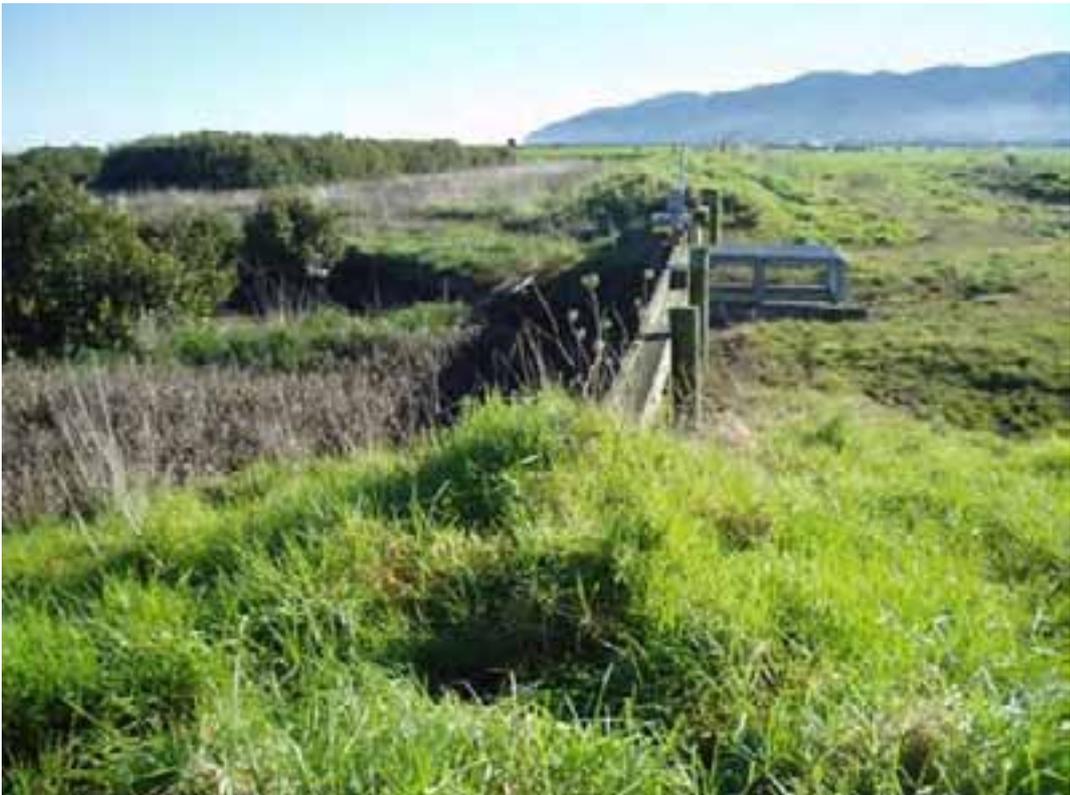
**Figure 19:** The sudden transition from mangrove, sea meadow and swamp clubrush vegetation to pastoral grasses (mainly kikuyu) at the stopbank and flood gate (coastline between the airfield and treatment ponds).

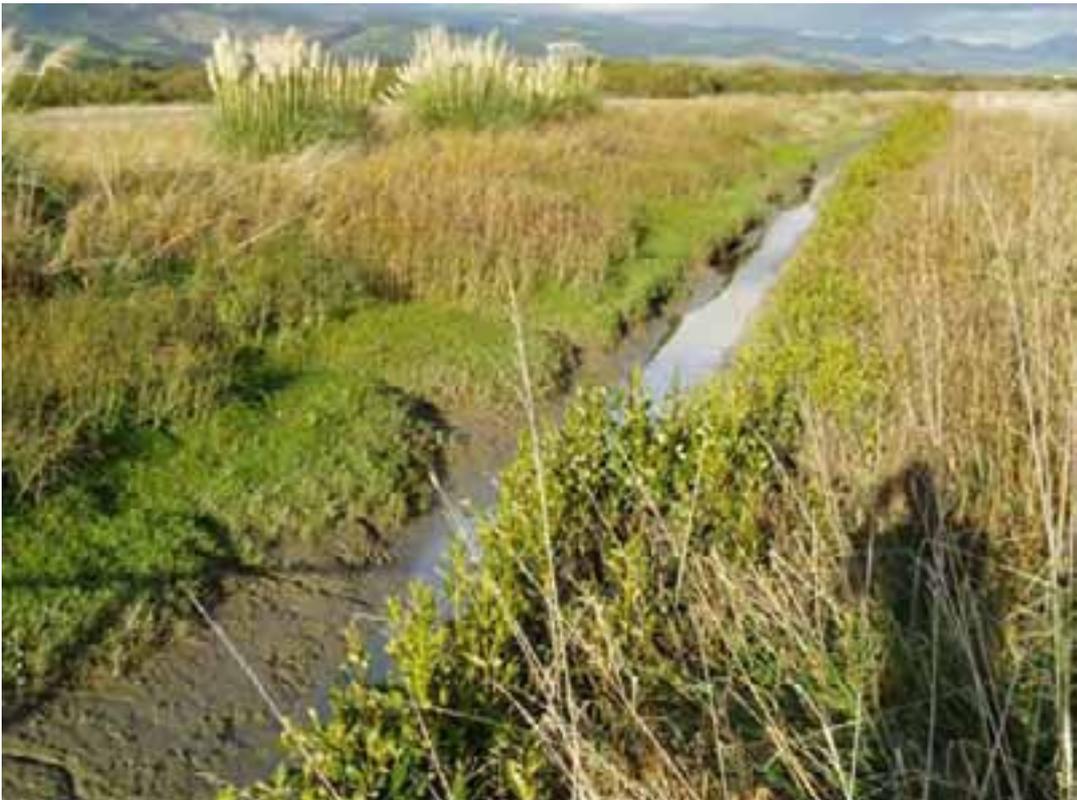
**Figure 25:** Mangroves and bachelor's button dissected the marsh clubrush swamp behind the main mangroves due to the presence of this drain.

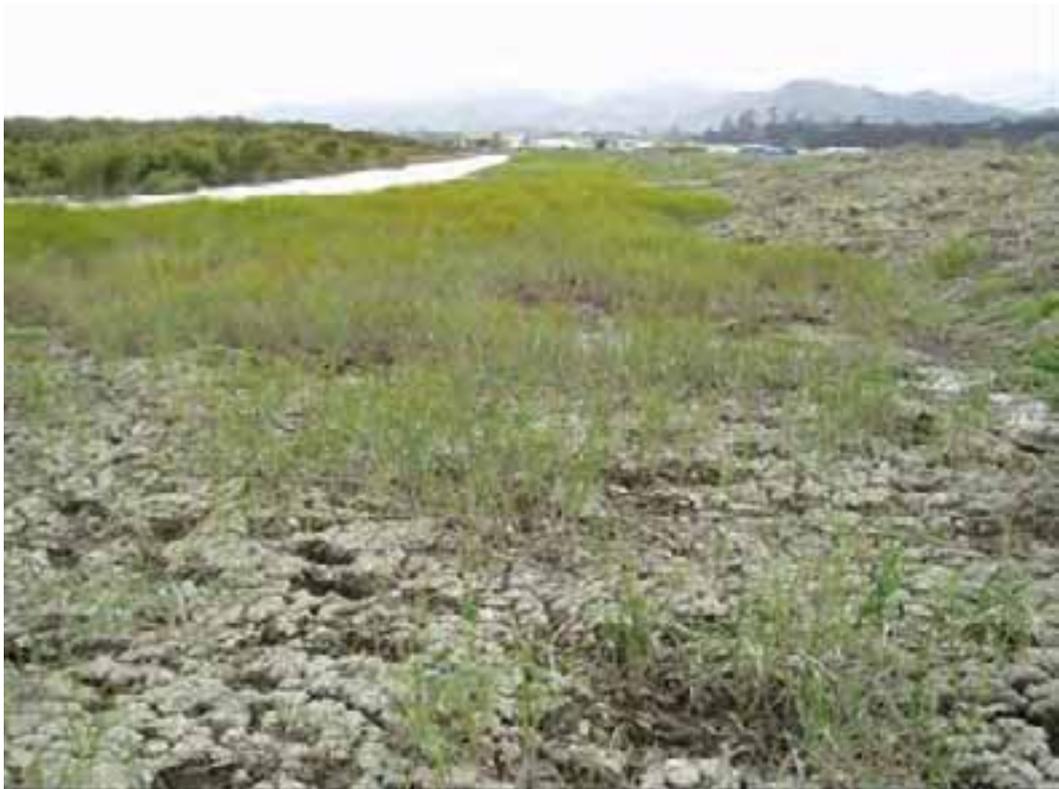
**Figure 26:** A cleared drain forms a landward boundary to the mangroves. Swamp clubrush was re-establishing on the dredgings. Kopu is in the background.

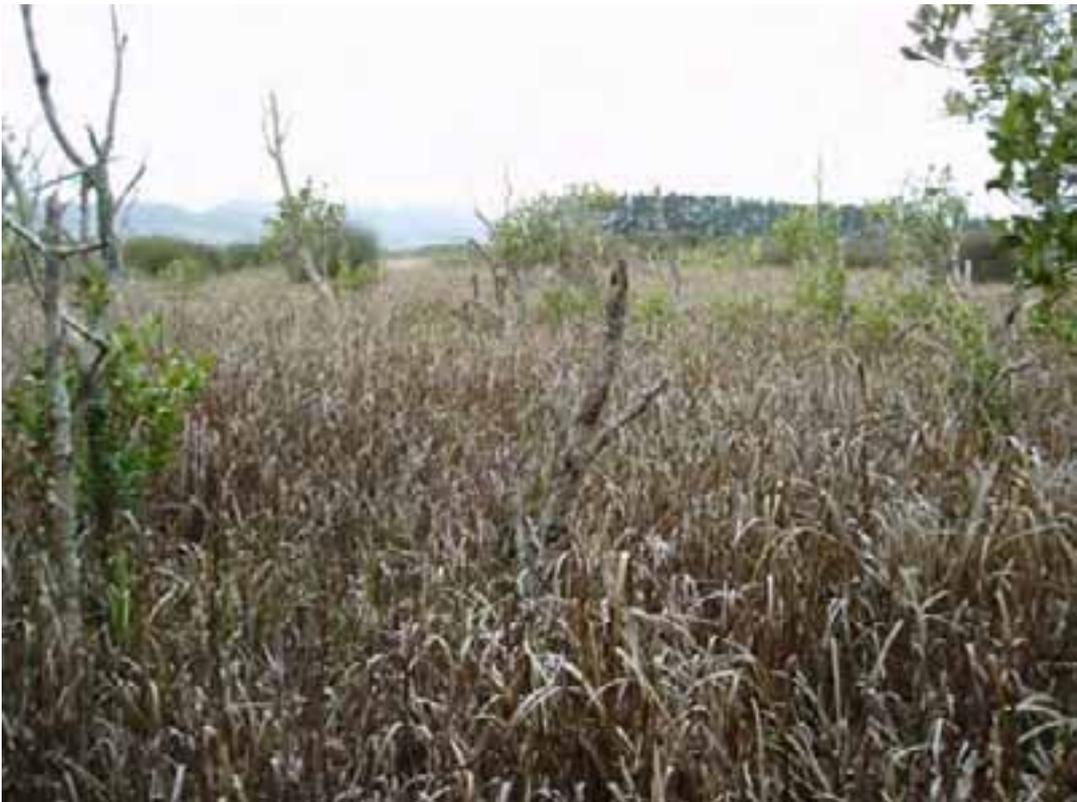
**Figure 27:** Marsh clubrush (dried leaves in foreground), large saltmarsh ribbonwood patches (dark patches in mid ground) and the odd flax characterised the back of the mangal near the Kirikiri Stream.

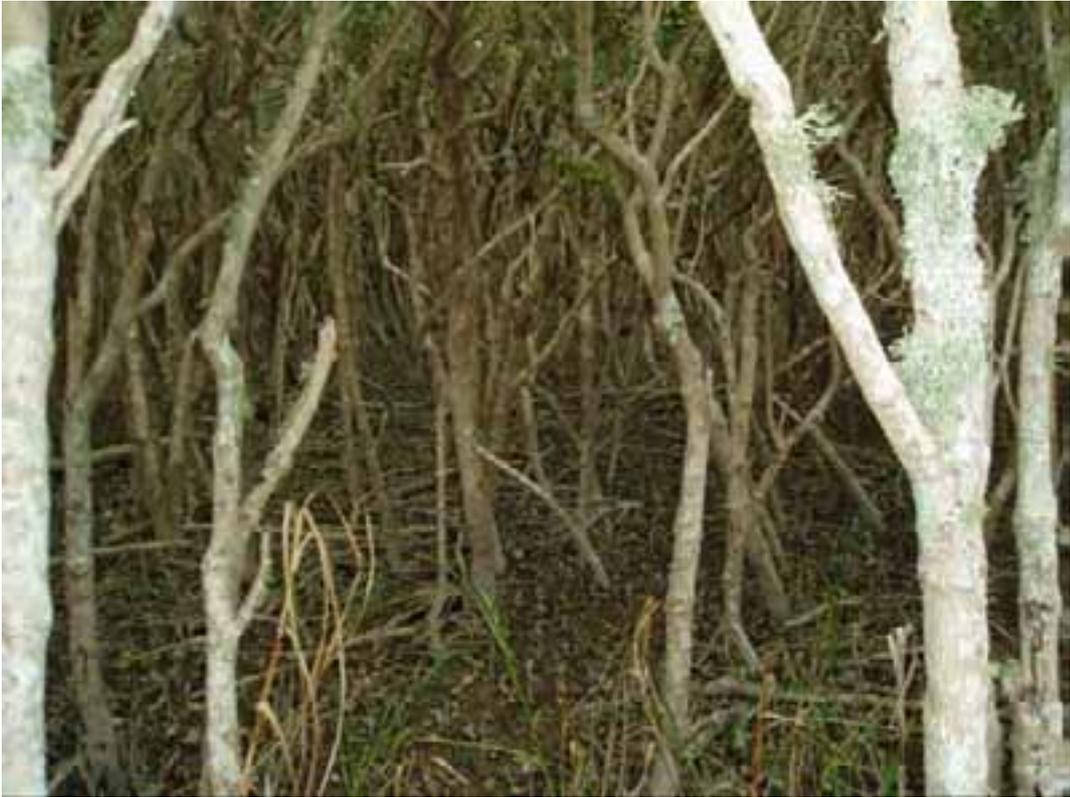
**Figure 28:** Dense 3-4 m mangal with no sea meadow groundcover along the true right bank of the Waihou River near the Kirikiri Stream.

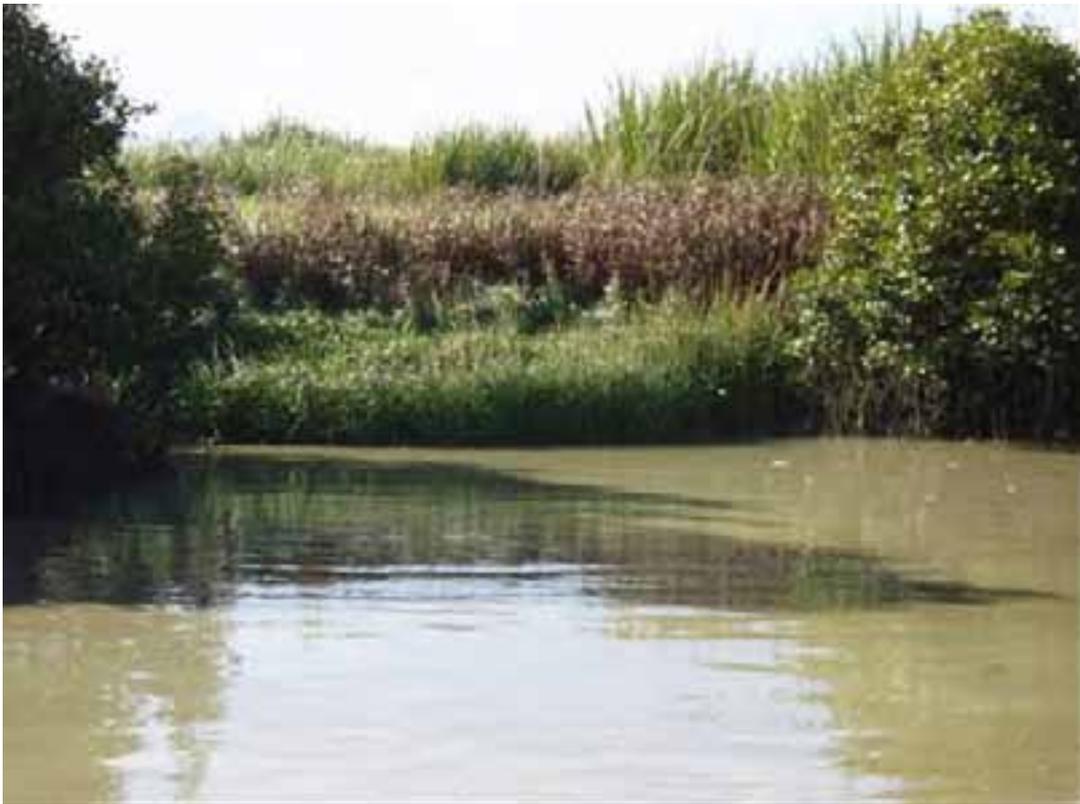
**Figure 30: Mangroves, spartina, swamp clubrush and raupo intermingled along the Waihou River bank.**

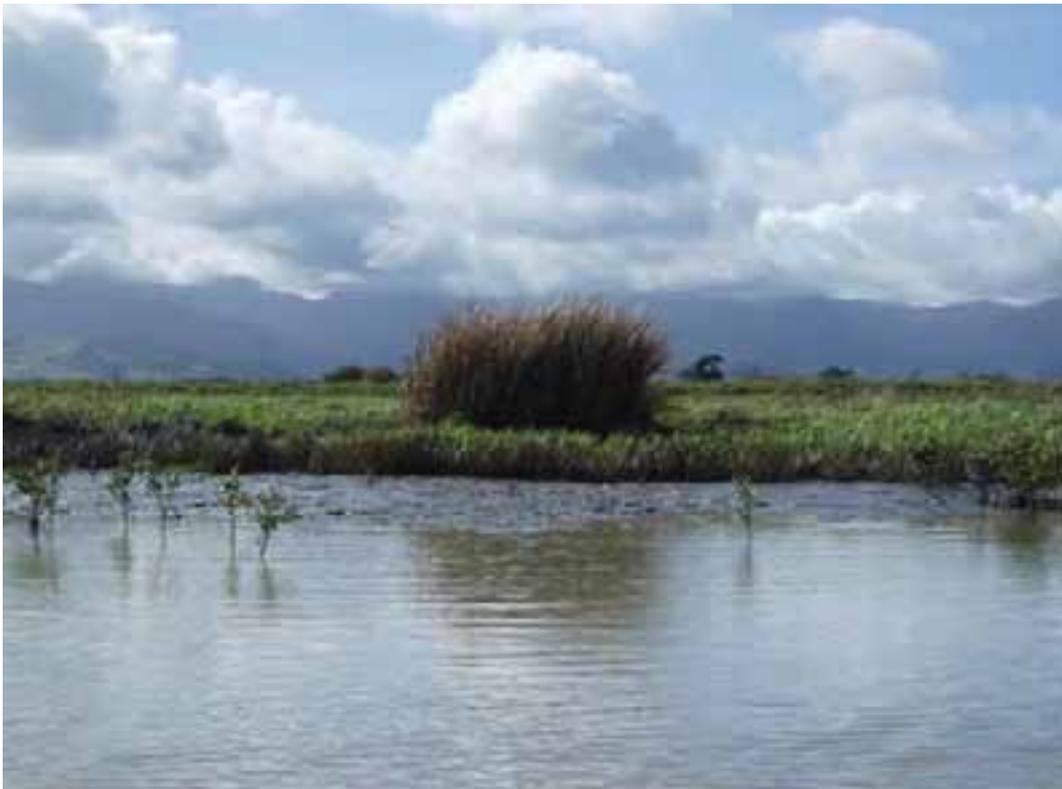
**Figure 32:** Annual rice grass on the true right bank of the Waihou River opposite Tarua.

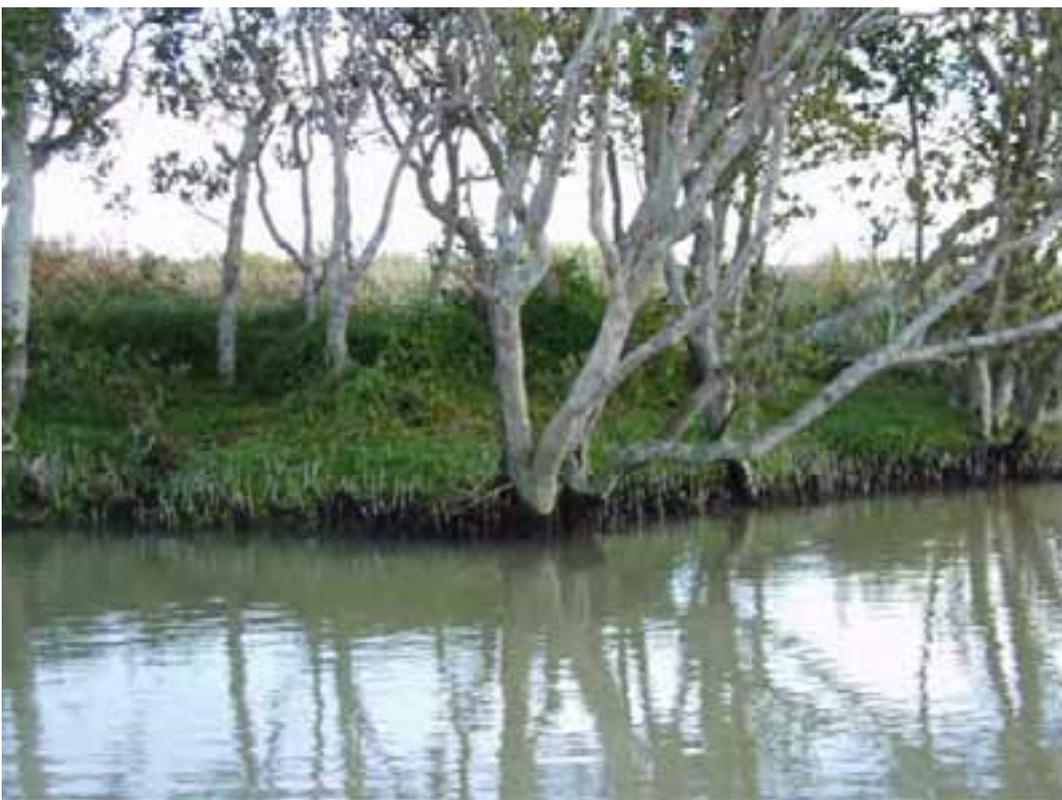
**Figure 33:** The thin band of mature mangroves lining the Waihou River bank downstream of Tarua. Sea meadow and orache carpeted the ground with farming immediately behind.

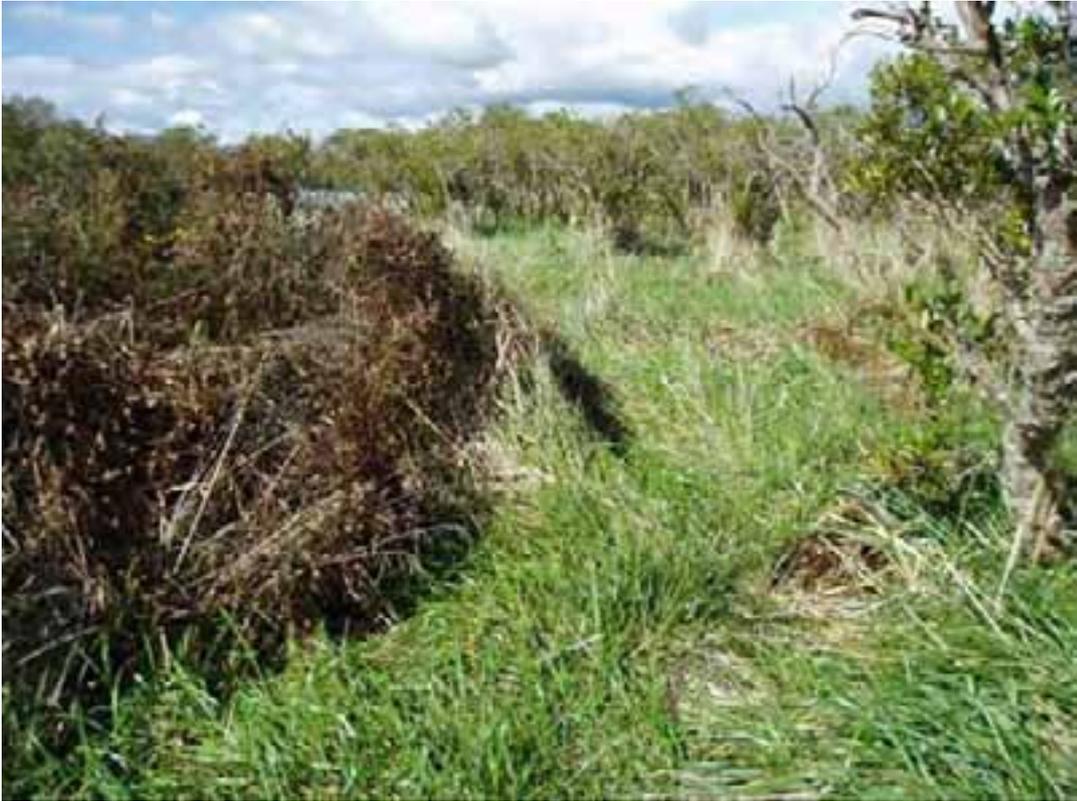
**Figure 34:** Old mangroves and tall fescue on the raised river bank near the Kopu Bridge. Convolvulus was climbing over a saltmarsh ribbonwood in the foreground.

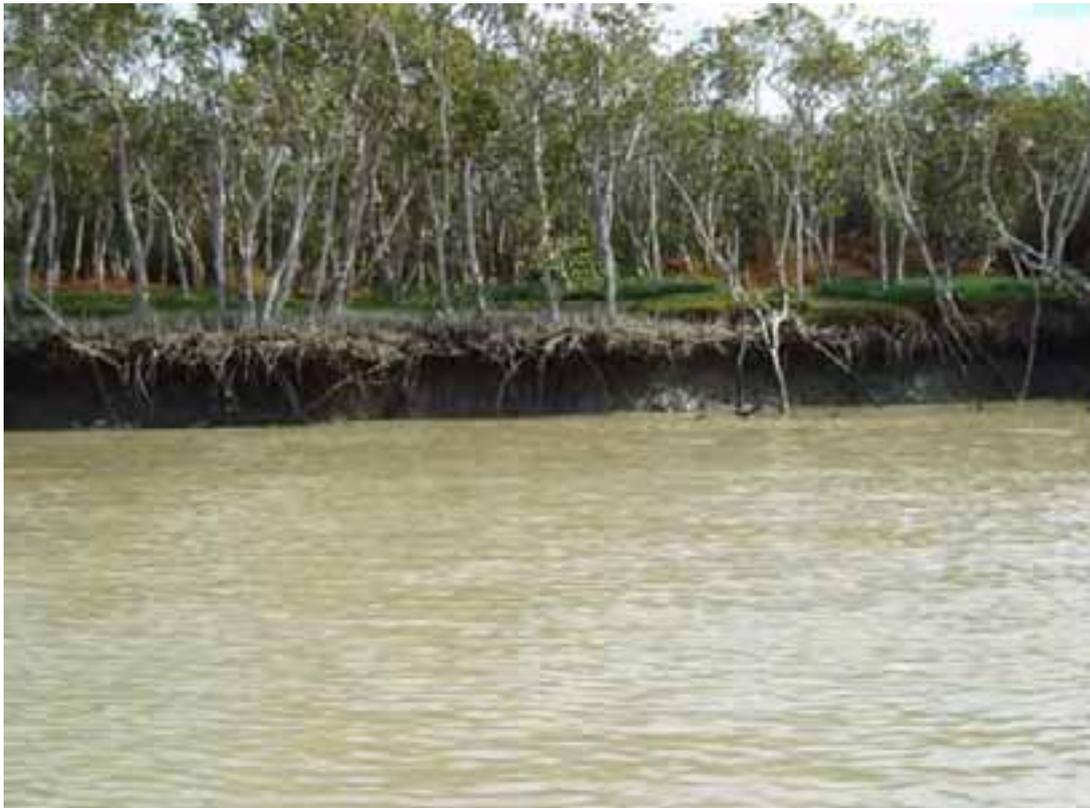
**Figure 35:** Dense sea meadow beds under the mangal canopy downstream of the Kopu Bridge (true left bank).

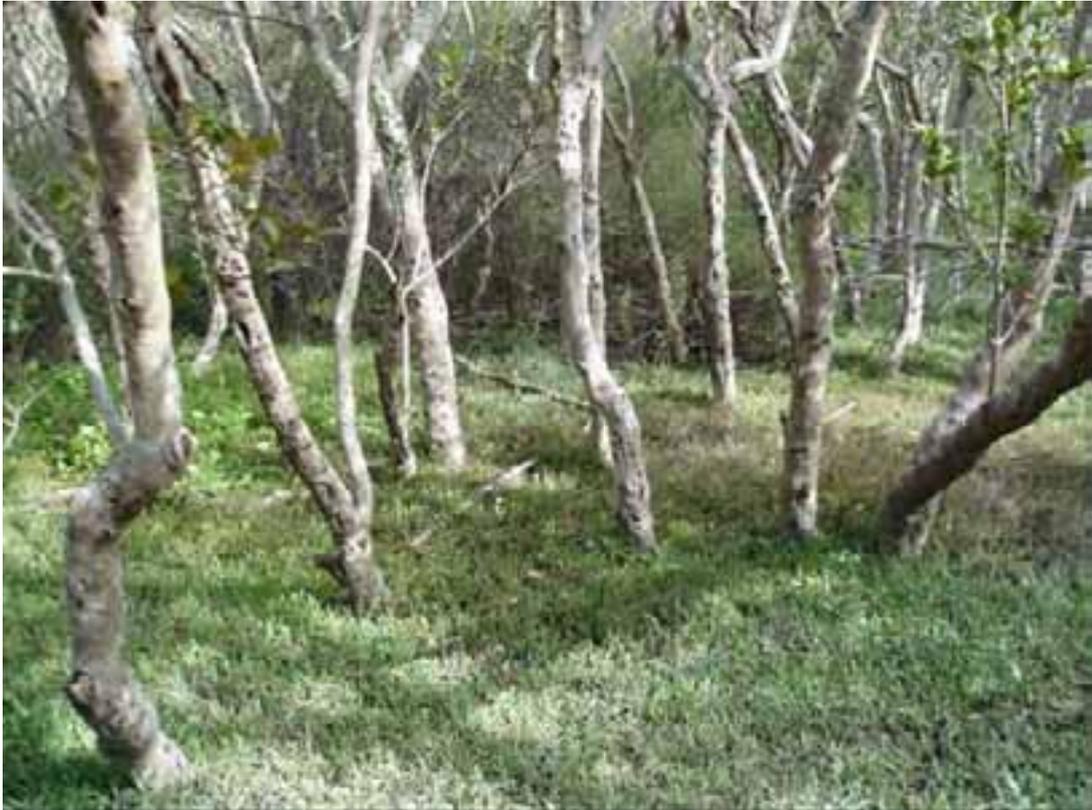
**Figure 36: Saltmarsh ribbonwood under the mangal canopy – downstream of the Kopu Bridge (true left bank).**

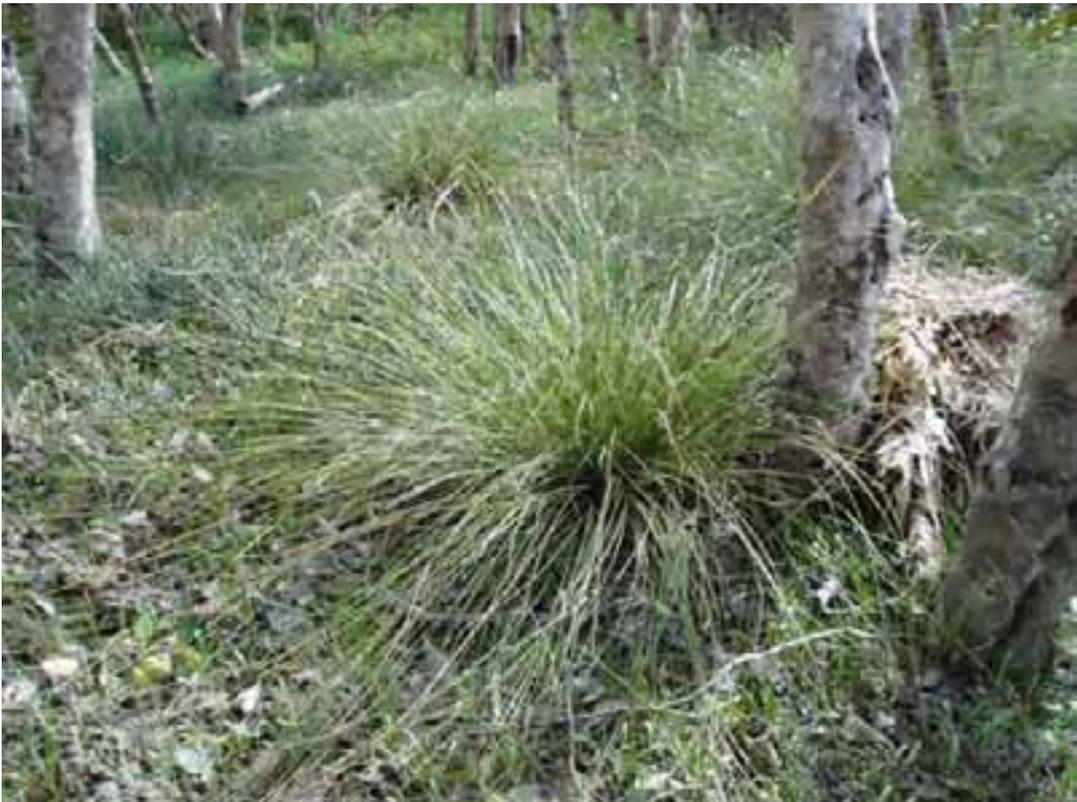
**Figure 37: An unidentified Carex amongst the remuremu and glasswort sea meadow under the mangal downstream of the Kopu Bridge (true left bank).**

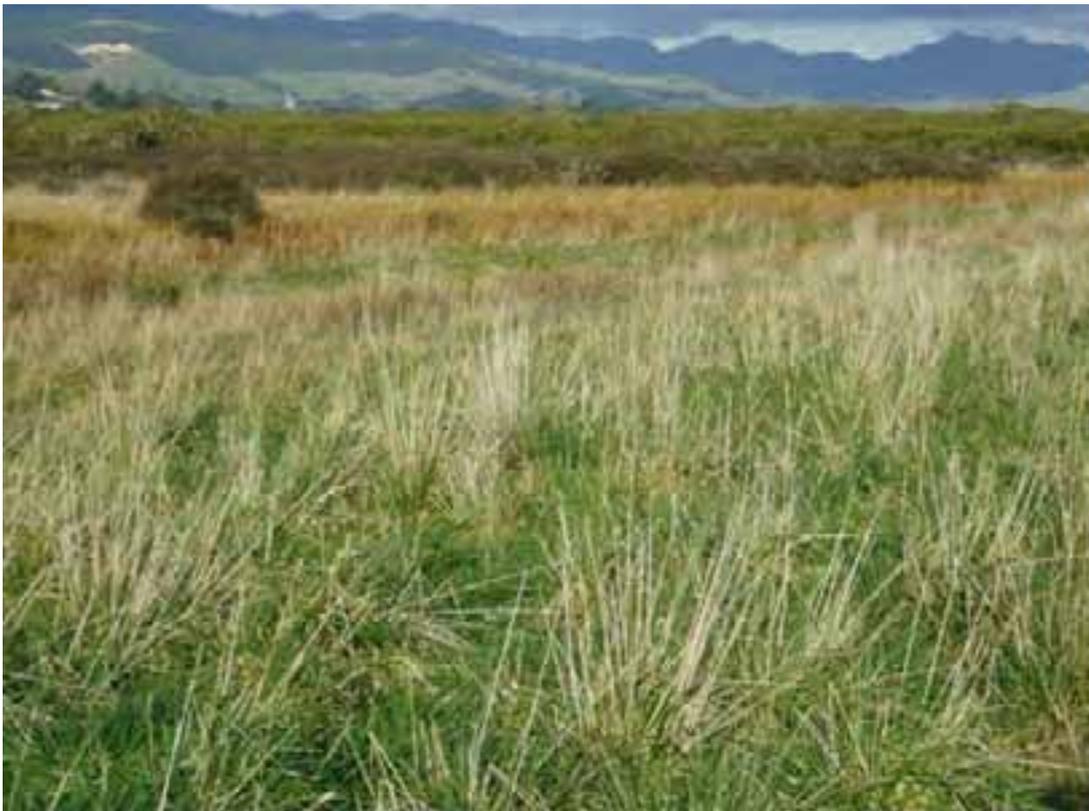
**Figure 39: Saltmarsh ribbonwood and marsh clubrush (golden) behind the true left bank Waihou mangal – downstream of the Kopu Bridge.**
