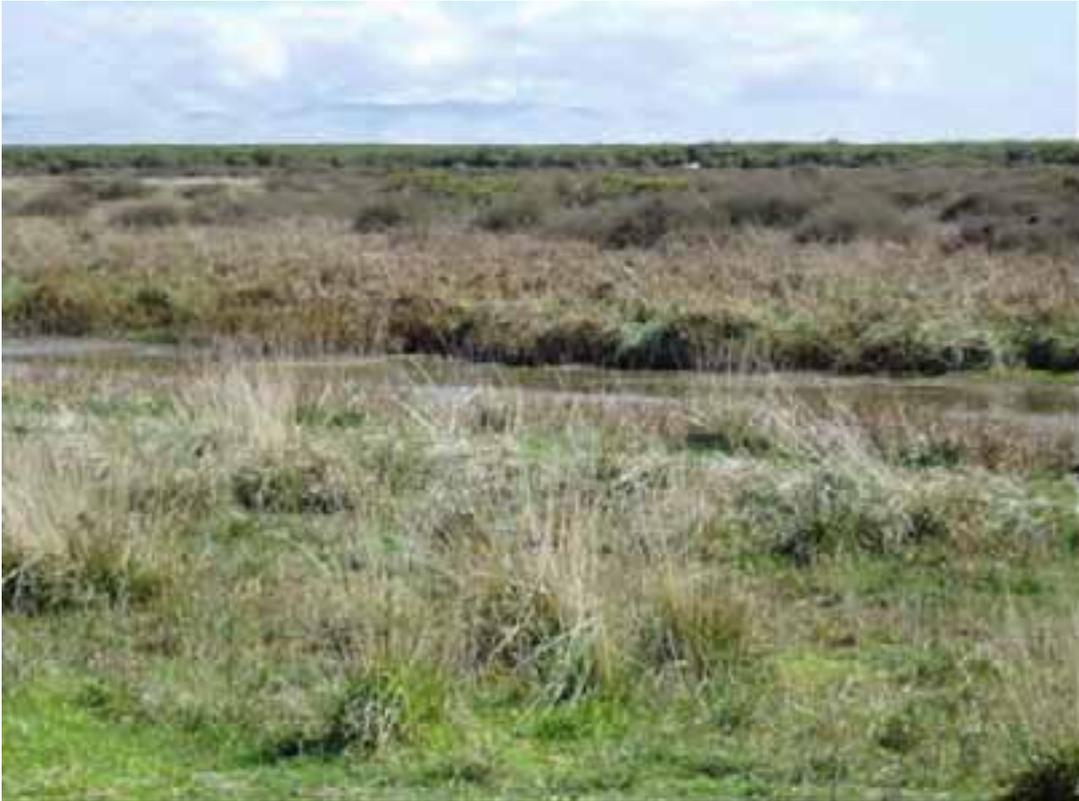
**Figure 46:** Fingers of saltmarsh ribbonwood extend out from the mangal boundary towards the stopbank, interspersed with marsh clubrush and tall fescue.

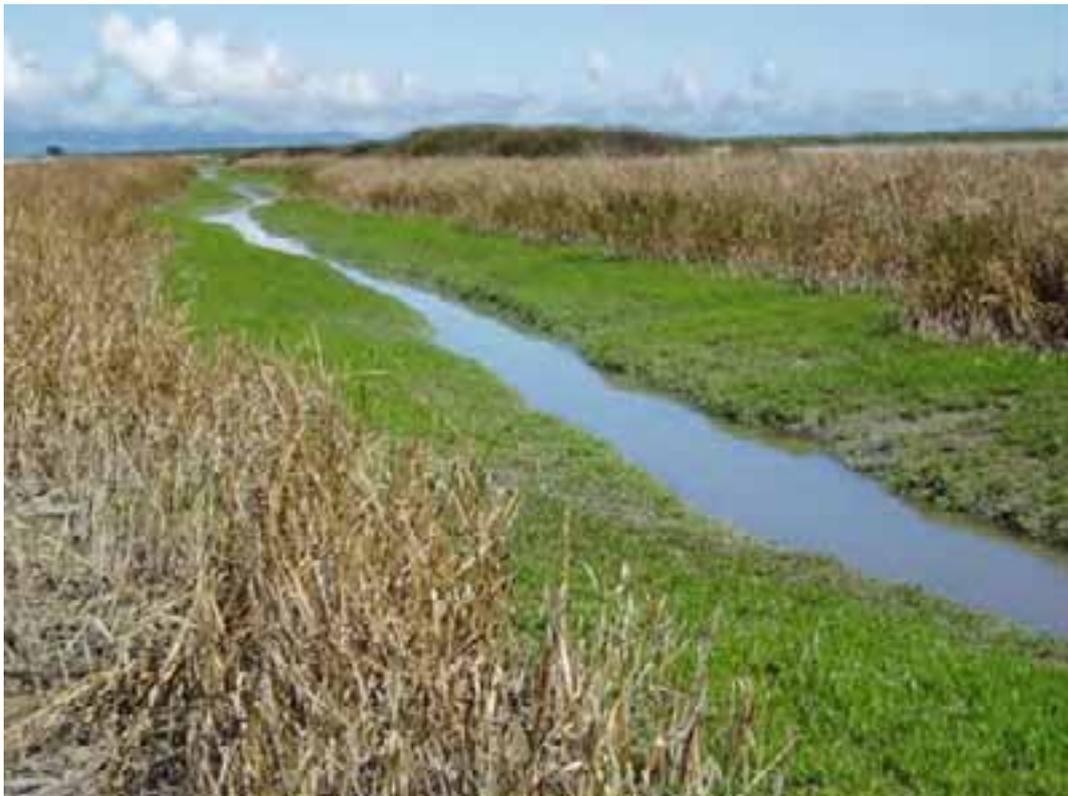
**Figure 47:** A bachelor's button dominated stretch of drain between the Waihou and Piako Rivers. Marsh clubrush dominated between the drain and the stopbank (left) and between the drain and mangal (right). A band of saltmarsh ribbonwood also lined a stretch of the seaward side of the drain.

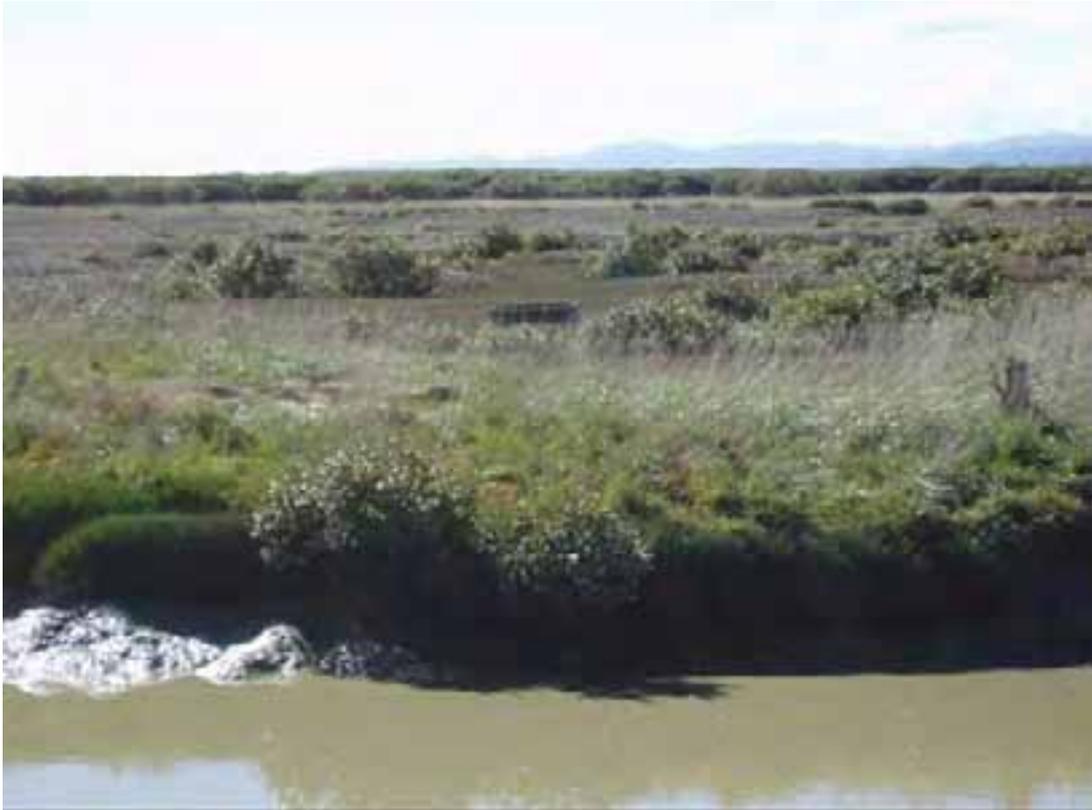
**Figure 48:** Reverted sea meadow, mangroves and swamp clubrush. Tall fescue dominated the old paddock stopbanks.

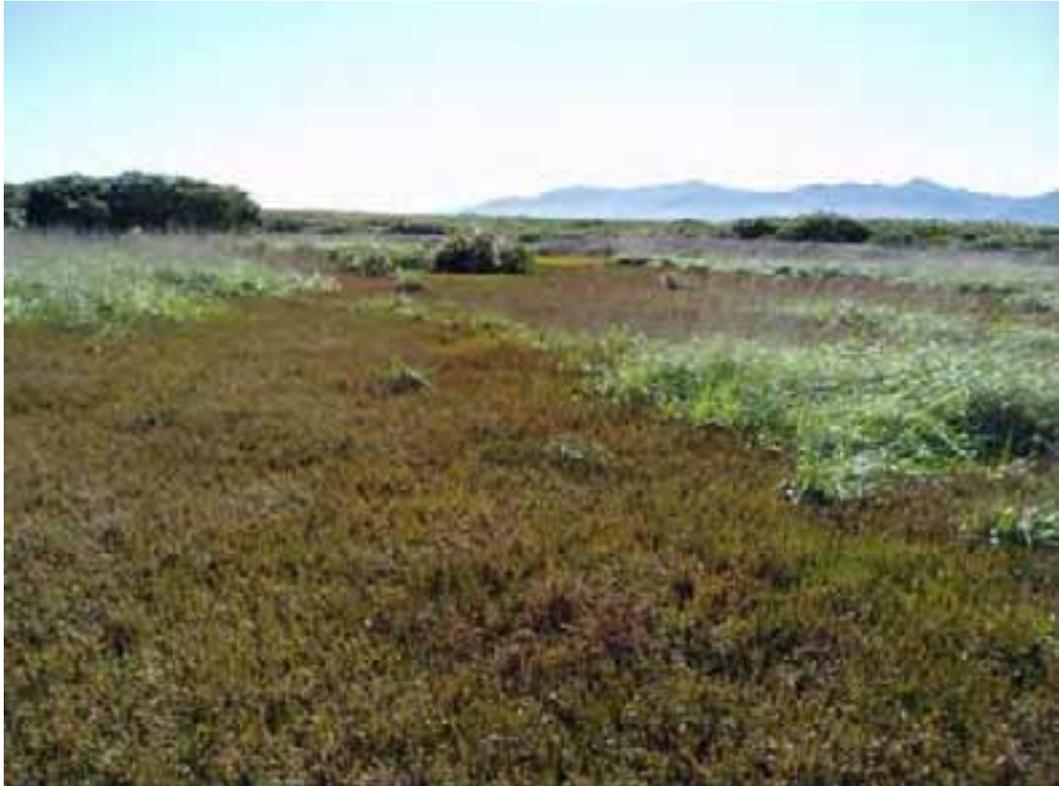
**Figure 50:** A patchwork of glasswort, tall fescue, swamp clubrush, spartina and mangroves. The spartina is the golden yellow patch showing in the distant centre beside a mangrove. Most of the spartina in the open was this colour presumably reflecting the effect of recent cold nights.

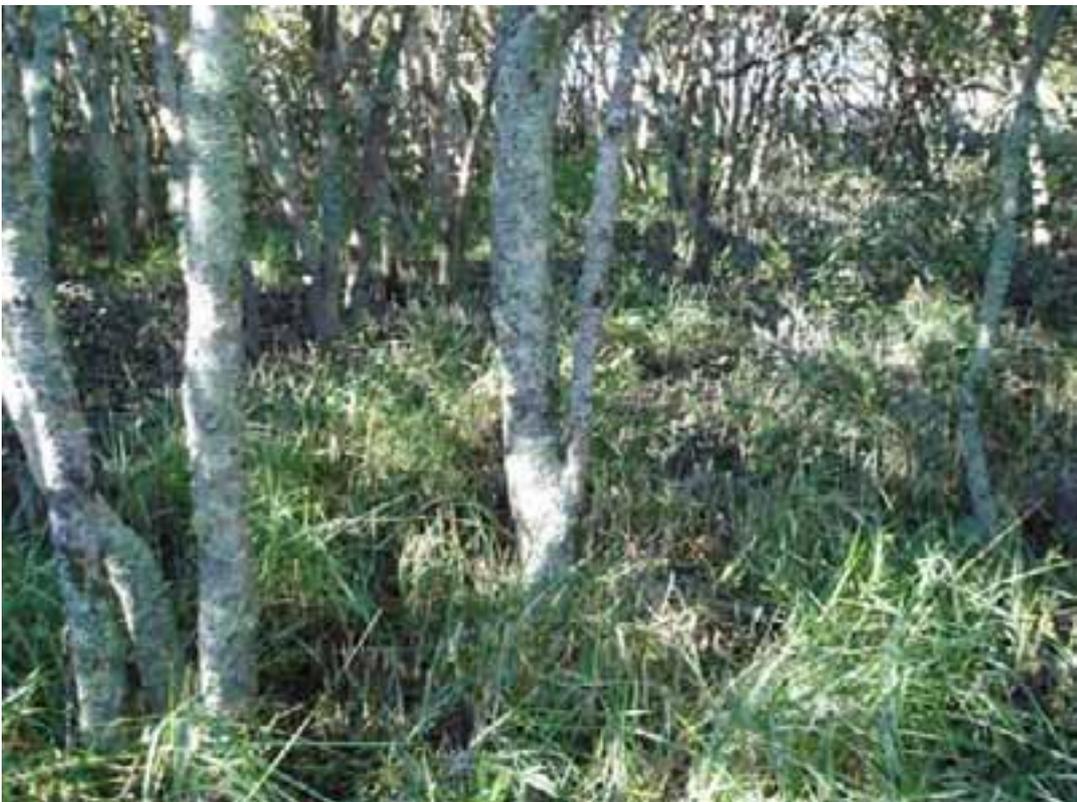
**Figure 51:** Spartina under a relatively dense mangrove canopy. Mouth of the Piako River (true right bank).

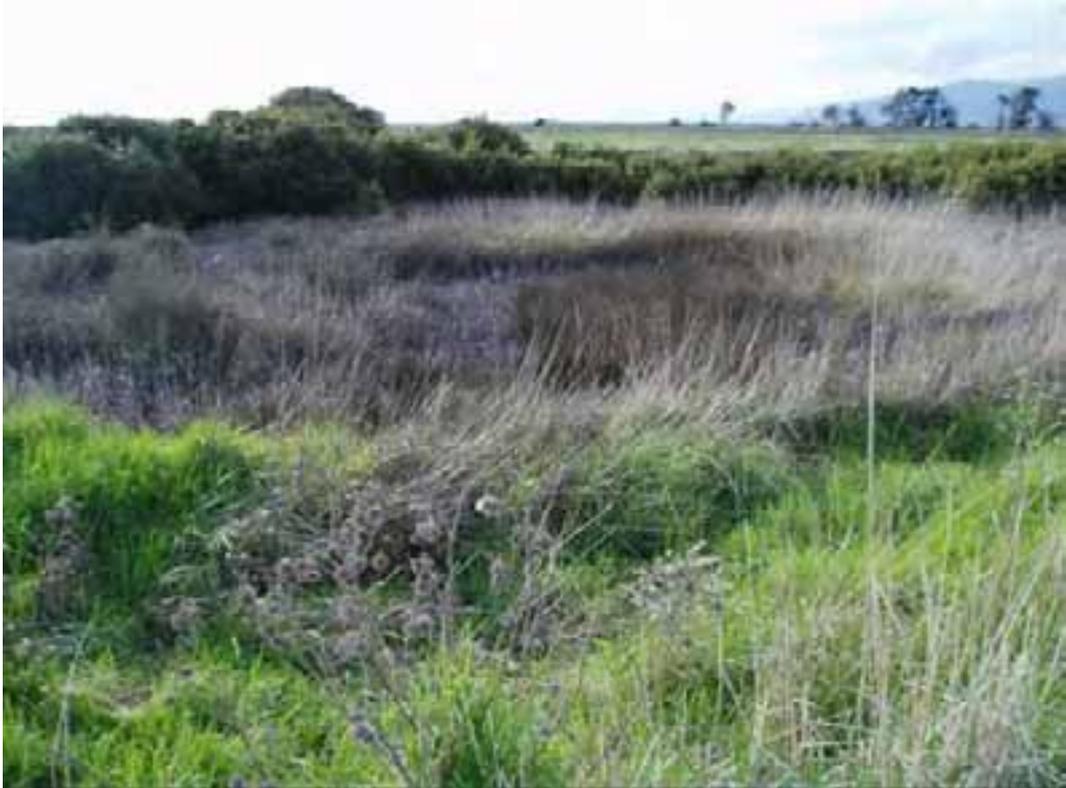
**Figure 54:** The largest patch of sea rush (dark brown in centre) found on the Piako River.

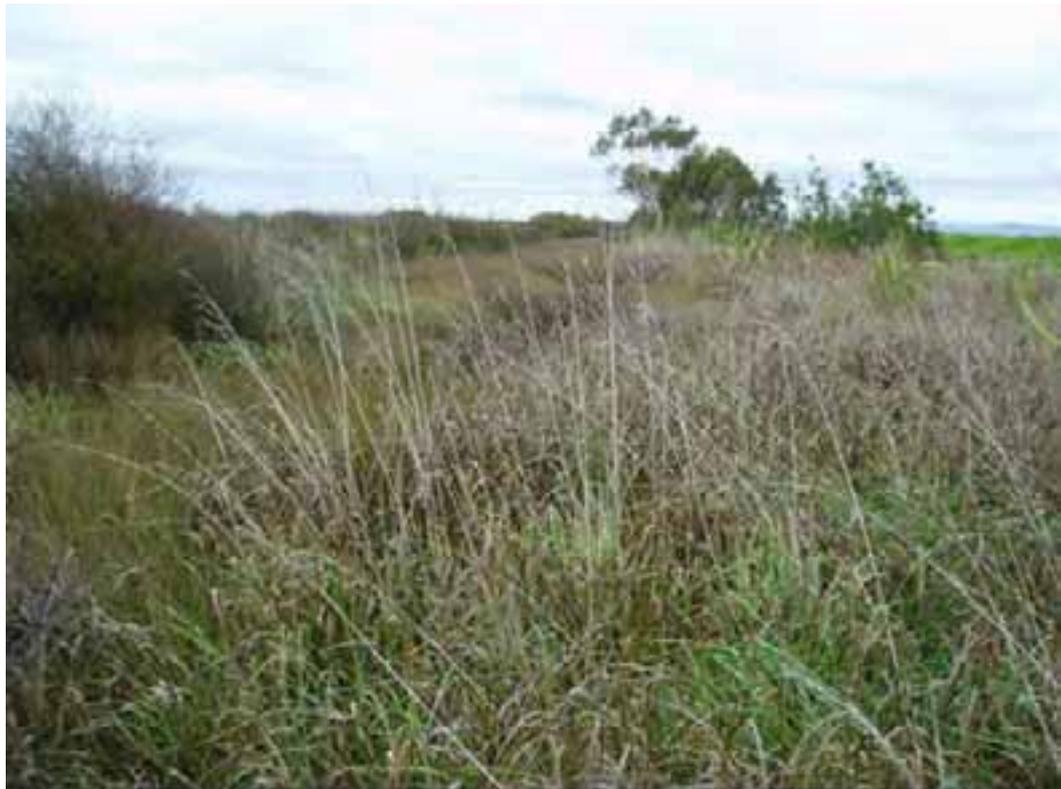
**Figure 58:** A good example of stopbank and riverside management. Here the largest band of oioi found in the Firth backed mangroves and saltmarsh ribbonwood on the edge of the Piako River (left), while marsh clubrush, tall fescue and flax grew landward towards the fenced stopbank.

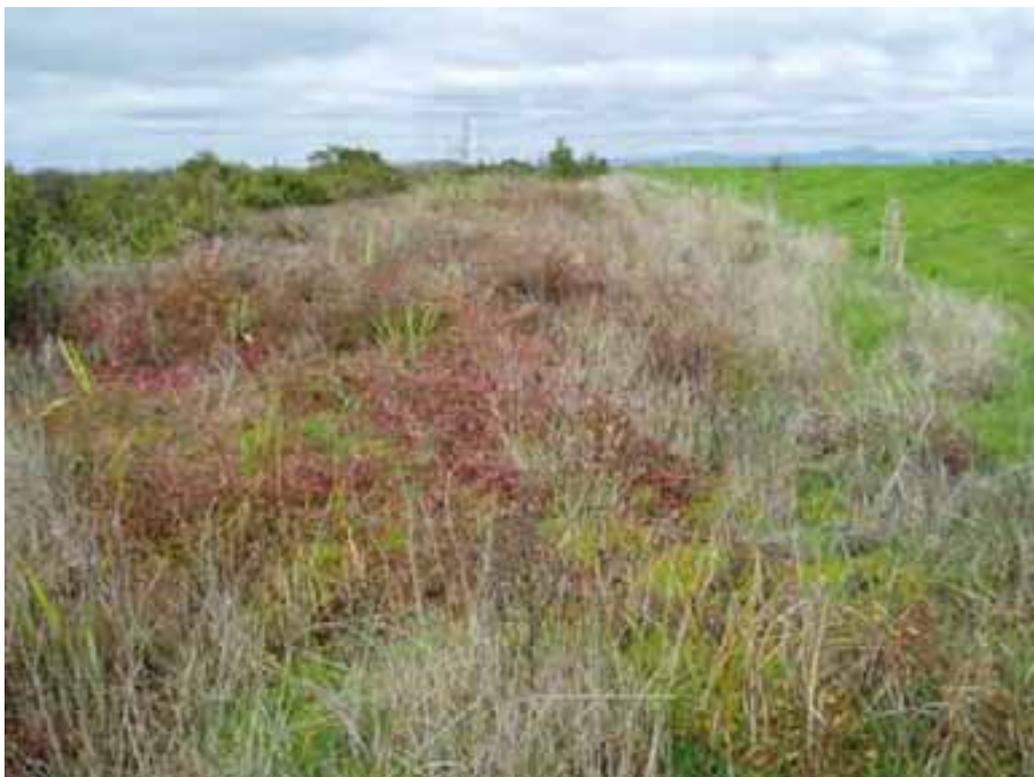
**Figure 59:** This shows good fencing and river bank management. The fence is placed at the toe of the stopbank, leaving the wet flat river edge to establish a good vegetation cover. The casuarinas (in background) are being replaced with flax planted amongst the sea meadow and other wetland species.

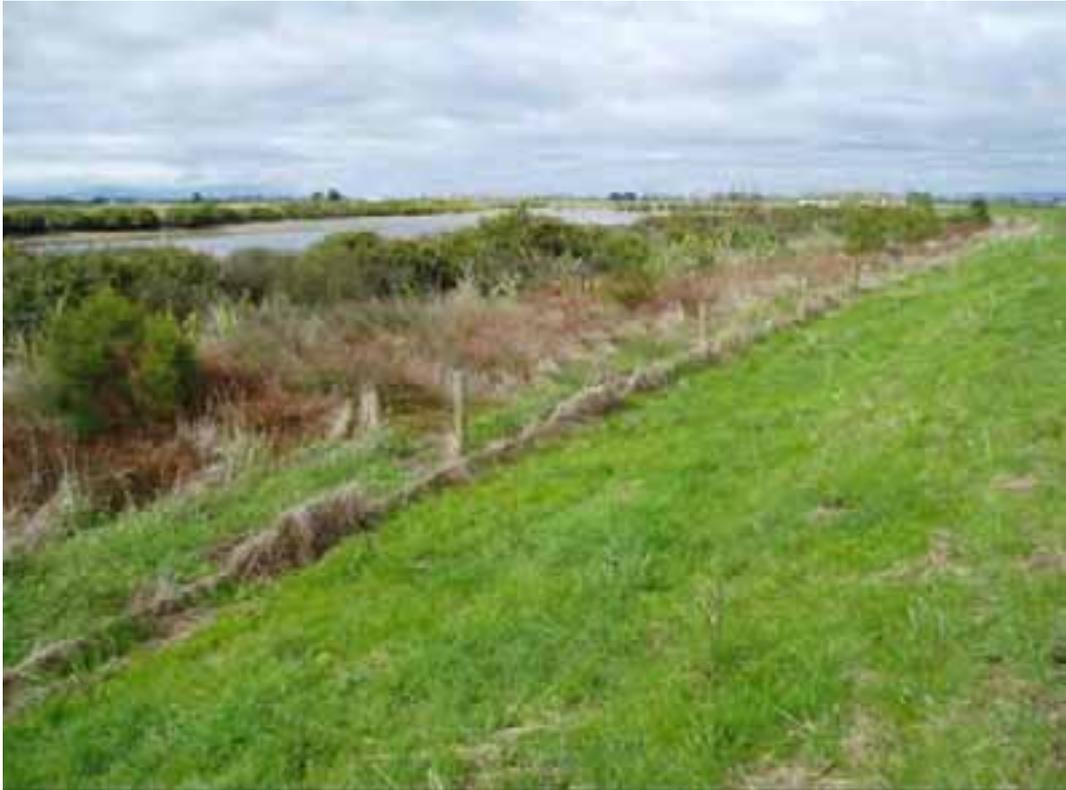
**Figure 60:** A view of the fenced off river bank and stopbank - just upstream of the Piako River bridge.

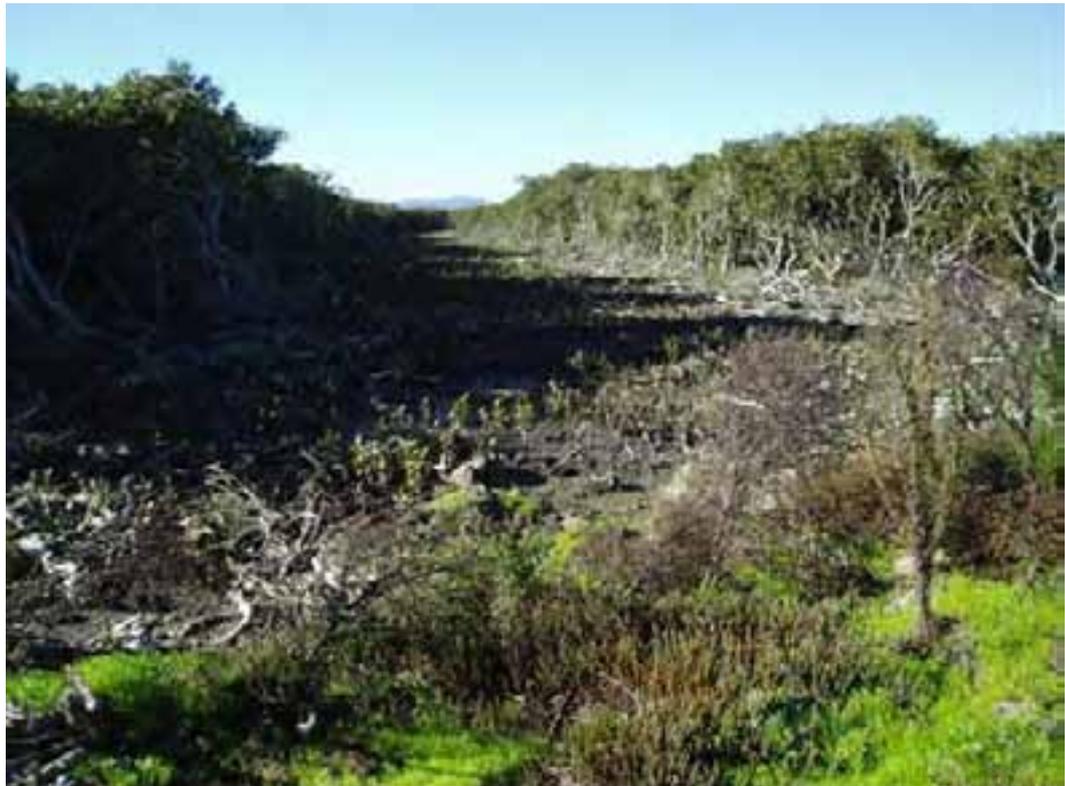
**Figure 65:** The other end of the 770 m path above.

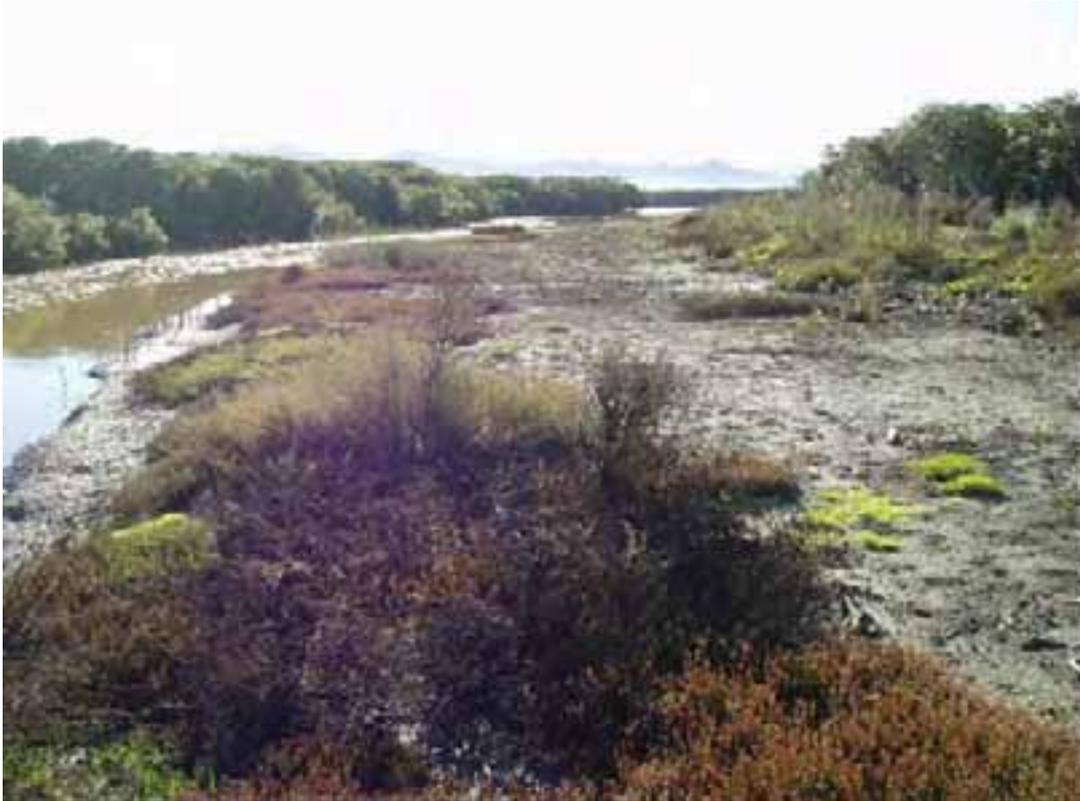
**Figure 66:** The channel that the path above led to, between the Piako and Waitakaruru Rivers.

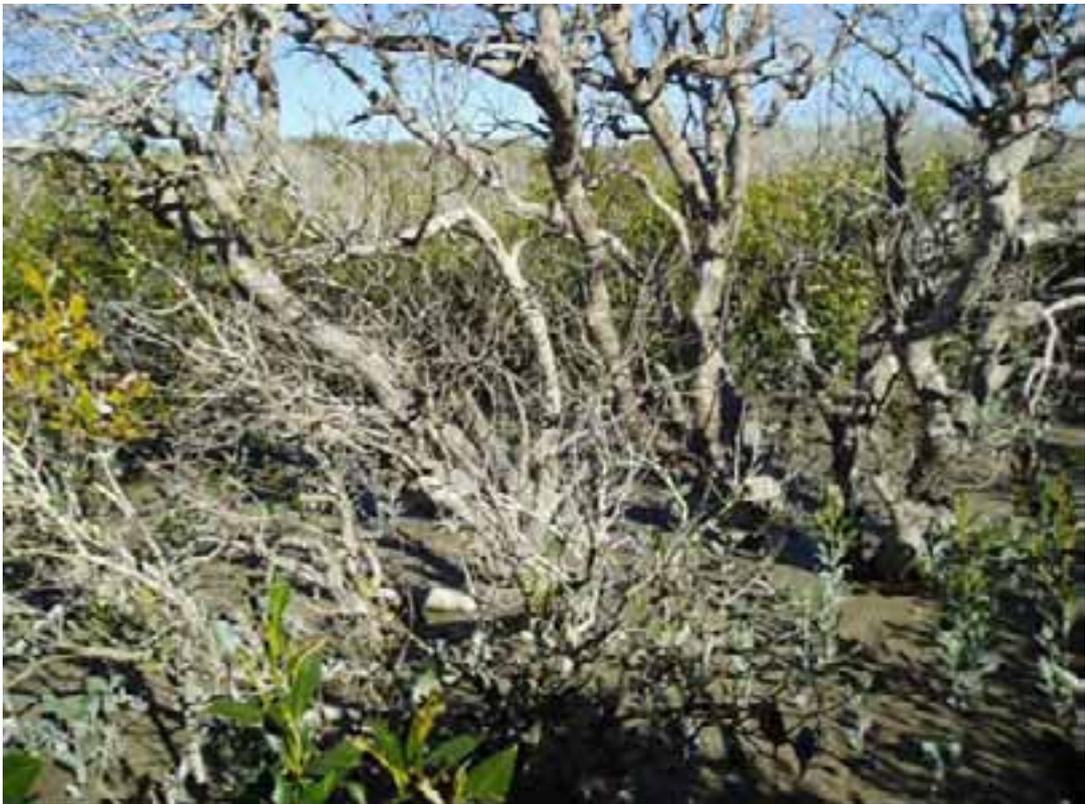
**Figure 70:** A large dead mangrove surrounded by 1 m high mangroves in the new outer mangrove zone at the mouth of the Piako River. The surrounding sediment was very muddy.

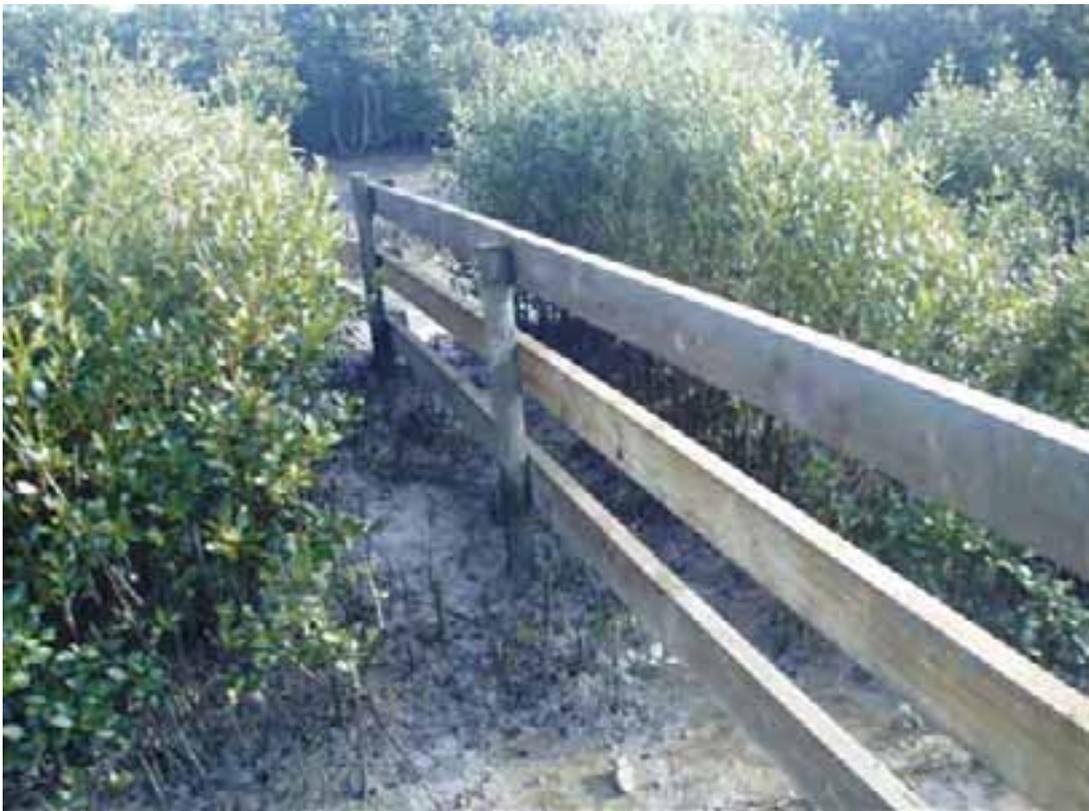
**Figure 77:** Recent fencing within the coastal marine area at the Waitakaruru end of the stopbank.

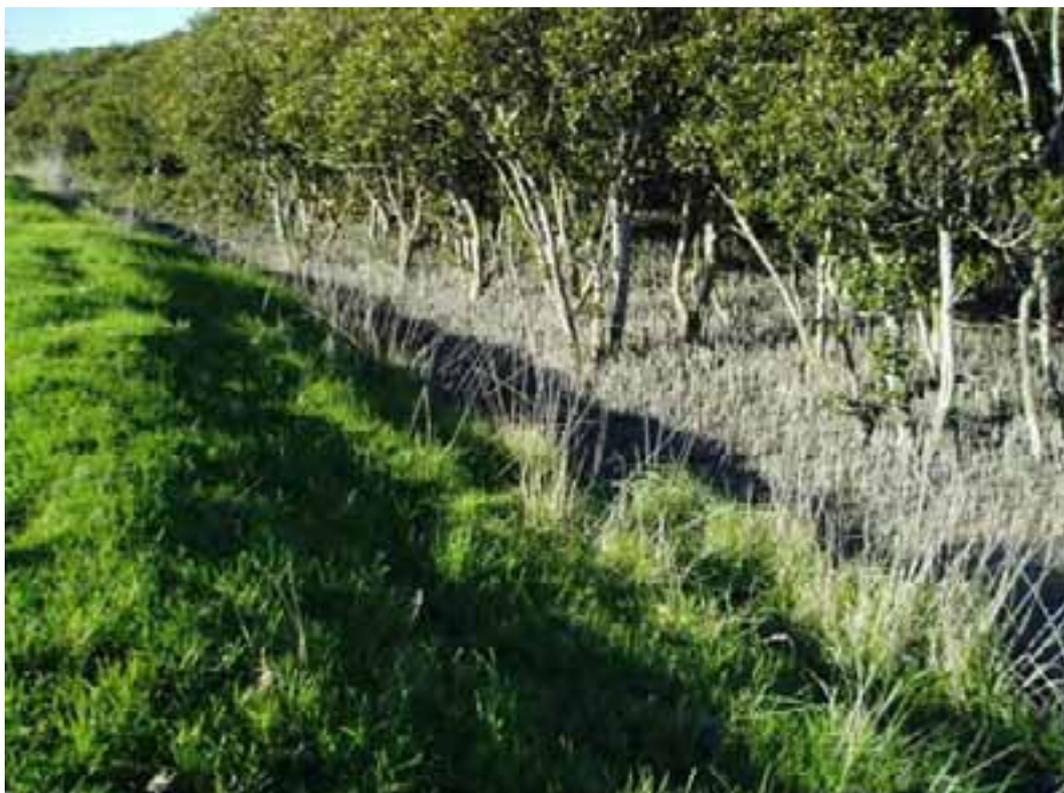
**Figure 79:** An abrupt transition from mangrove swamp to pasture where the stopbank encroaches into the floodplain at the mouth of the Waitakaruru River (true right bank).

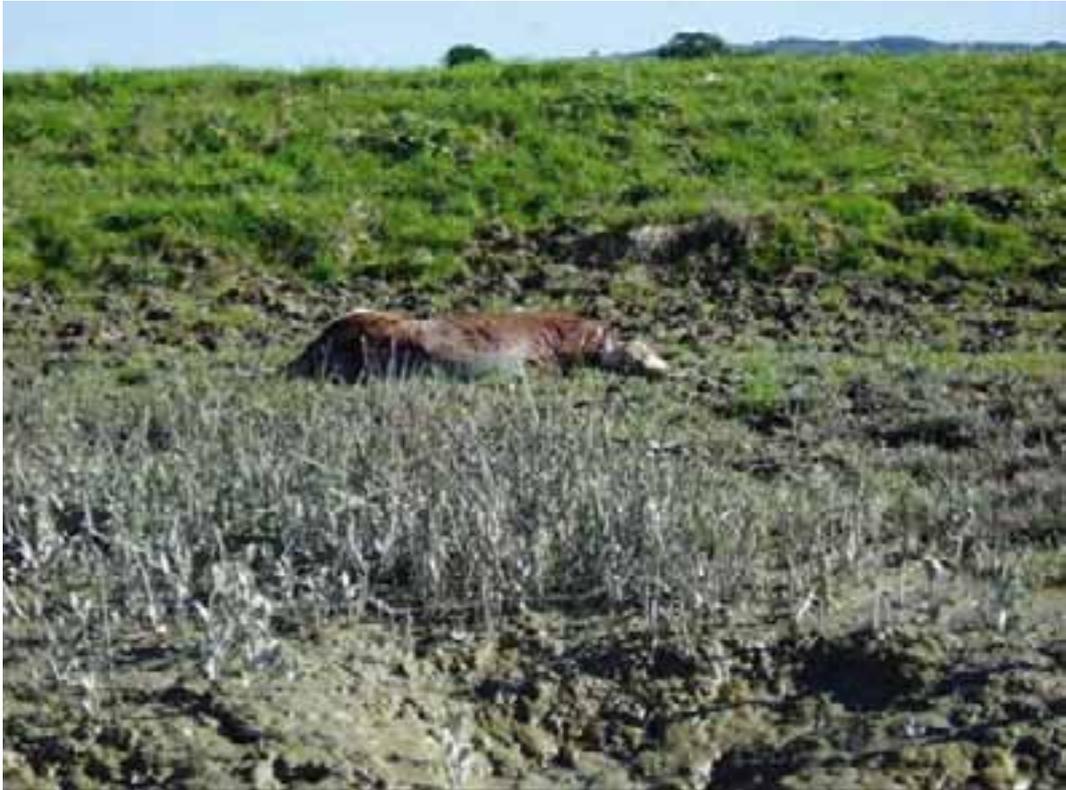
**Figure 86:** A dead cow found on the river bank of the upper Waitakaruru Canal near the upper reach of the saltwater influence. The unfenced banks were predominantly covered in marsh clubrush with some bachelor's button.

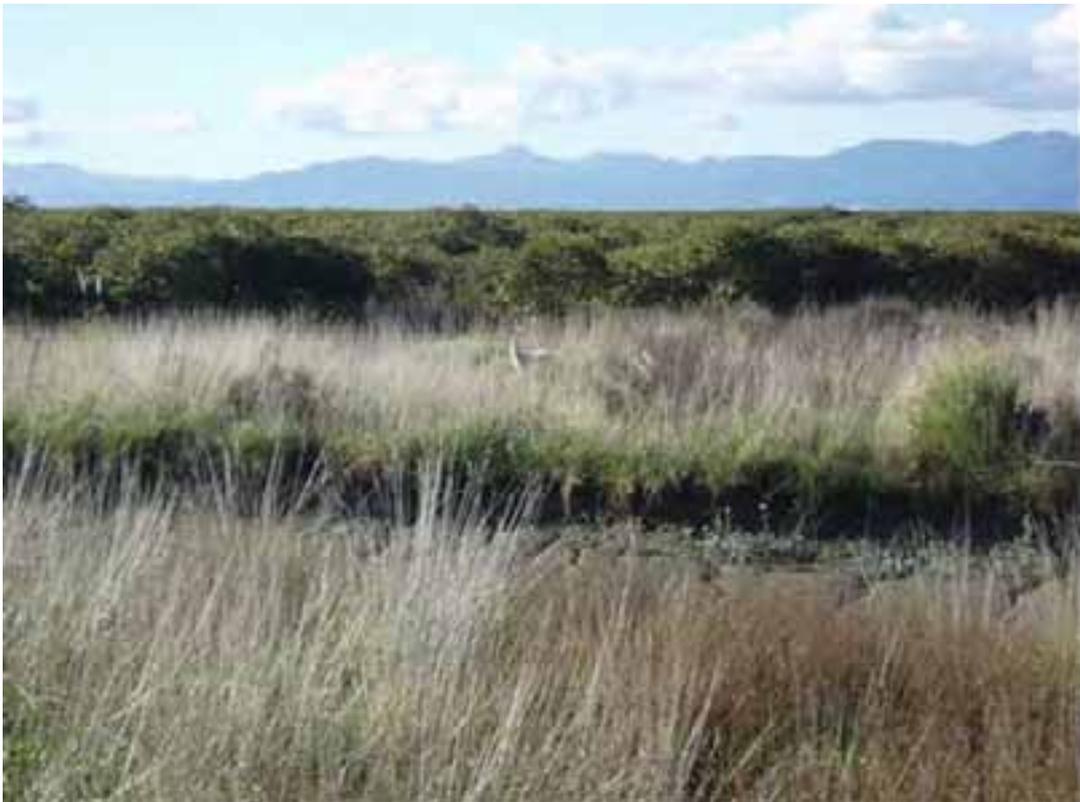
**Figure 88:** A white goat and kid across the stopbank drain in the main Firth wetland near the Waitakaruru River mouth (true left bank). Various access points from the stopbank existed between Waitakaruru and the Karito Canal.

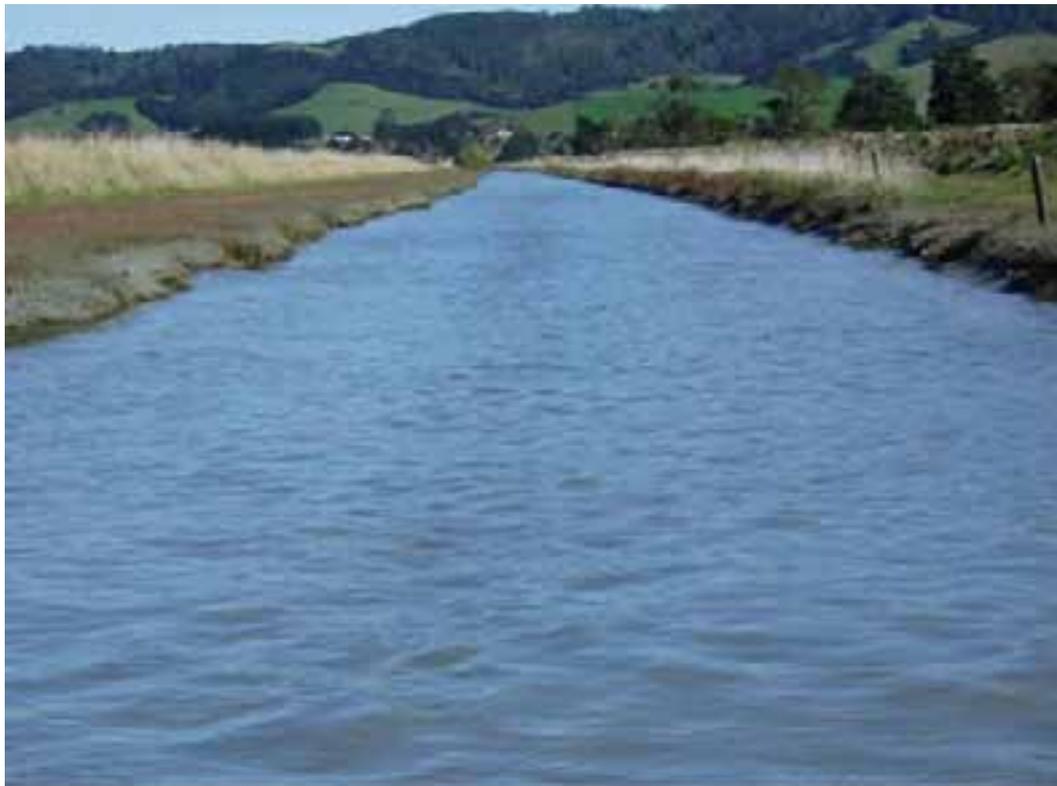
**Figure 91:** The dredged banks of the Karito Canal covered in sea meadow. Note the mangroves suddenly appearing upstream (in the distance) on the true right bank where dredging has only taken place from the true left bank.

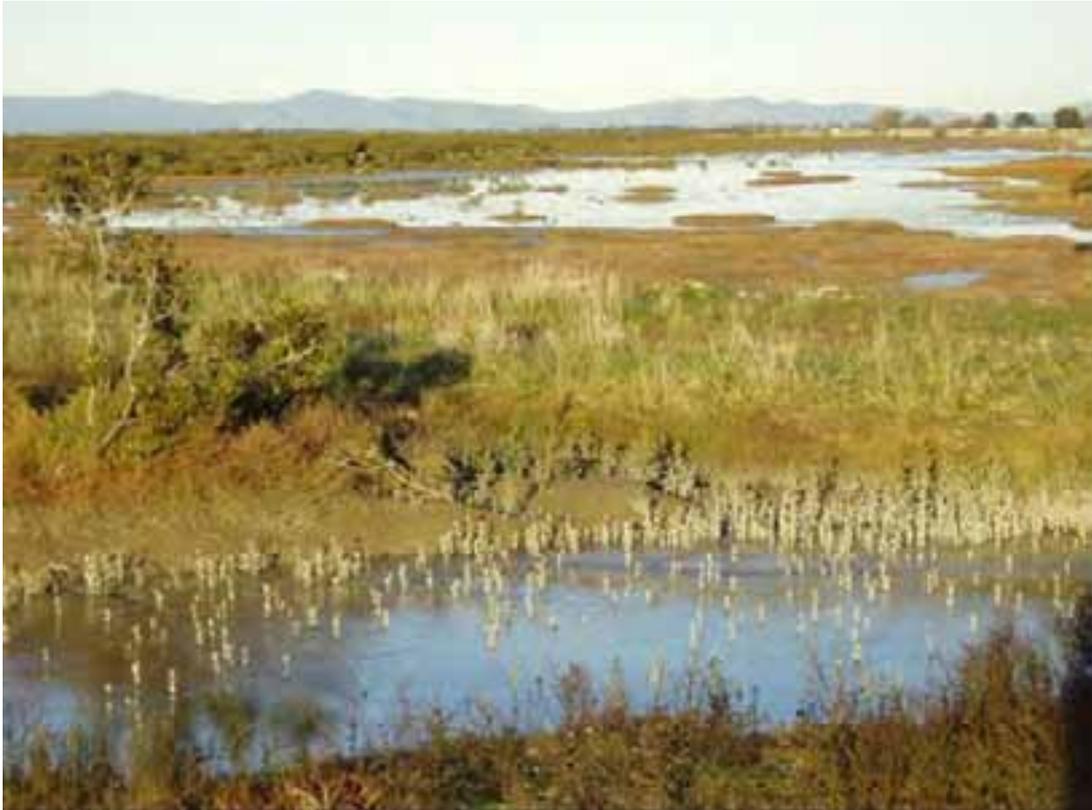
**Figure 92:** Sea meadow north-west of Karito Canal with a large patch of spartina near a maimai (orange patch abutting mangroves on left) and along the stopbank drain (orange patch extending up right hand side of photo). A white heron is standing at the end of the spartina along the drain.

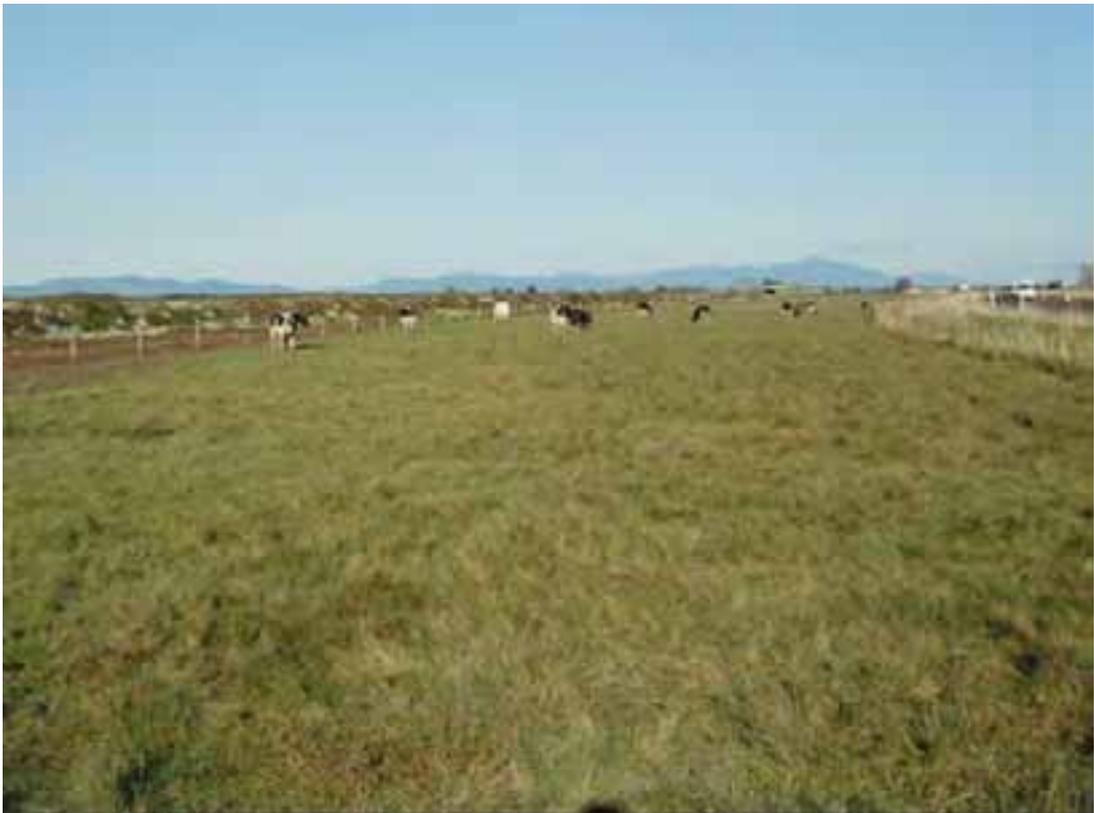
**Figure 94:** A view of the new stopbank shown above and the narrow strip of grazing between the bank and the Miranda road right. The pasture appears to be poor quality and has a mix of sea meadow species in it.

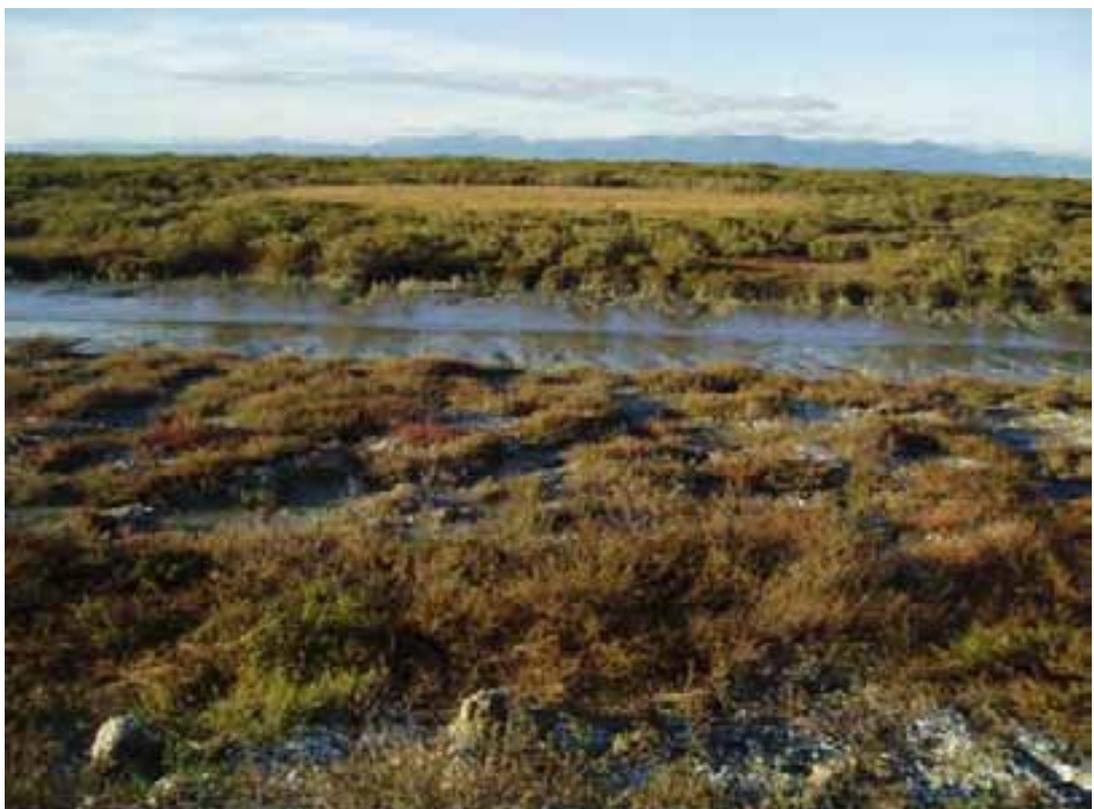
**Figure 95:** A large patch of spartina (centre background) in the mangal opposite the new drain and stopbank.

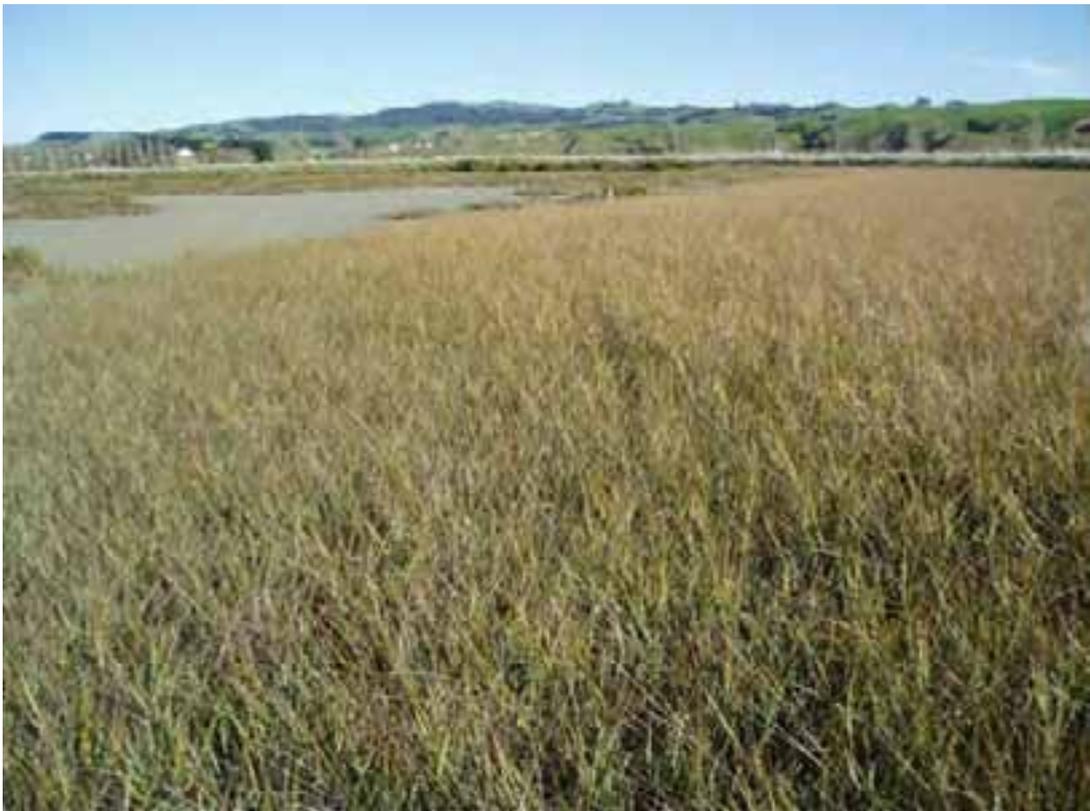
**Figure 97:** A dense spartina patch lay within a curve of the stopbank. Sea meadow and scattered mangroves are visible seaward.

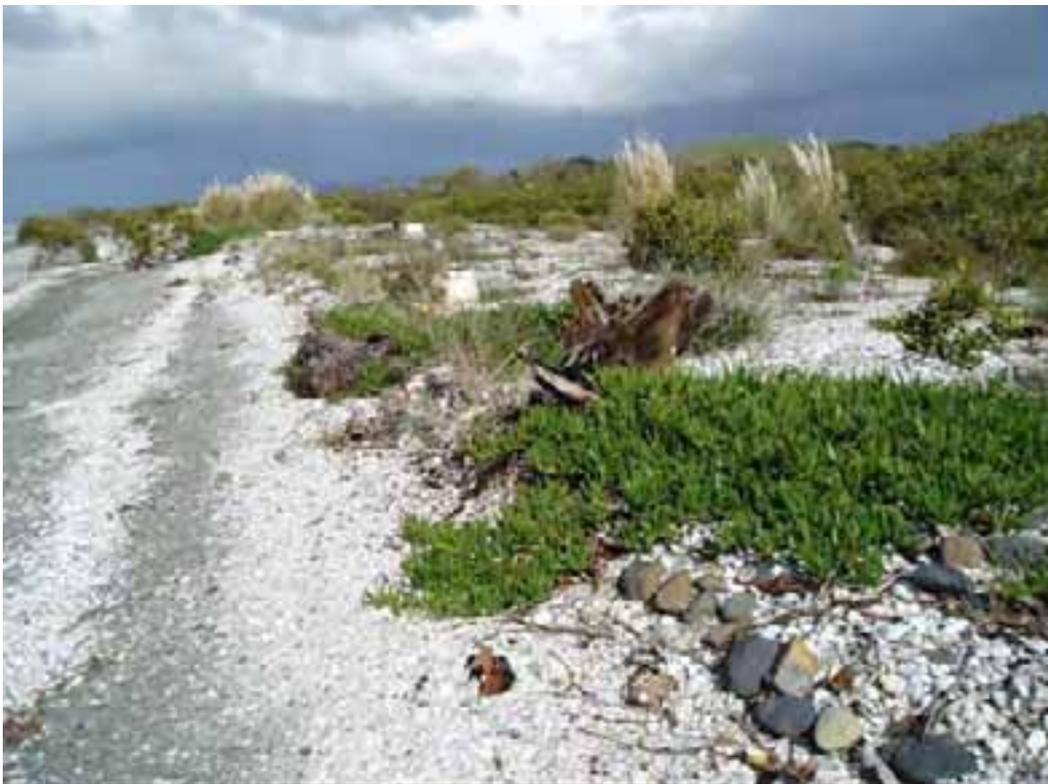
**Figure 103:** A view along an active frontal chenier on the Miranda coast. Note the mangroves that are being subsumed by the advancing chenier. Various weed species colonise the chenier bank. In this photo pampas and African iceplant are visible.

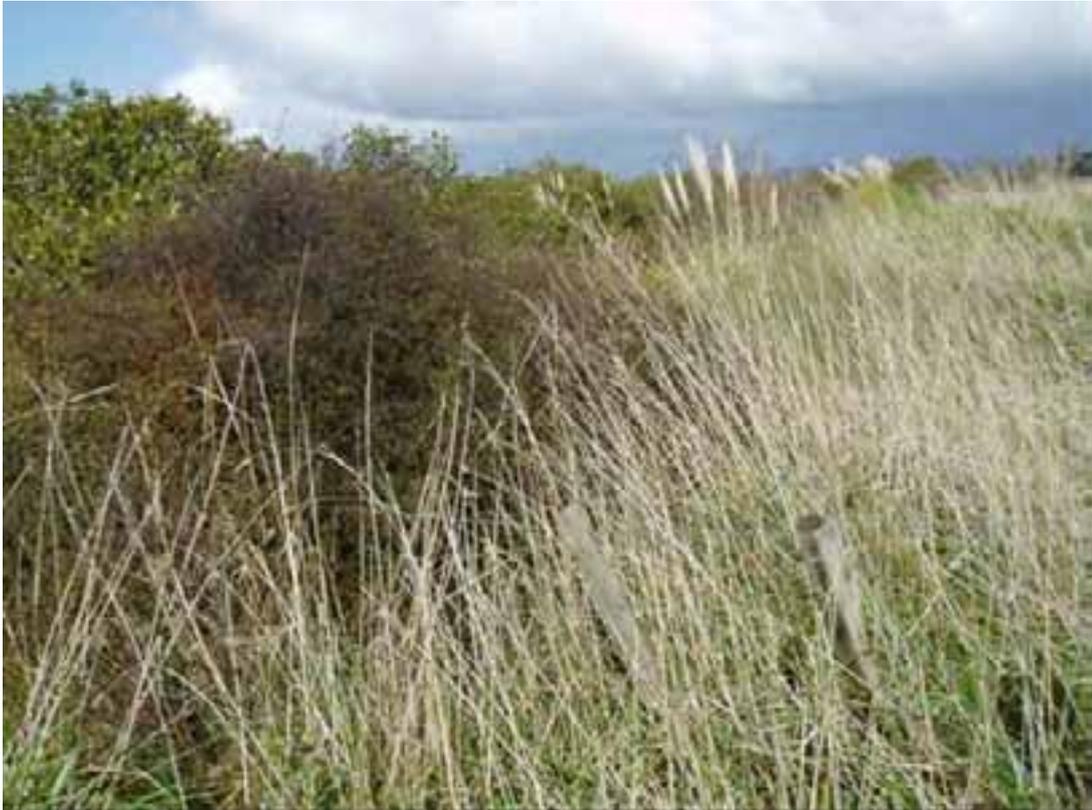
**Figure 110: A view of mangroves backed by saltmarsh ribbonwood, tall fescue and pampas just south of Kaiuaa. The coastal zone has been in-filled to the north of this estuarine vegetation community.**
